NORFOLK SOUTHERN RAILWAY CO. SHENANDOAH VALLEY RAIL CORRIDOR BRIDGE EVALUATION

STRASBURG, VIRGINIA
SHENANDOAH COUNTY

PROJECT NO. 23-1502.101

August 25, 2023

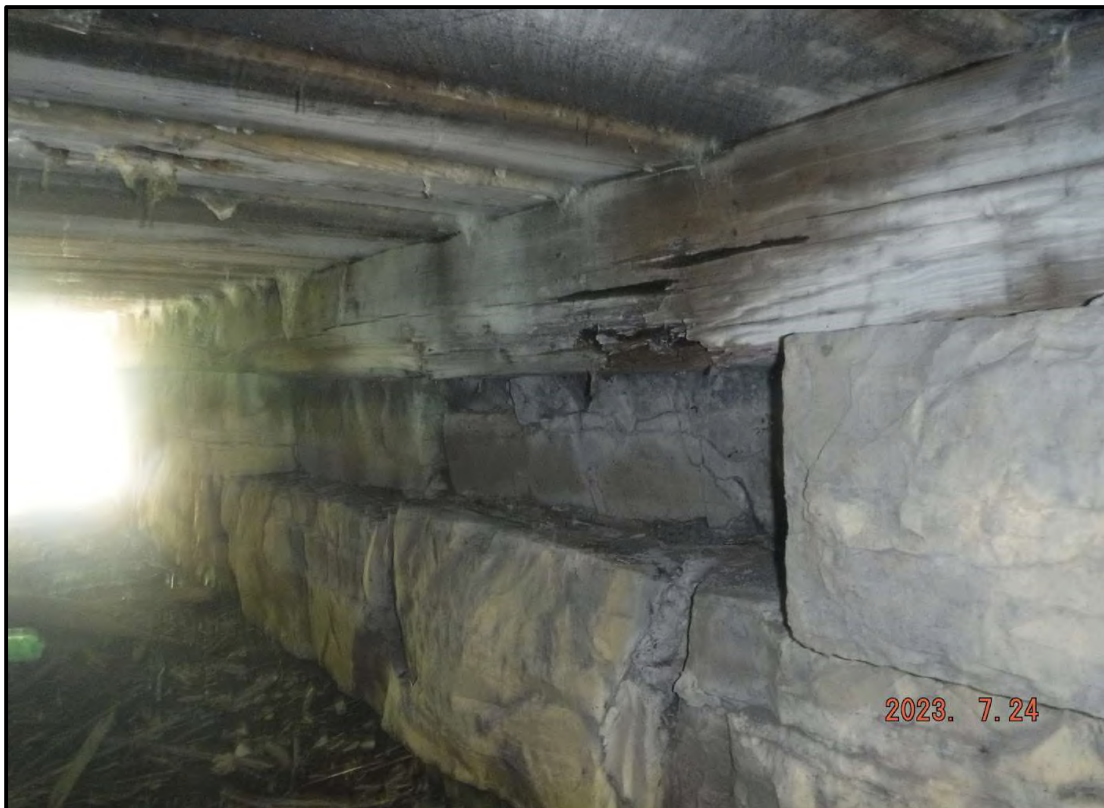
Photo 4: Spalled/Broken Stones At South End of West Abutment

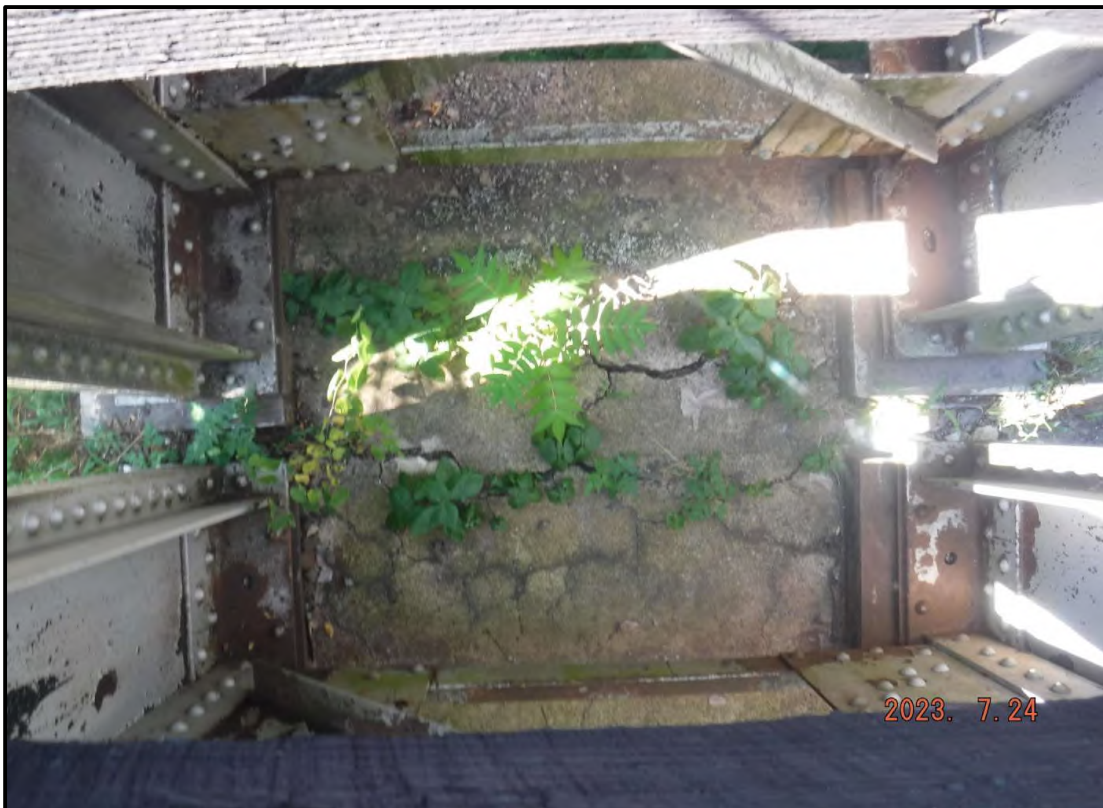
Photo 2: Pier 3 Bridge Seat With Wide Cracks

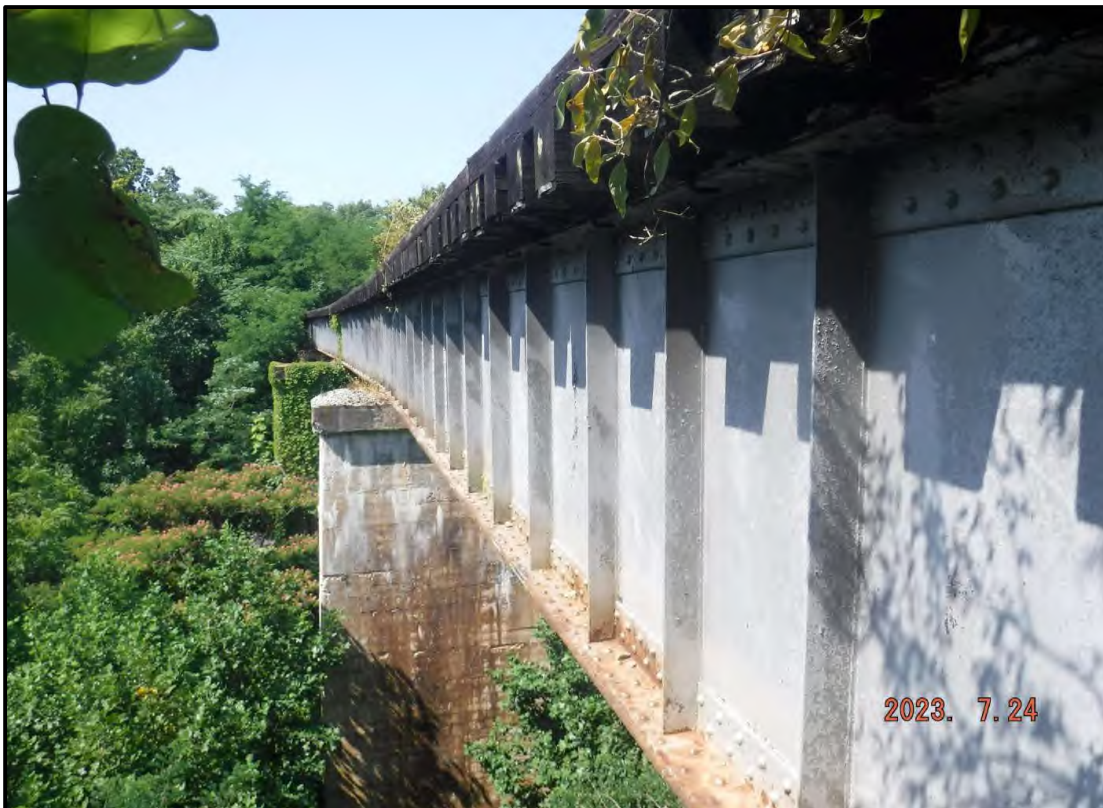
Photo 5: Undermined East Approach Ballast Trough

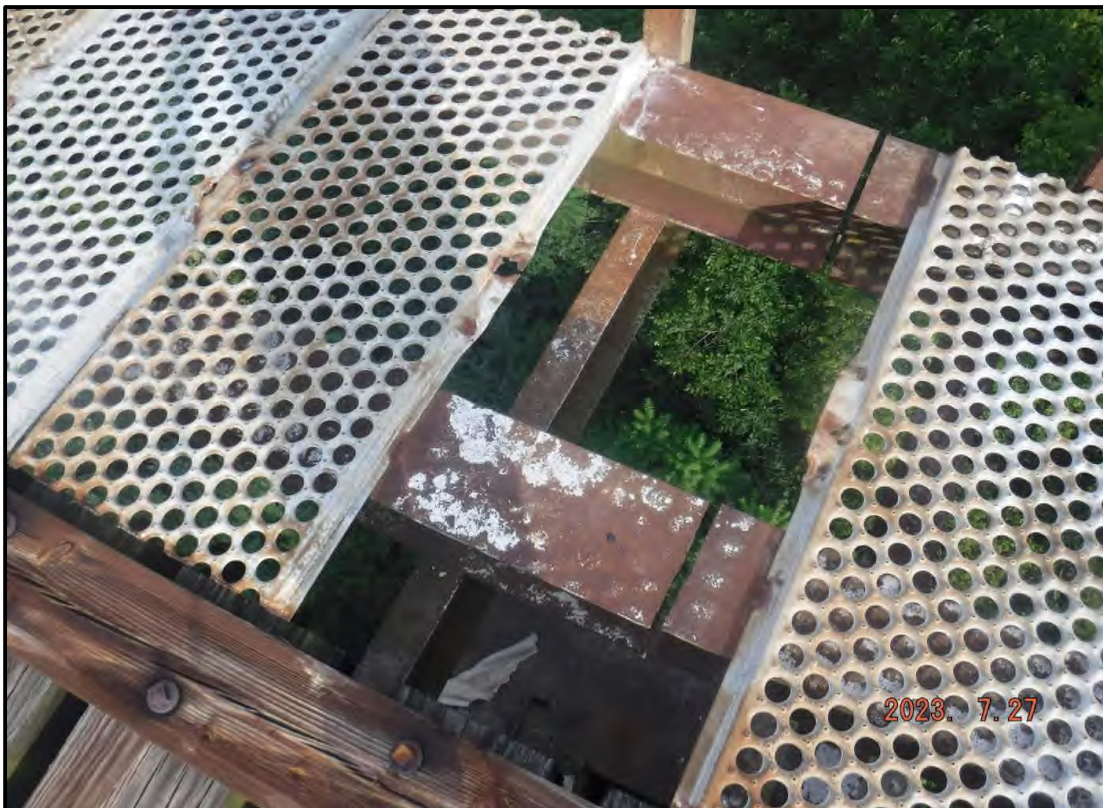
Photo 2: Missing Walkway Grate over Pier 3 of Main Spans

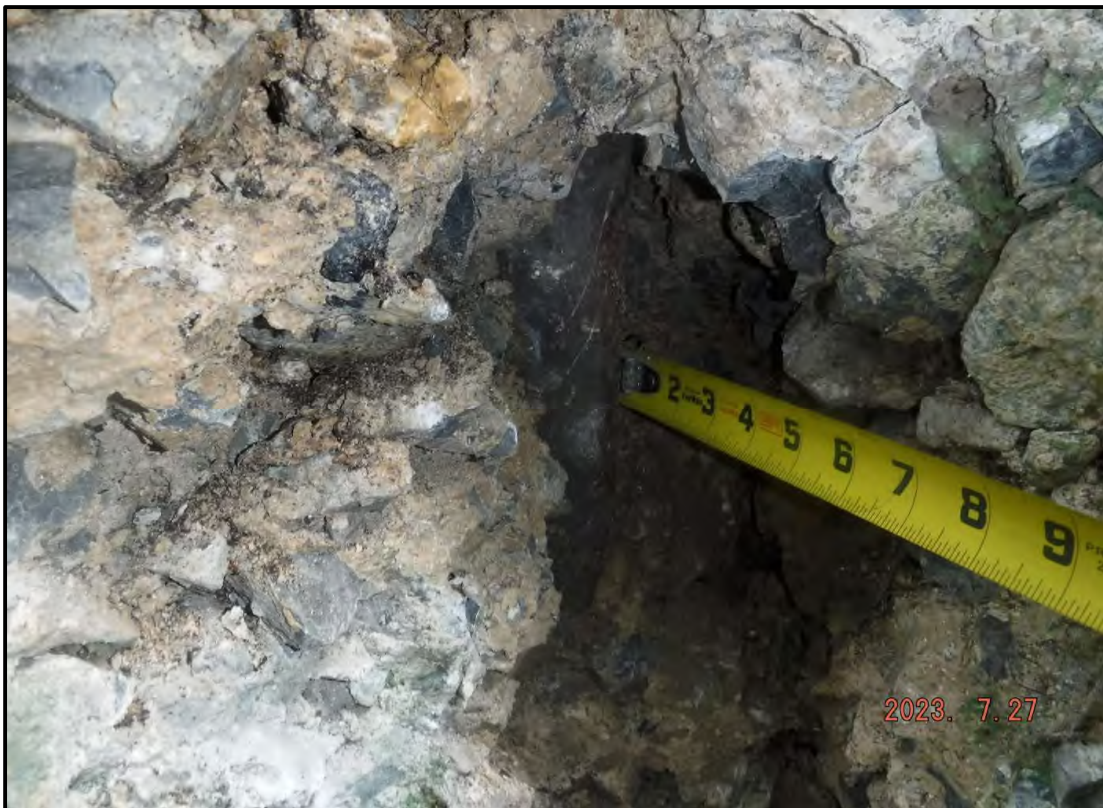
Photo 7: Spalled Concrete on Main Span Bent 2 North Pedestal

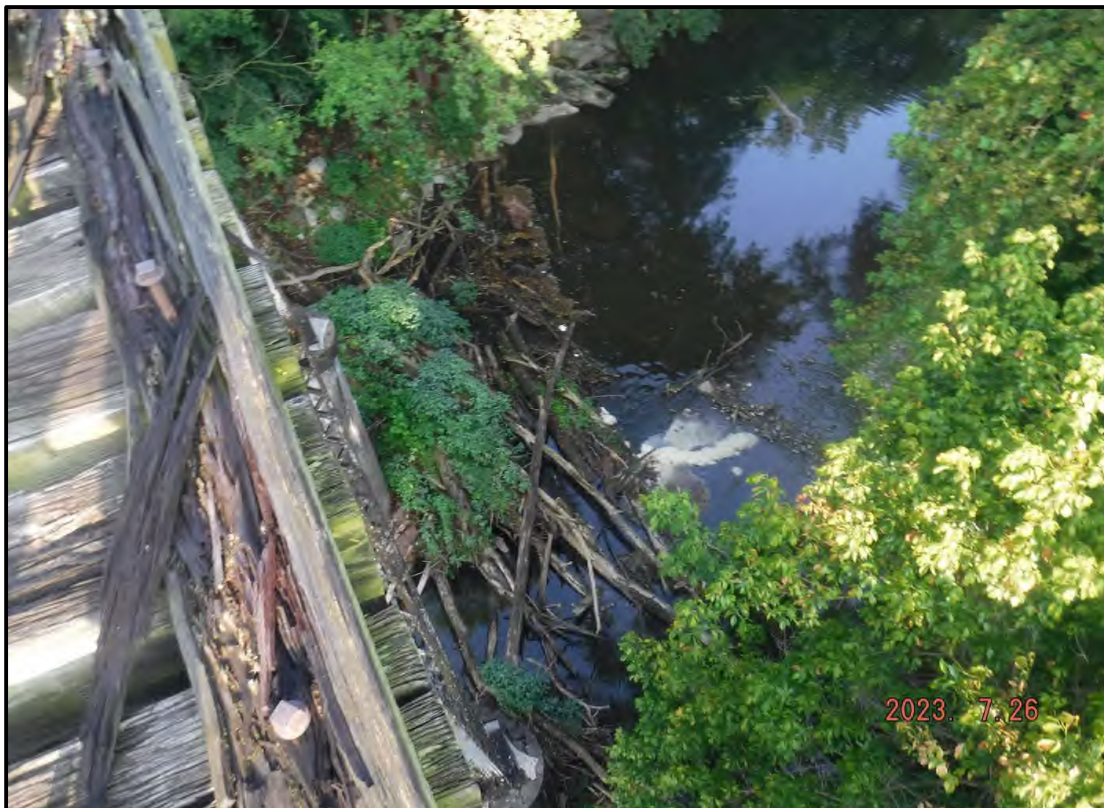
Photo 2: Flood Debris Against the North Side of the Steel Bent Tower

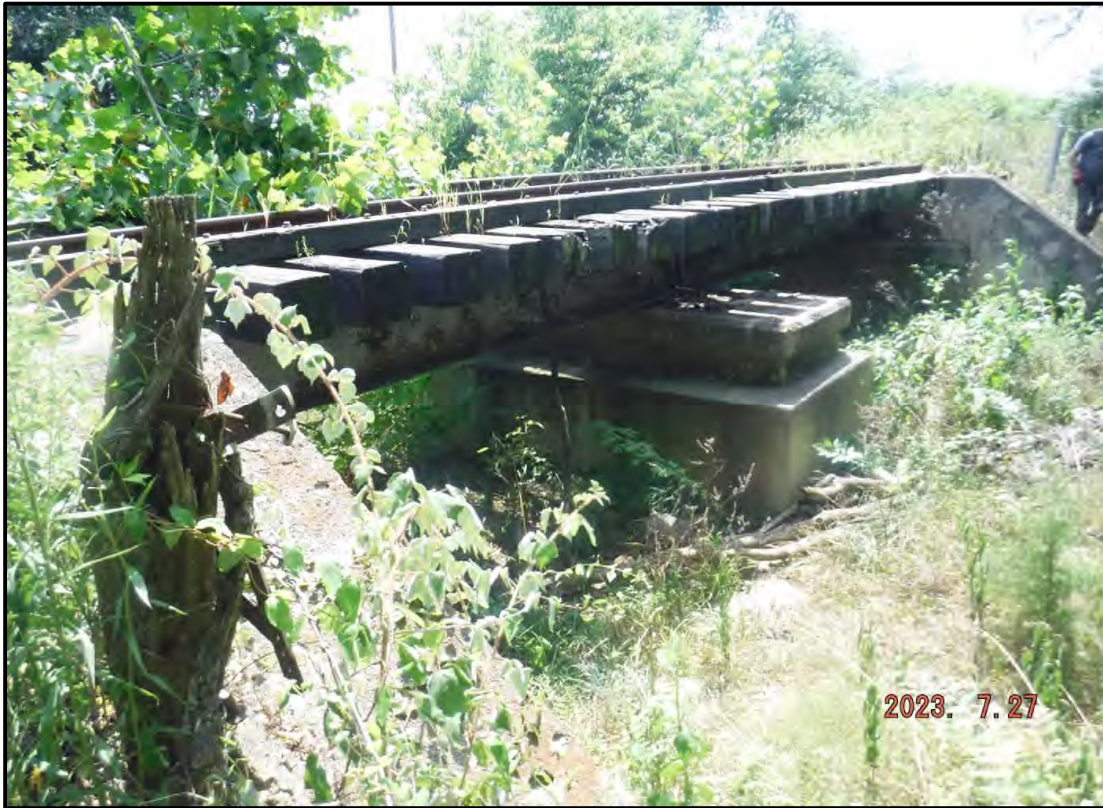
Photo 6: Typical Spalled Bridge Seat (Outside of Bearings)

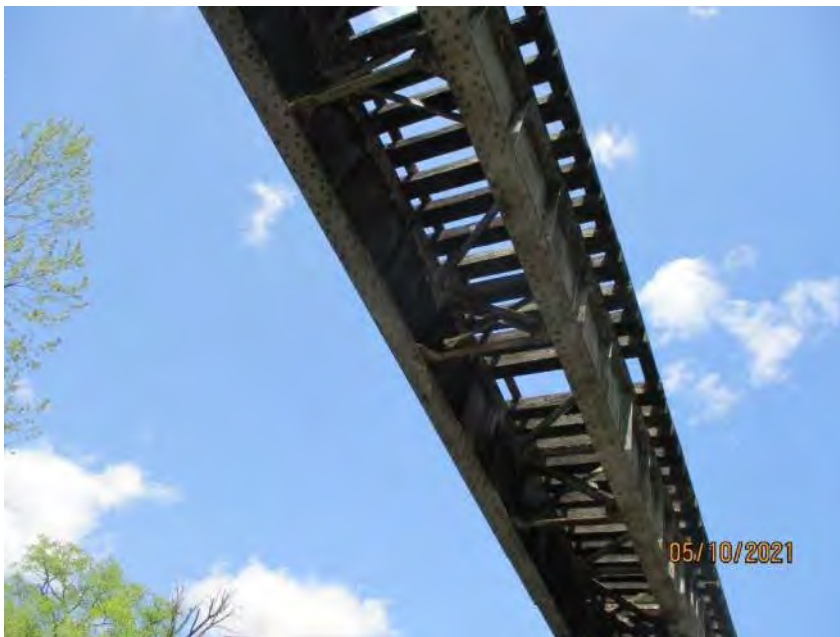
Looking north at top of structure toward Abutment B.

Deteriorated railroad ties throughout. Structure was not safe to cross.

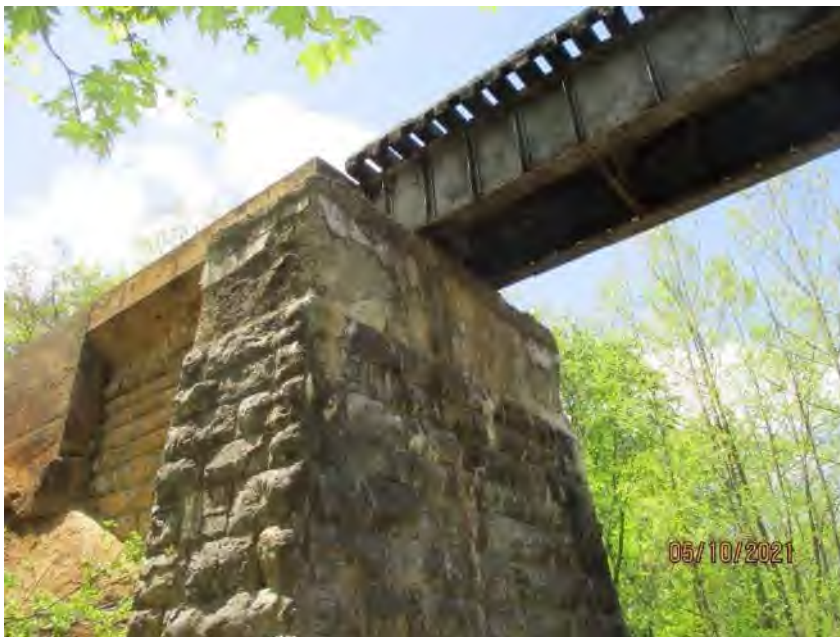
Looking at structure from downstream end.

Typical girder configuration with failed protective coating with minor surface rust thought out.

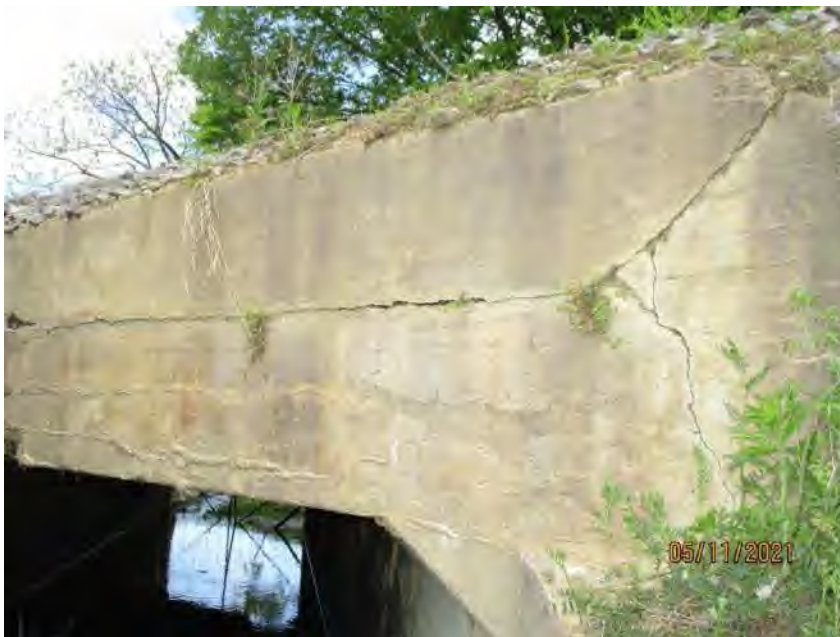
Upstream headwall

Area of spall:
5' long x 9.5" high x 14" wide x 3"
deep

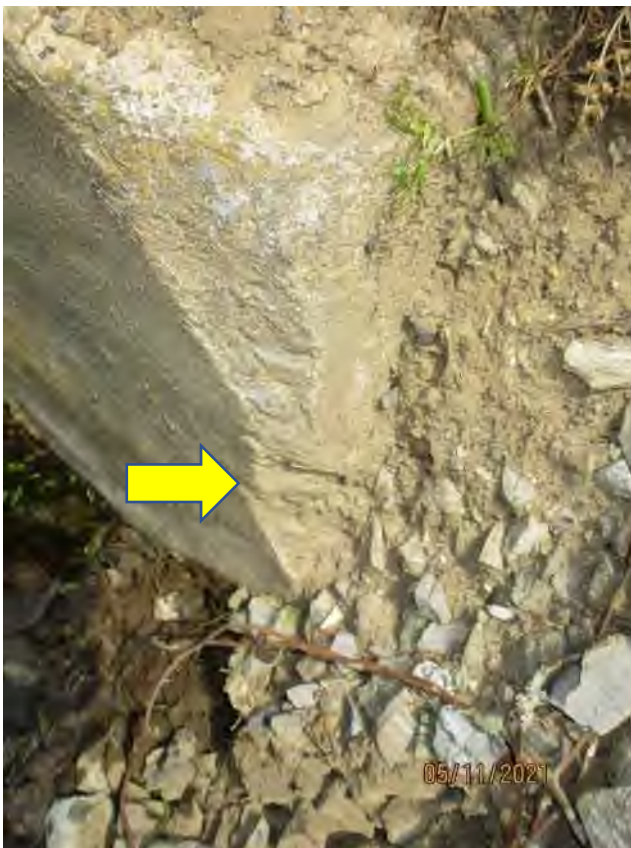
Southeast wingwall on downstream end.

Area of spall:
6" high x 3" wide x 2" deep

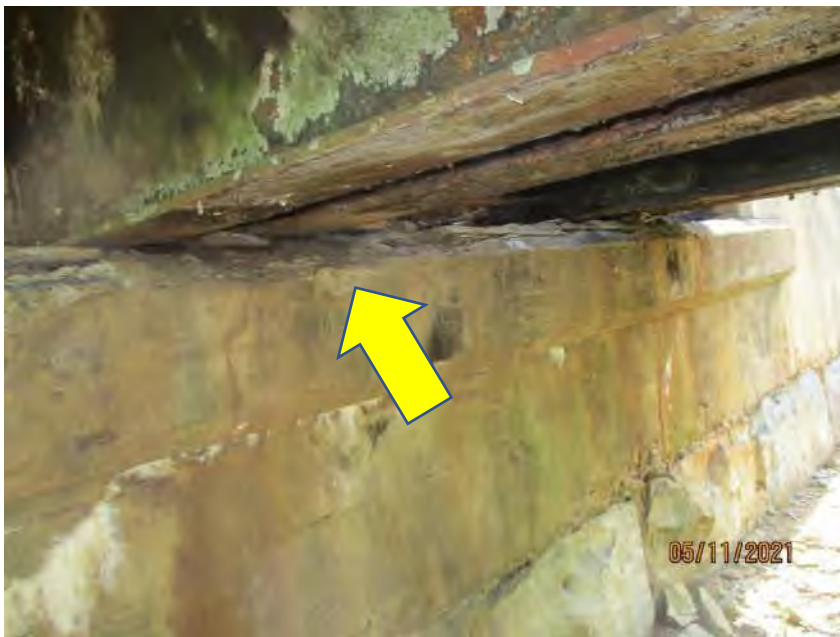
Abutment B upstream side.

Concrete spall:
2' long x 1' high x 2" deep.

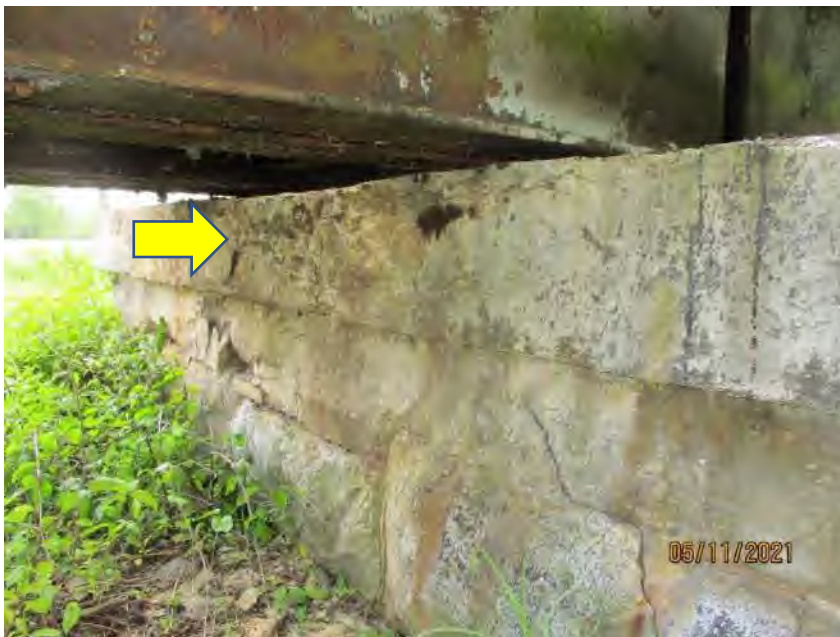
Surface rust on girders and superstructure elements with failed coating.

Accumulation of debris on bearing seat.

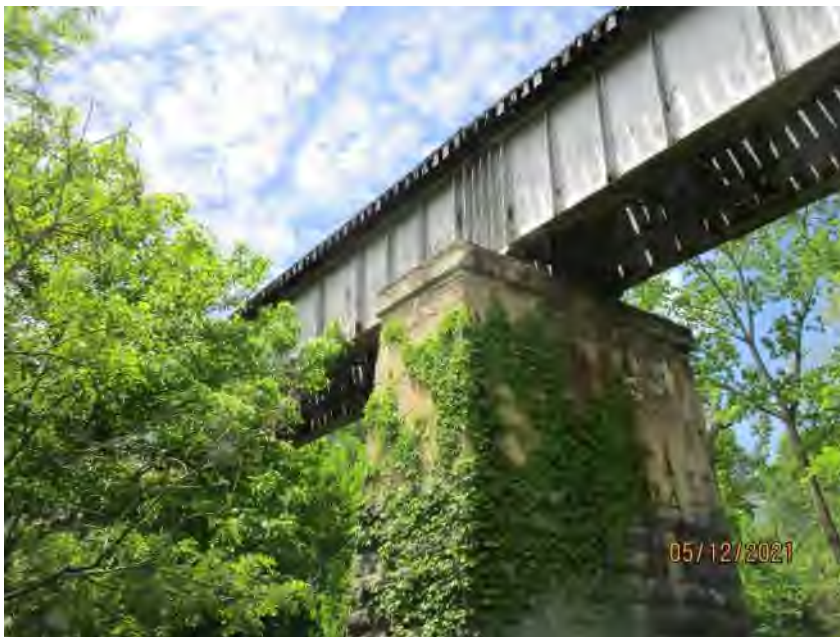
Pier 1, Span 1 side downstream end of cap.

Top of pier cap exhibit surface spalling all the way around.

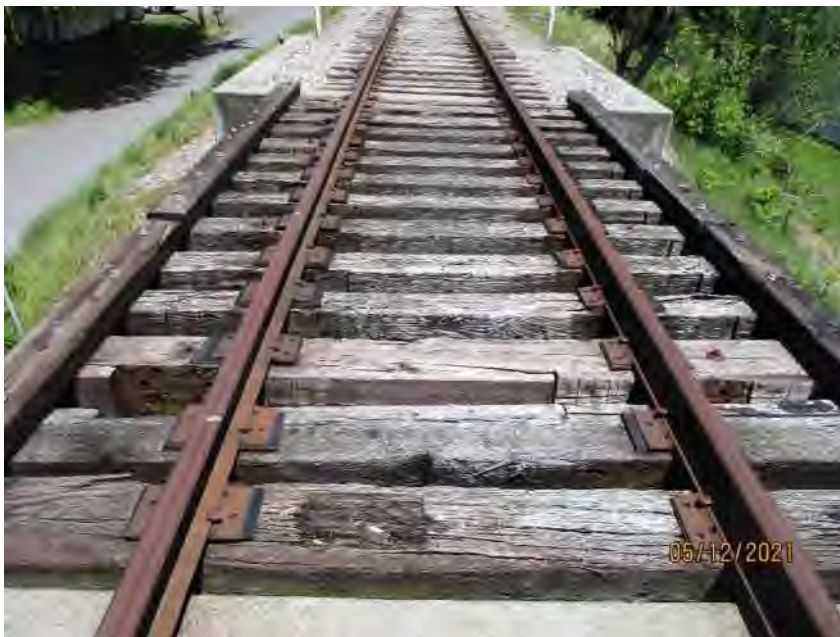
Looking north at Abutment B.

Timber railroad ties shown are mildly deteriorated.

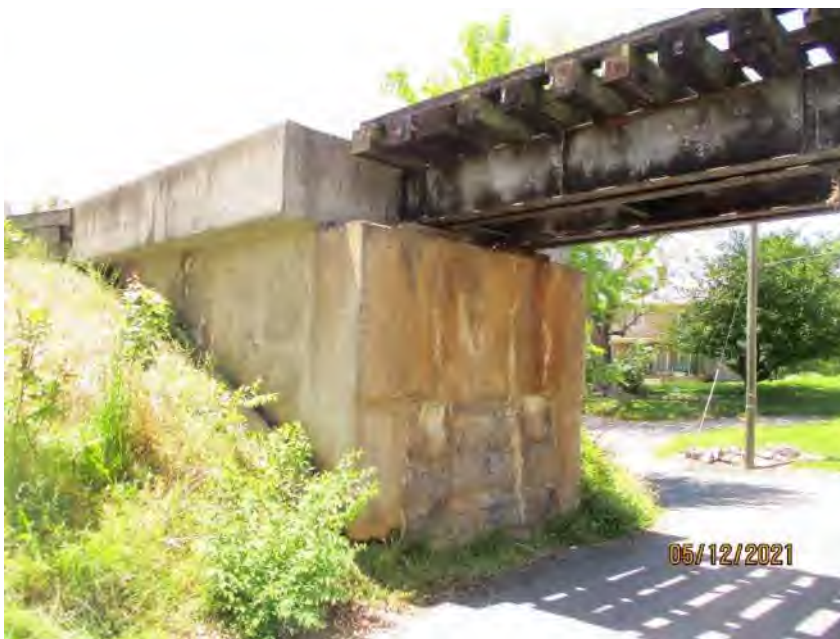
Looking at both double girder units at Abutment B.

Typical girder configuration with failed protective coating and minor surface rust thought out.

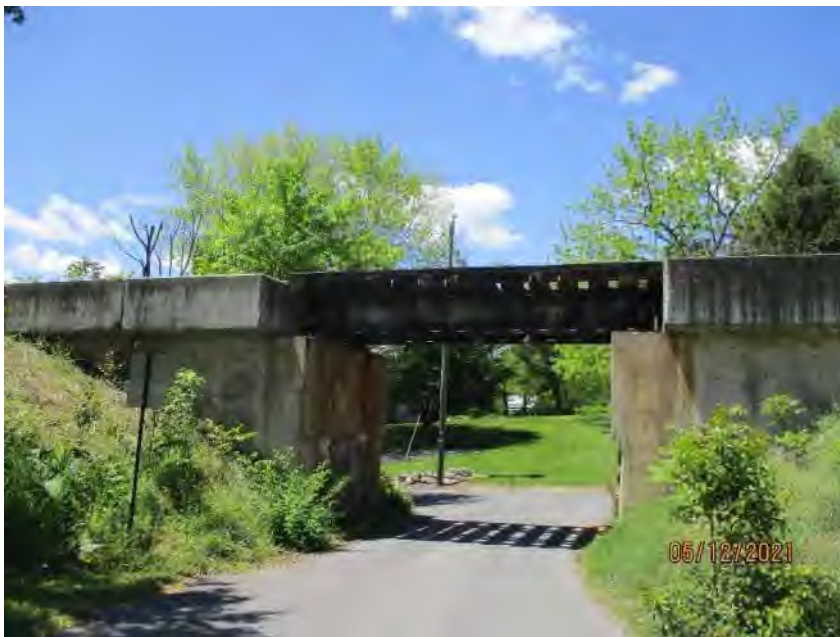
Abutment B.

Minor cracking throughout face
with efflorescence.

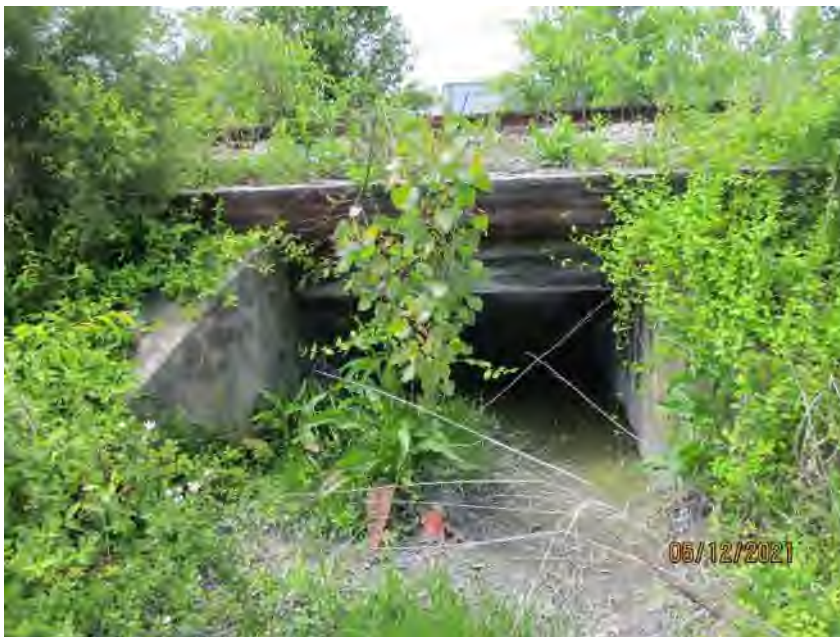
Upstream exterior beam.

Area of decay:
4' long x 11" high x 10" wide

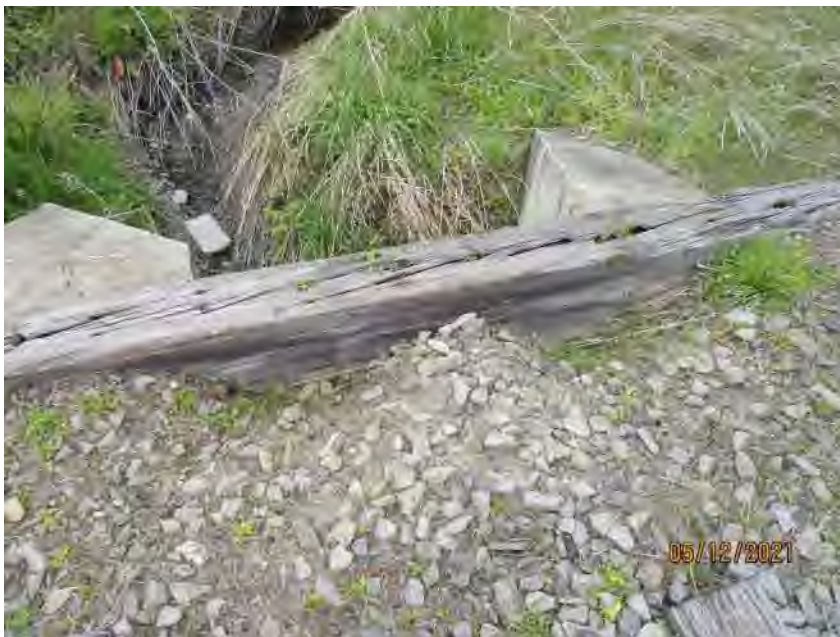
Timber railroad ties shown are mildly deteriorated.

Vegetation growth along the path.

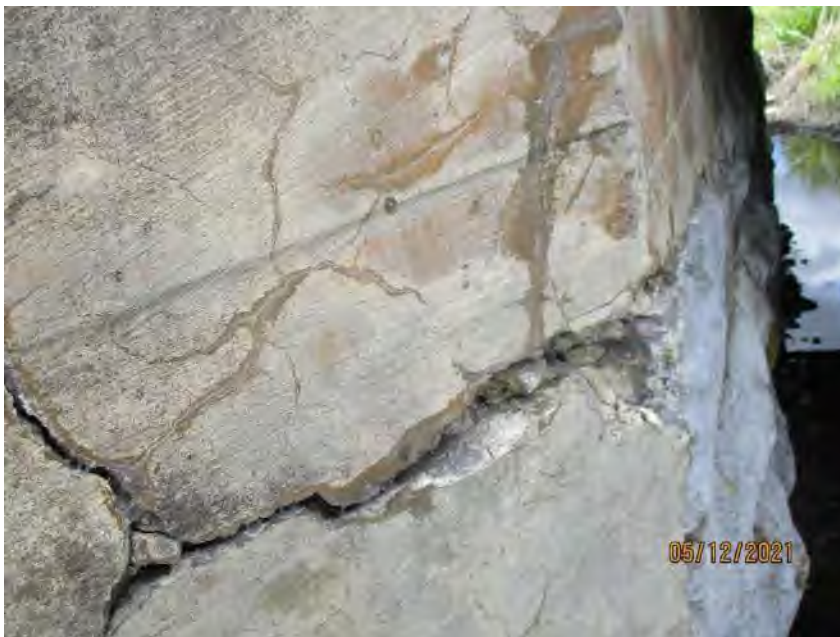
Downstream south wingwall

Area of spall:
19" long x 9" high x 3.5" deep

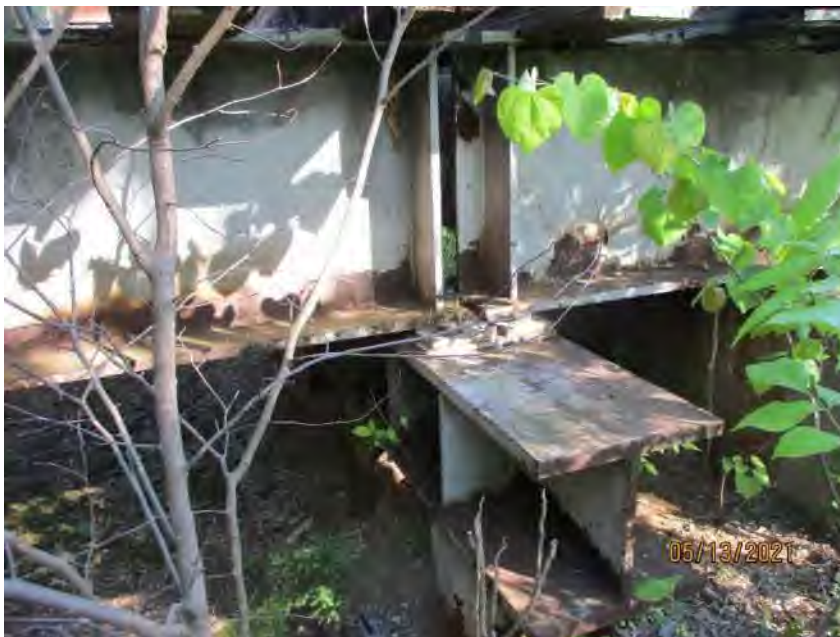
Photo #1

Timber railroad ties shown are heavily deteriorated.

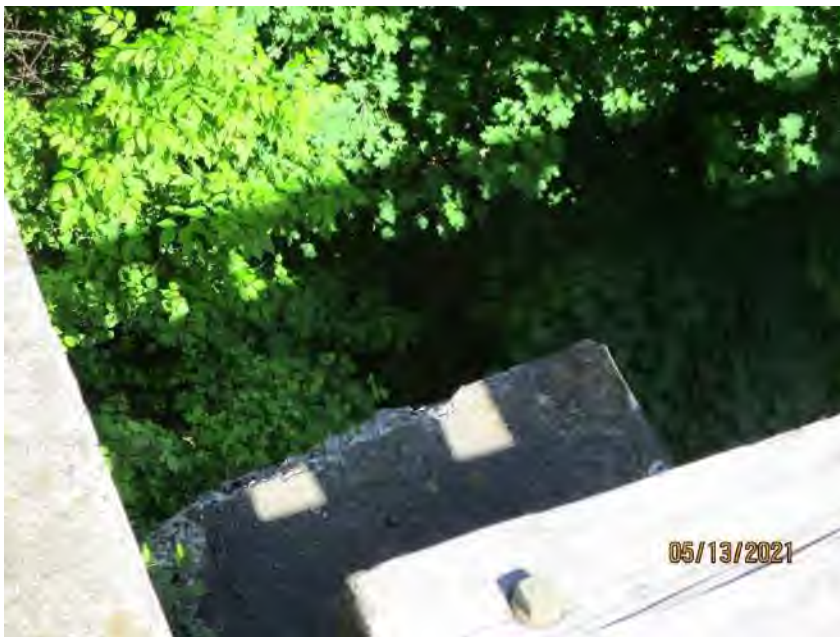
Abutment A wingwall upstream side.

Area of spall:
7' long x 15" wide x 2.5" deep

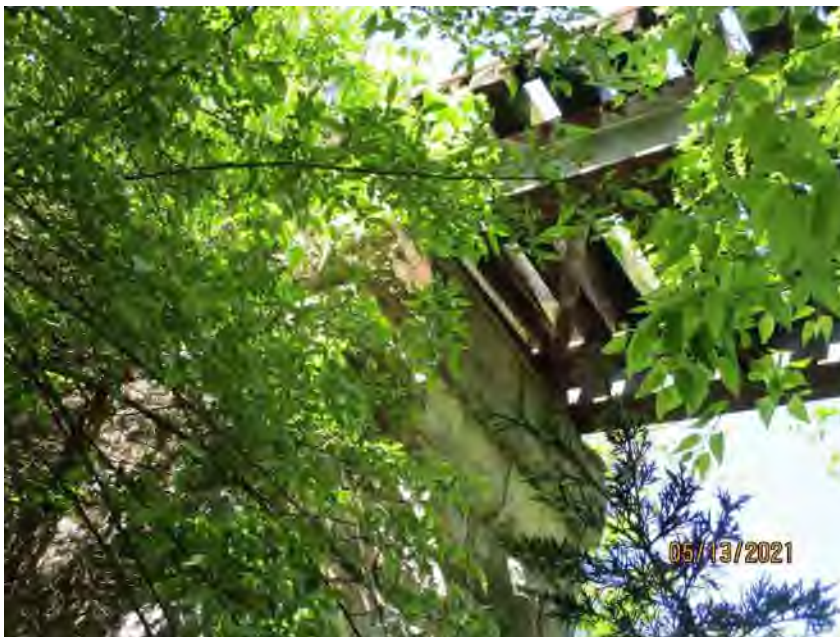
Looking south at top of structure toward Abutment A

Timber railroad ties shown are mildly deteriorated.

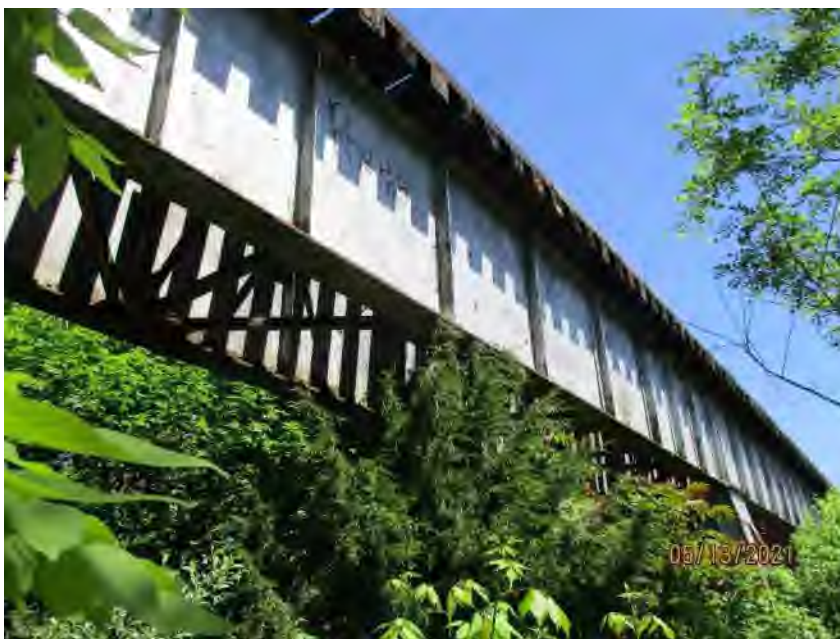
Looking south at Abutment A.

Timber railroad ties shown are mildly deteriorated.

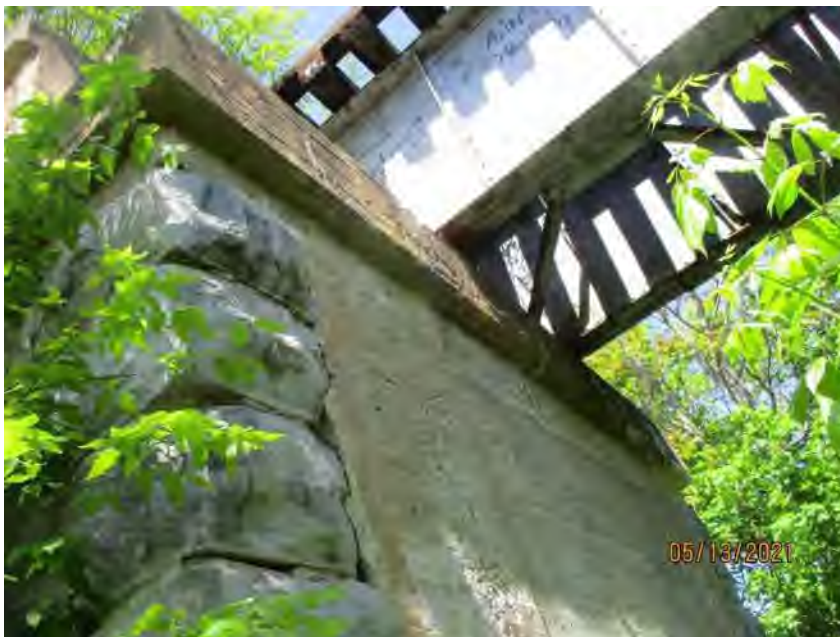
Underside of the girders from the upstream side.

Typical girder configuration with failed protective coating and minor surface rust throughout.

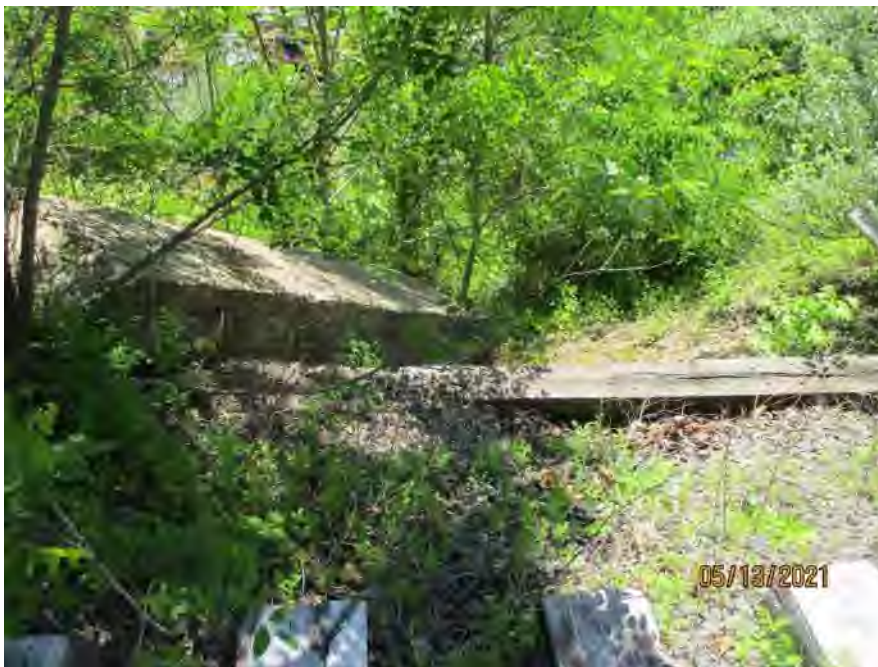
Abutment A

Upstream side erosion with
missing timber beam.

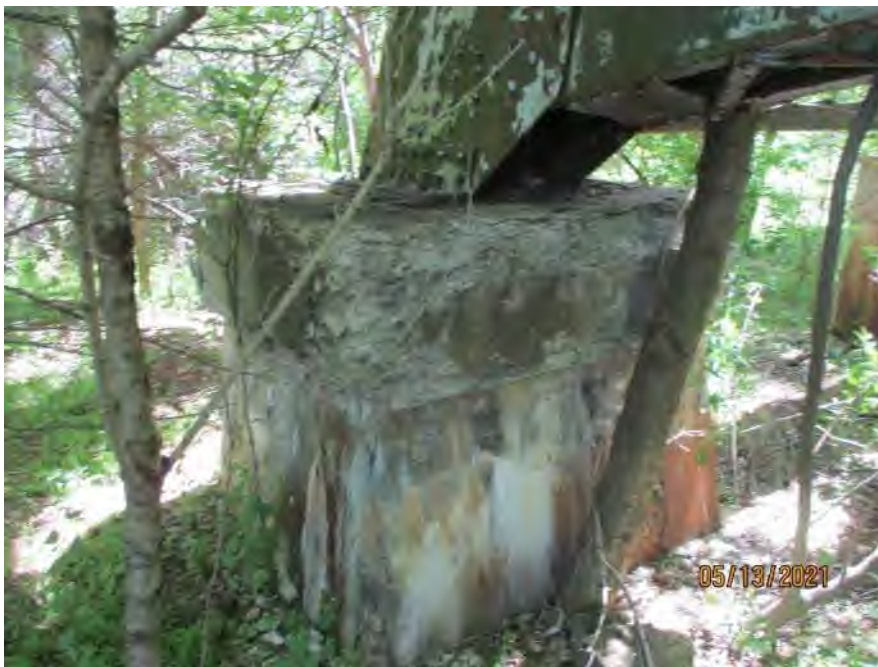
Pier 1

Typical steel pier with failed protective coating and minor surface rust throughout.

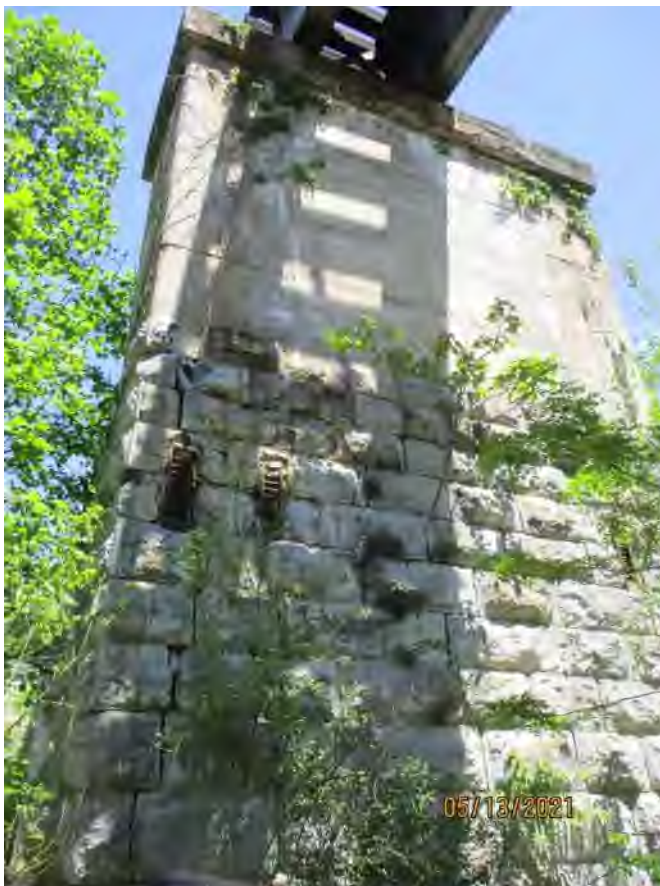
At Battlefield Rd looking south.

Map cracking with heavy efflorescence.

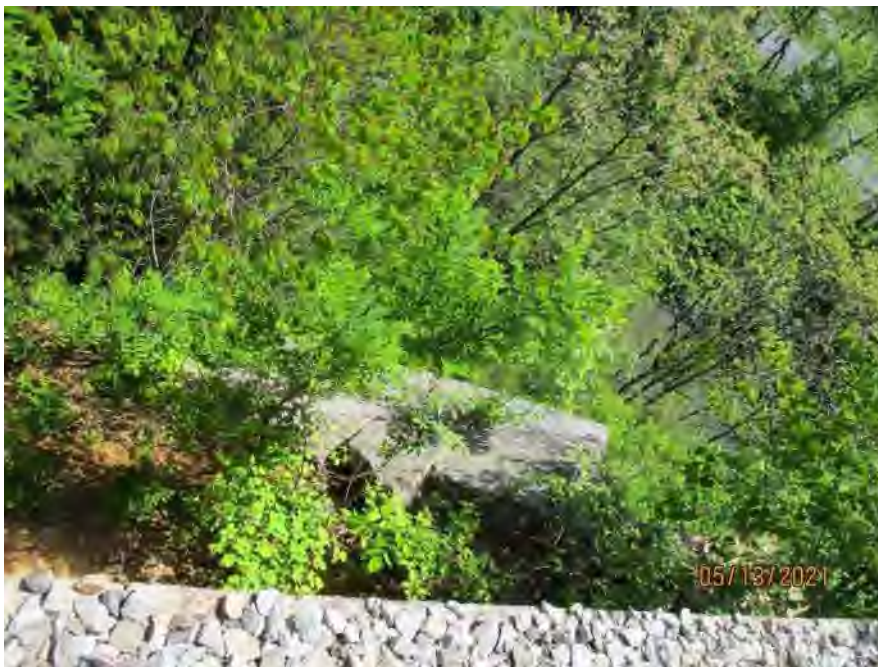
Looking north on upstream side.

Map cracking efflorescence.
