NORFOLK SOUTHERN RAILWAY CO. SHENANDOAH VALLEY RAIL CORRIDOR BRIDGE EVALUATION

STRASBURG, VIRGINIA
SHENANDOAH COUNTY

PROJECT NO. 23-1502.101

August 25, 2023

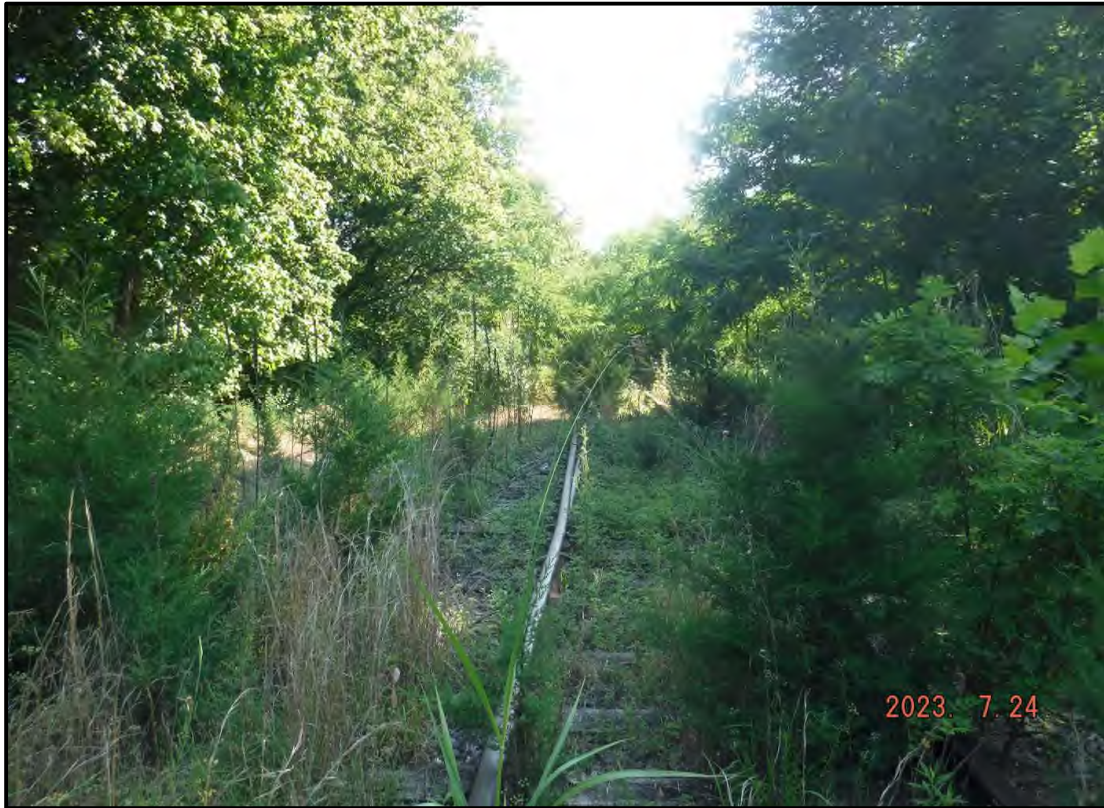
Photo 1: Track on Bridge

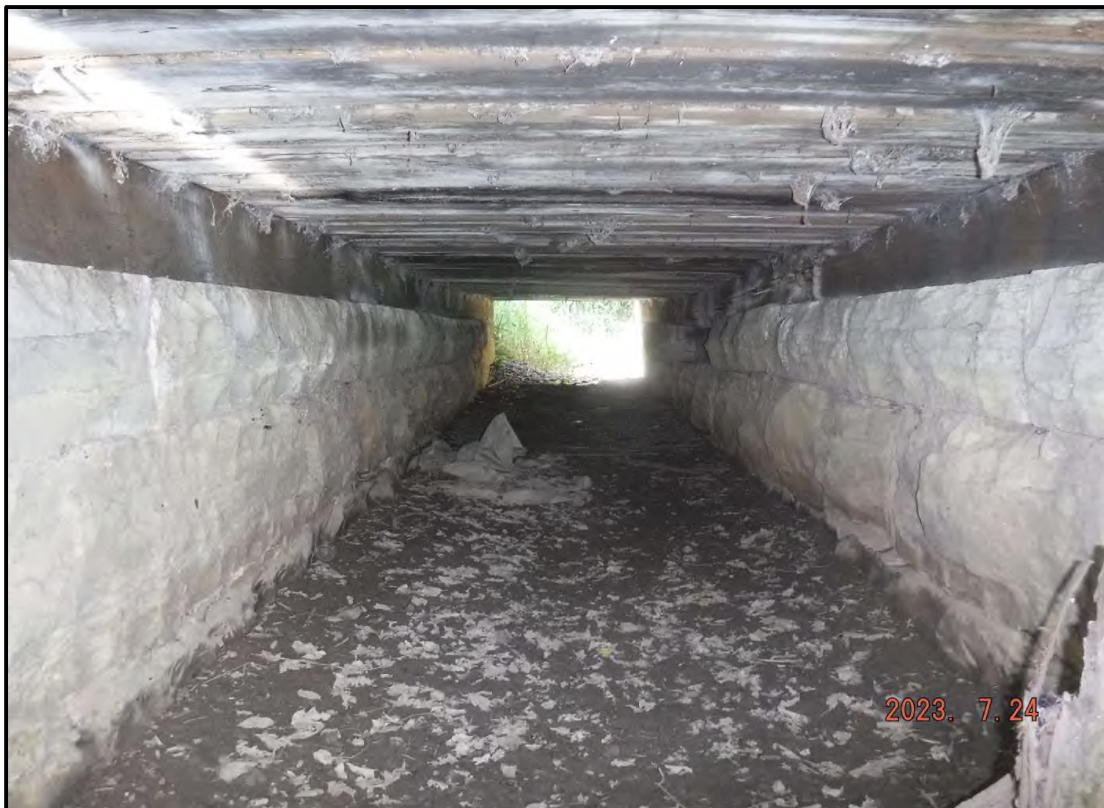
Photo 2: Through Structure

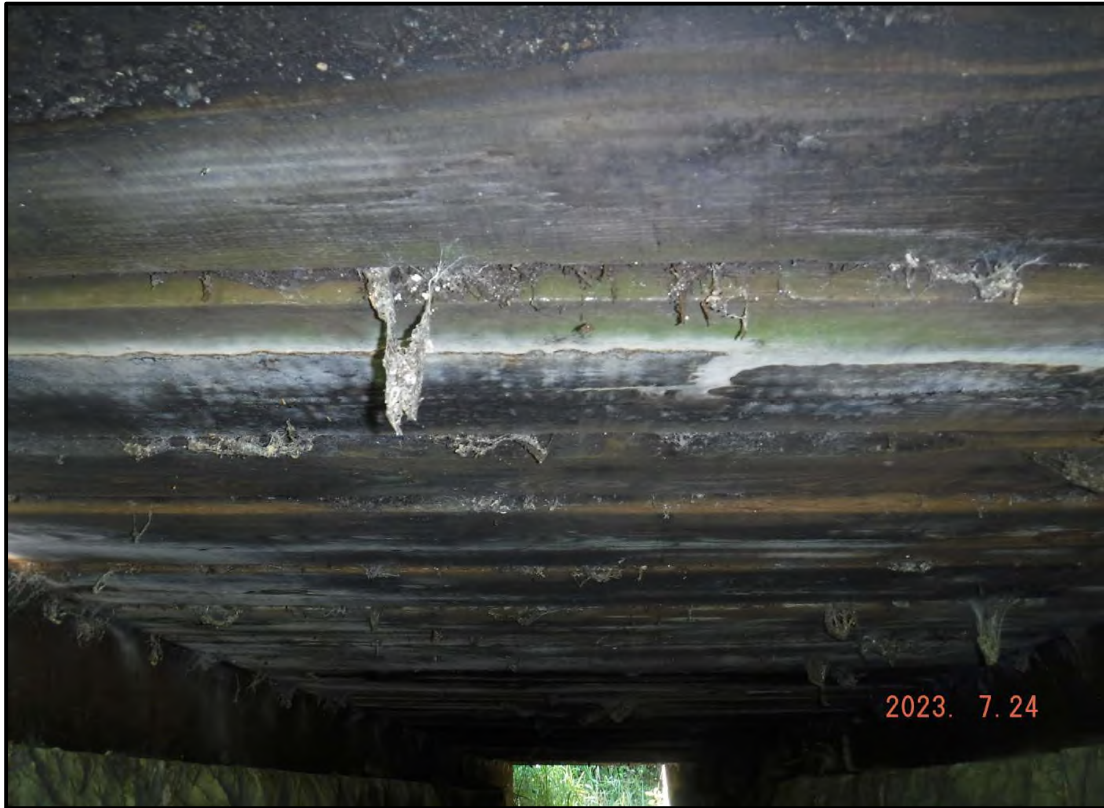
Photo 3: Typical Condition of Timber Slab

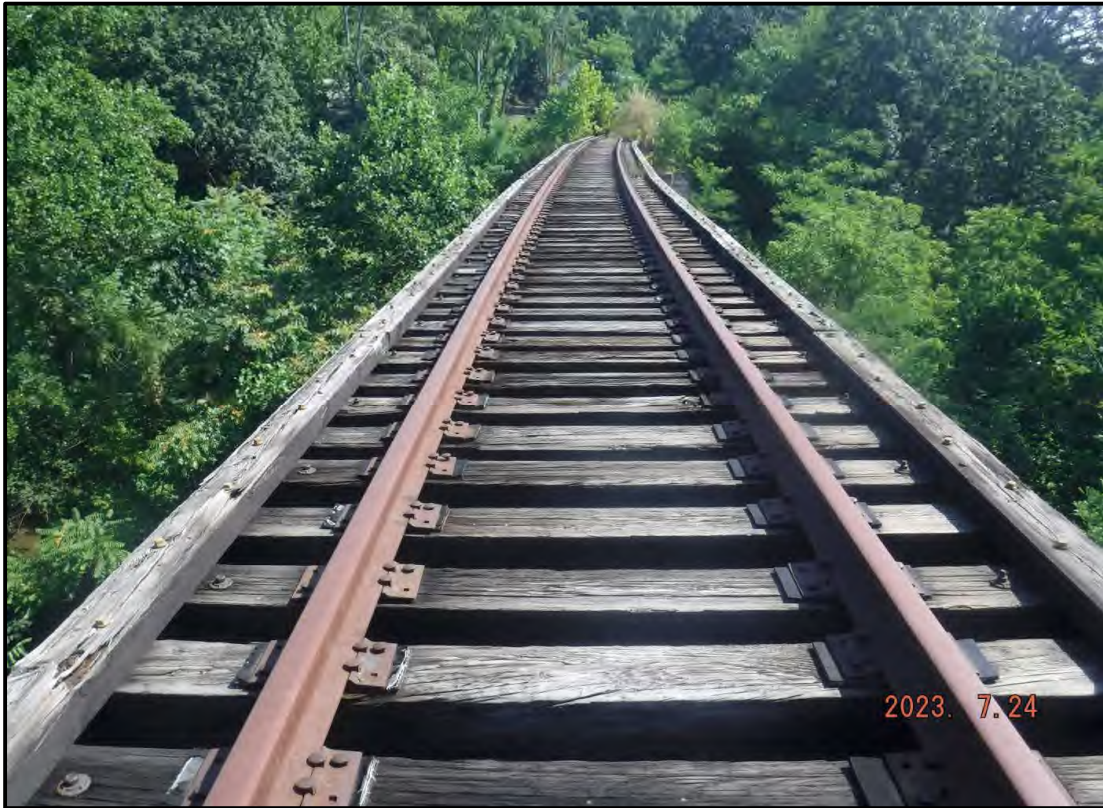
Photo 1: General Condition of Timber Tie Deck

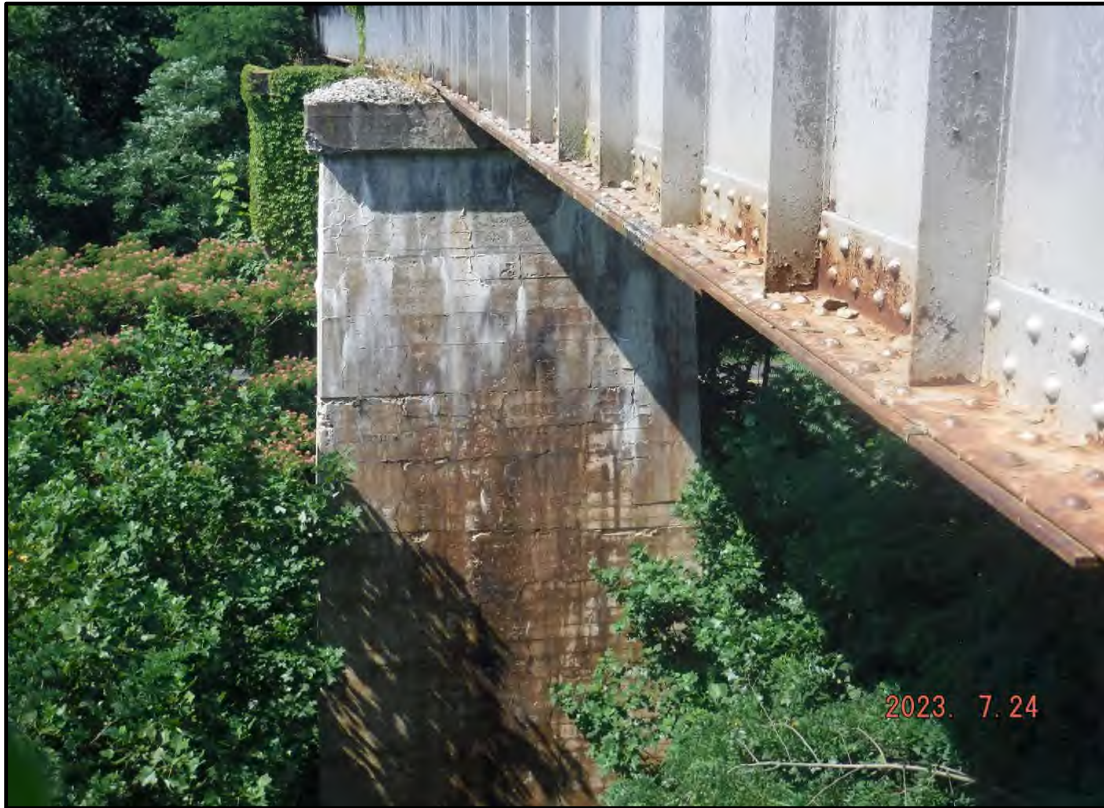
Photo 3: Typical Reinforced Concrete Portion of Pier

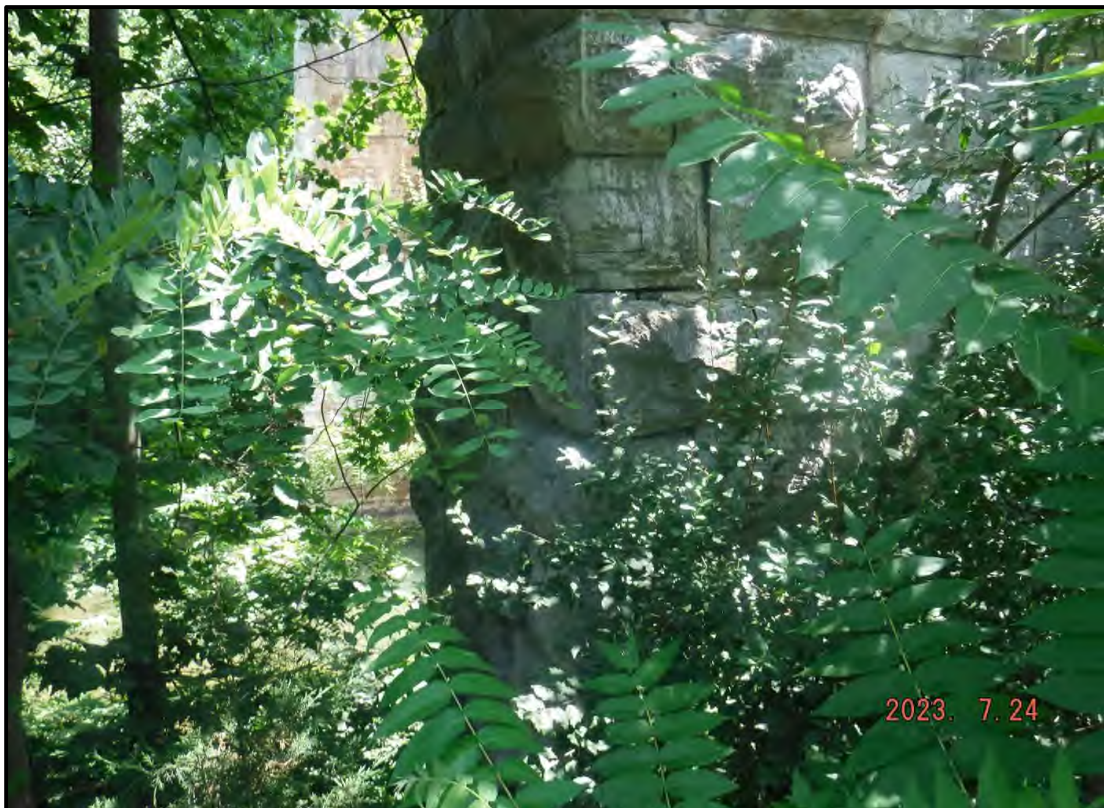
Photo 4: Typical Stone Masonry Portion of Pier

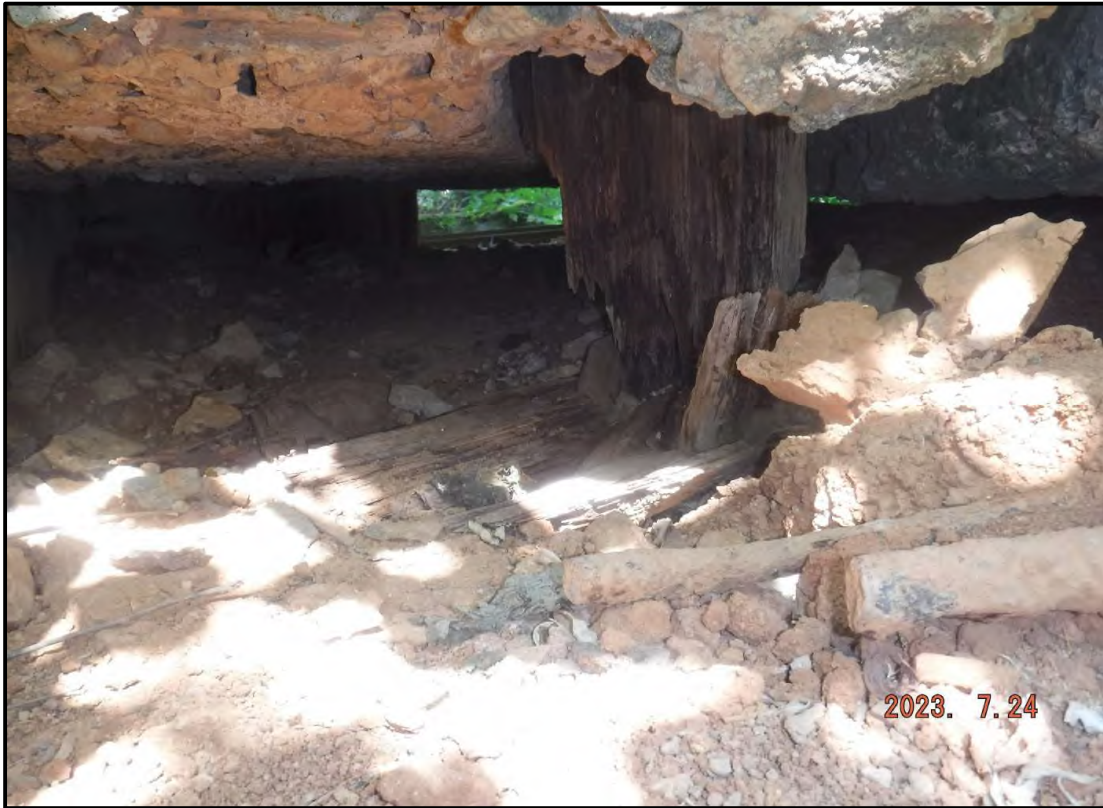
Photo 5: Undermined East Approach Ballast Trough

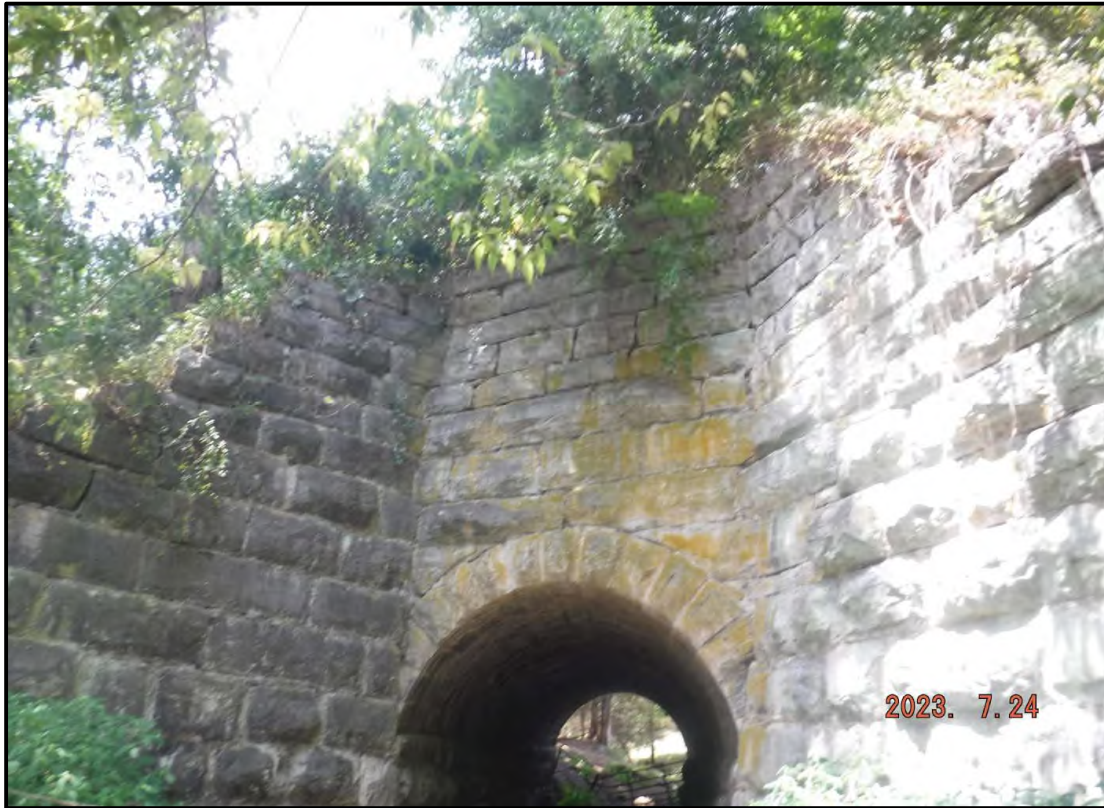
Photo 1: South Elevation

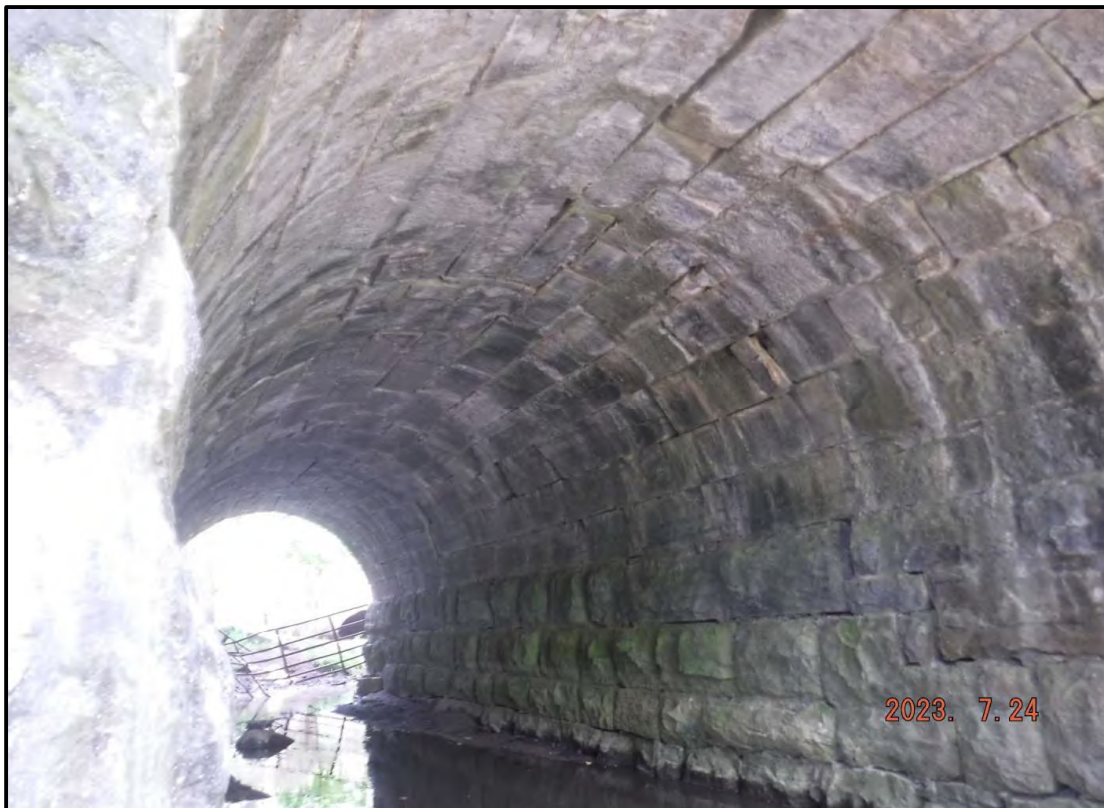
Photo 2: Through Arch (From South End)

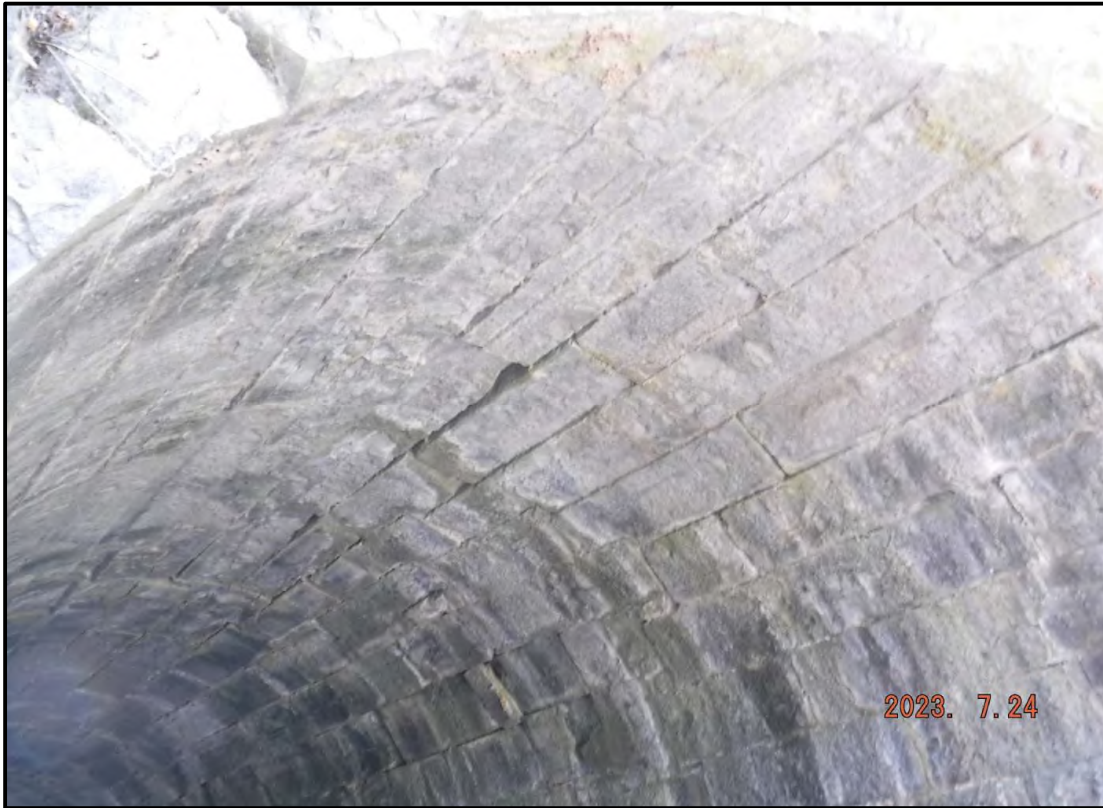
Photo 3: Arch Barrel (From South End)

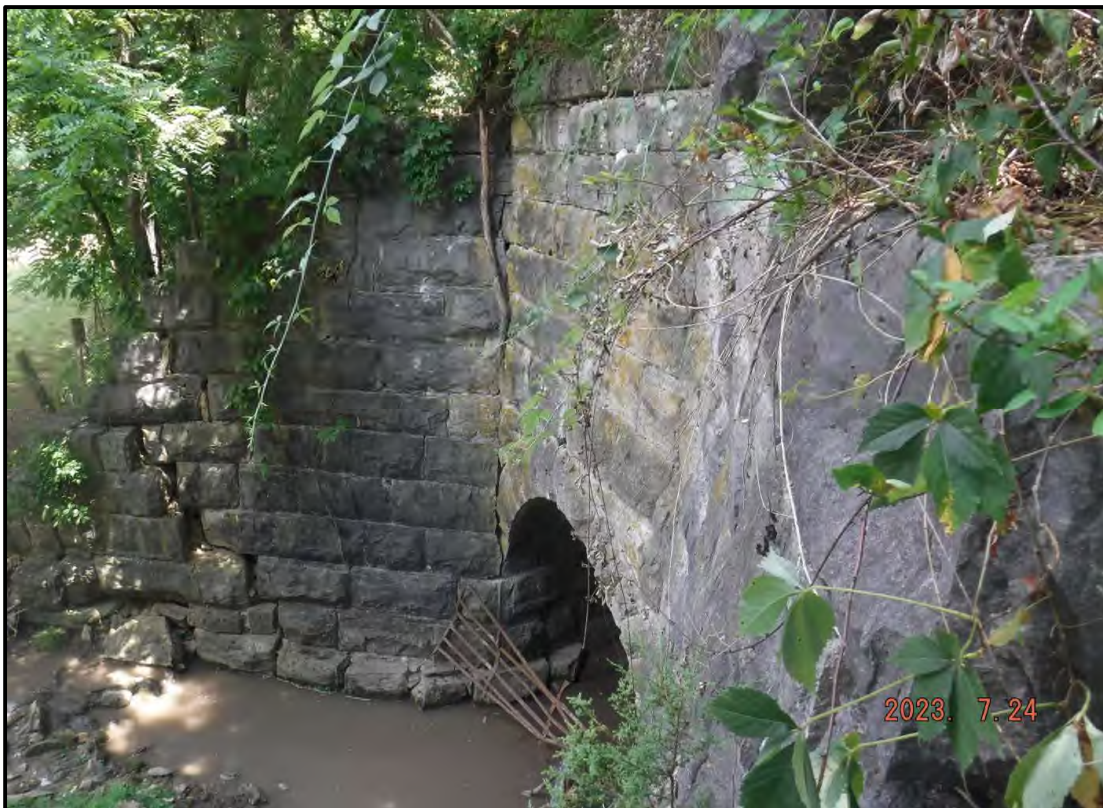
Photo 4: North End of Structure (From NW Wing)

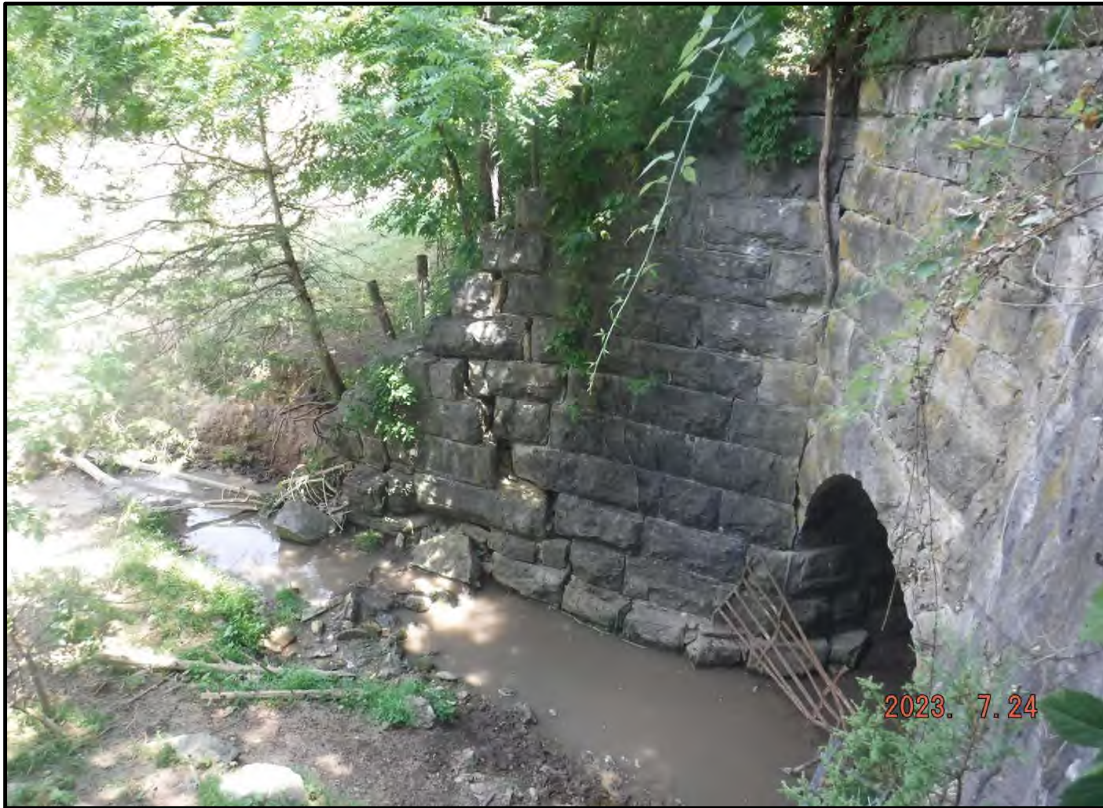
Photo 5: NE Wing with Free End Separation

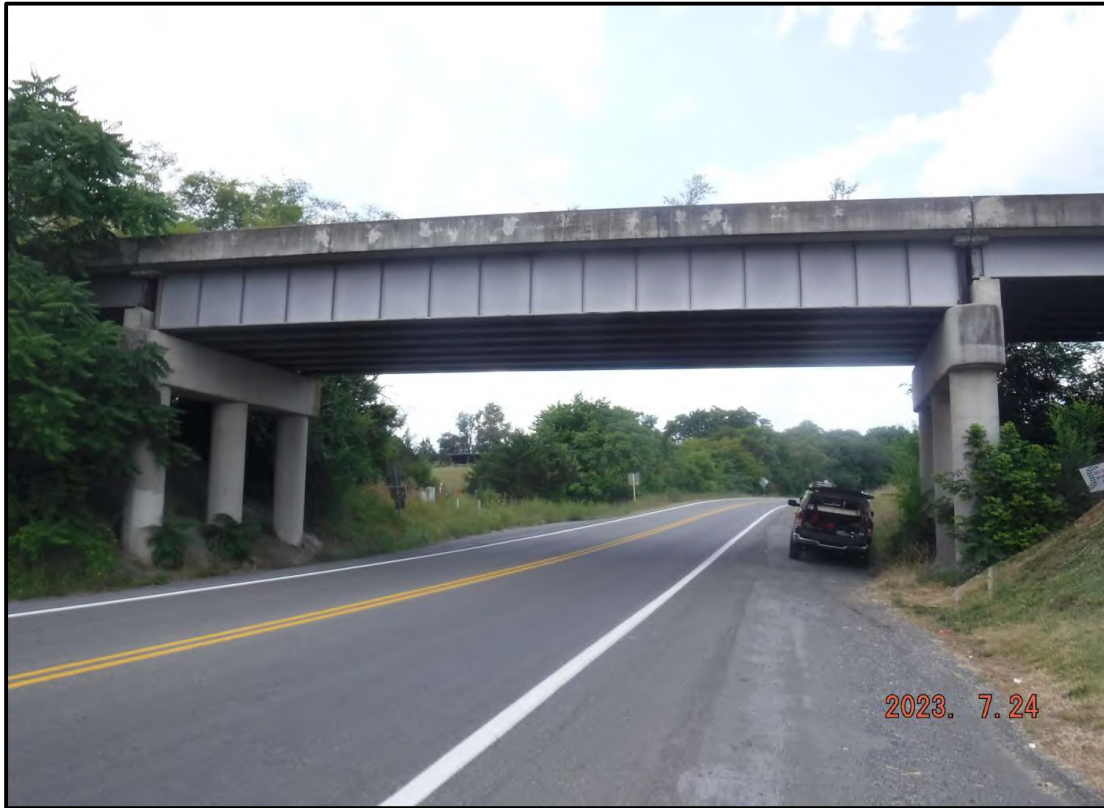
Photo 1: South Elevation

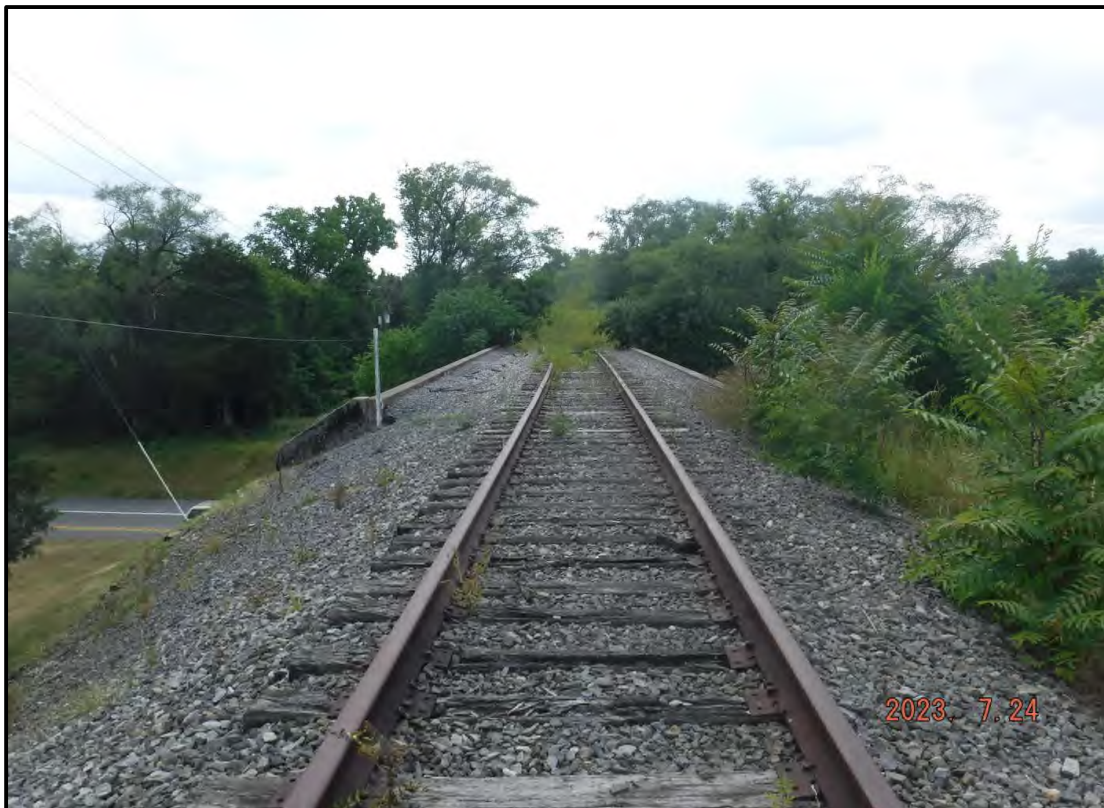
Photo 2: West Approach

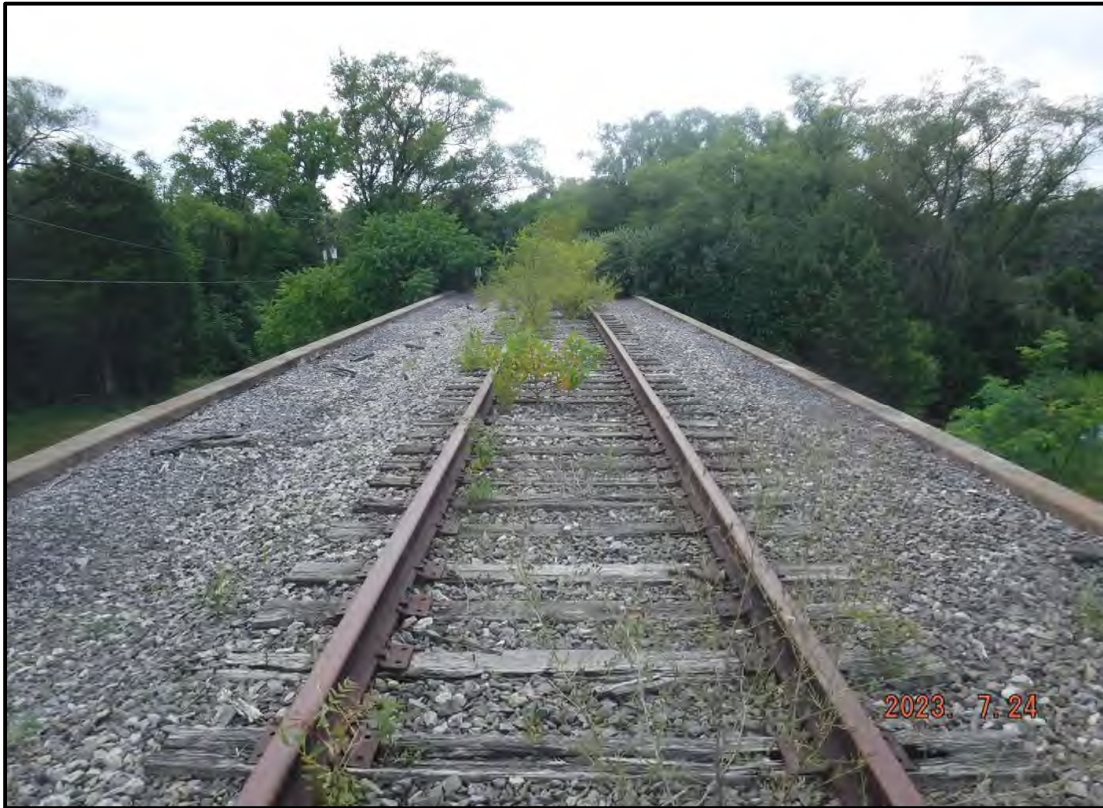
Photo 3: Bridge Deck

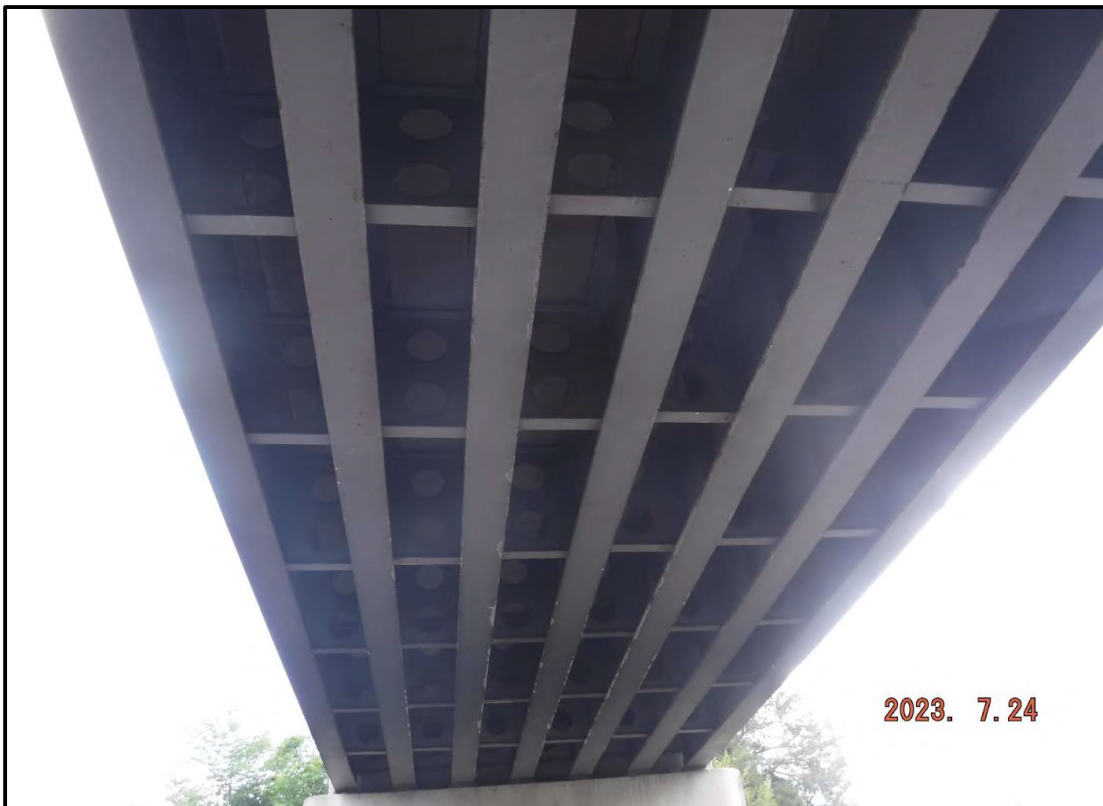
Photo 4: Underside of Typical Span (Span 2 Shown)

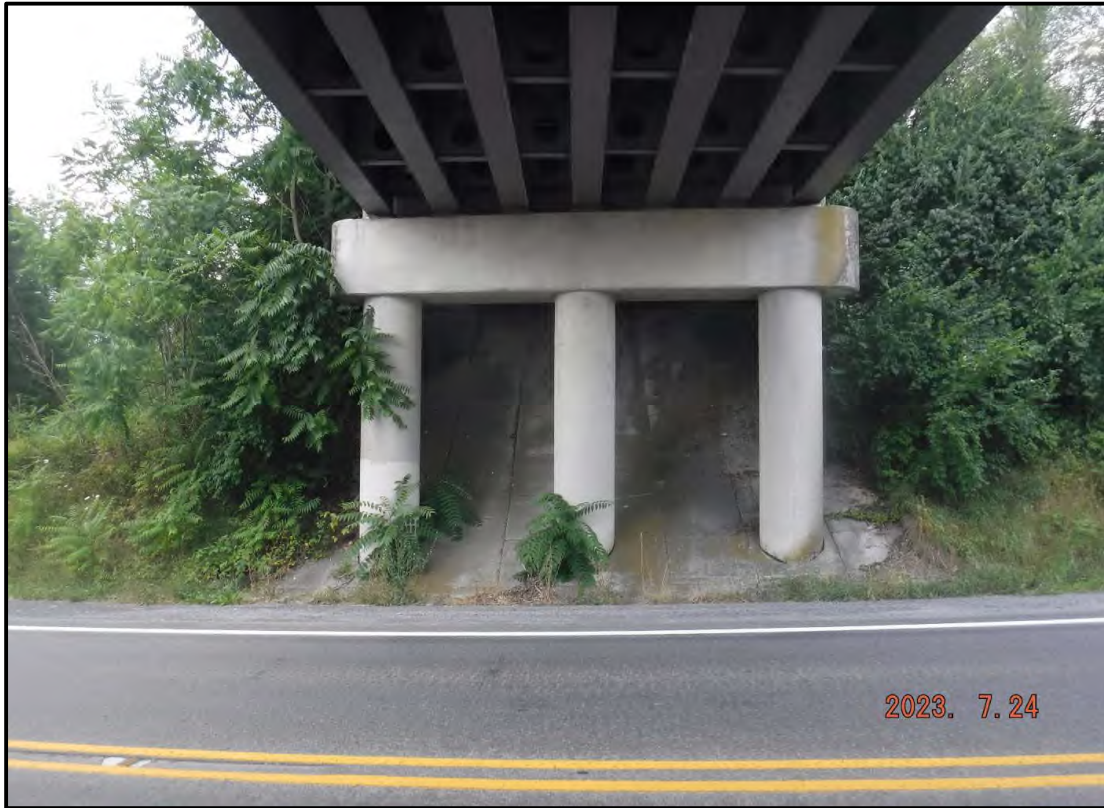
Photo 5: Typical Pier (East Side of Pier 2 Shown)

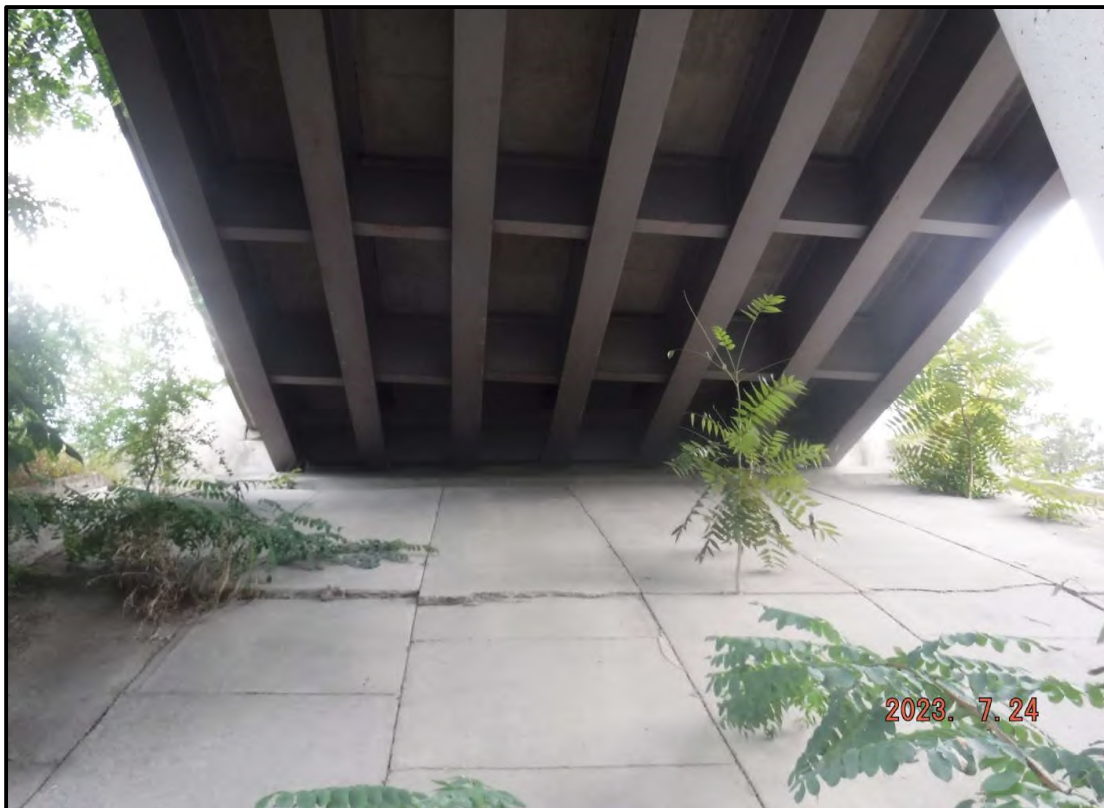
Photo 6: North Abutment

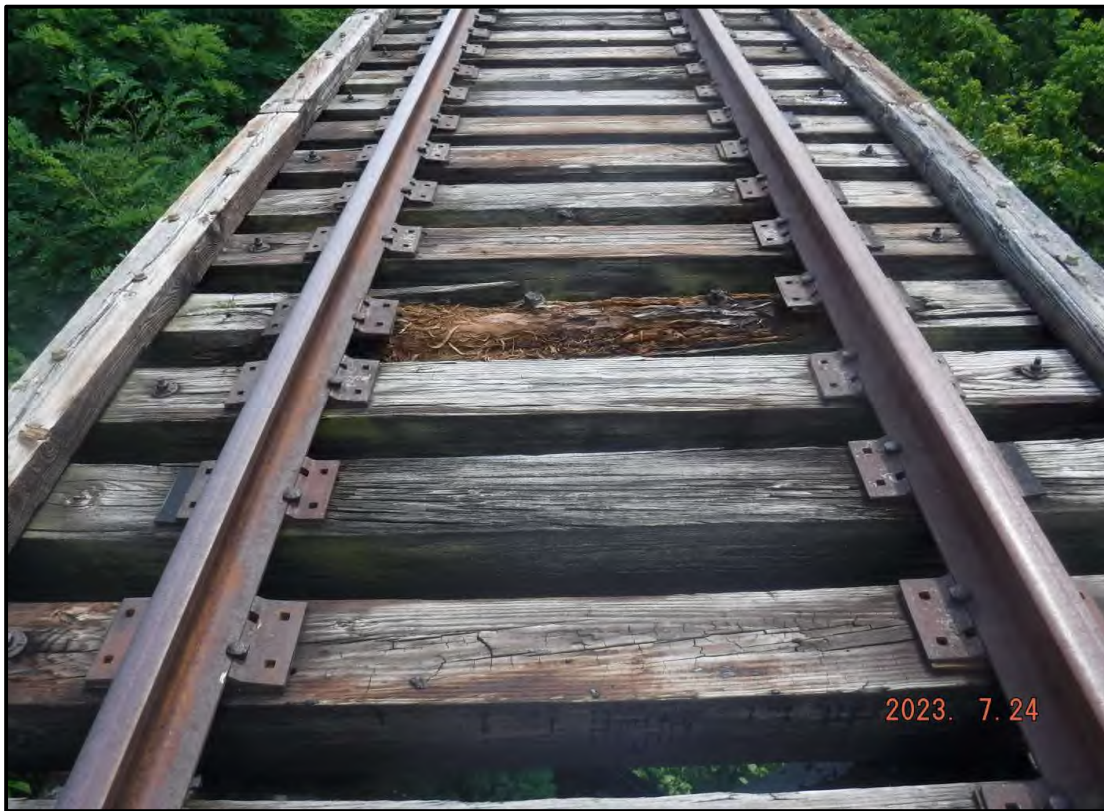
Photo 1: General Condition of Timber Tie Deck

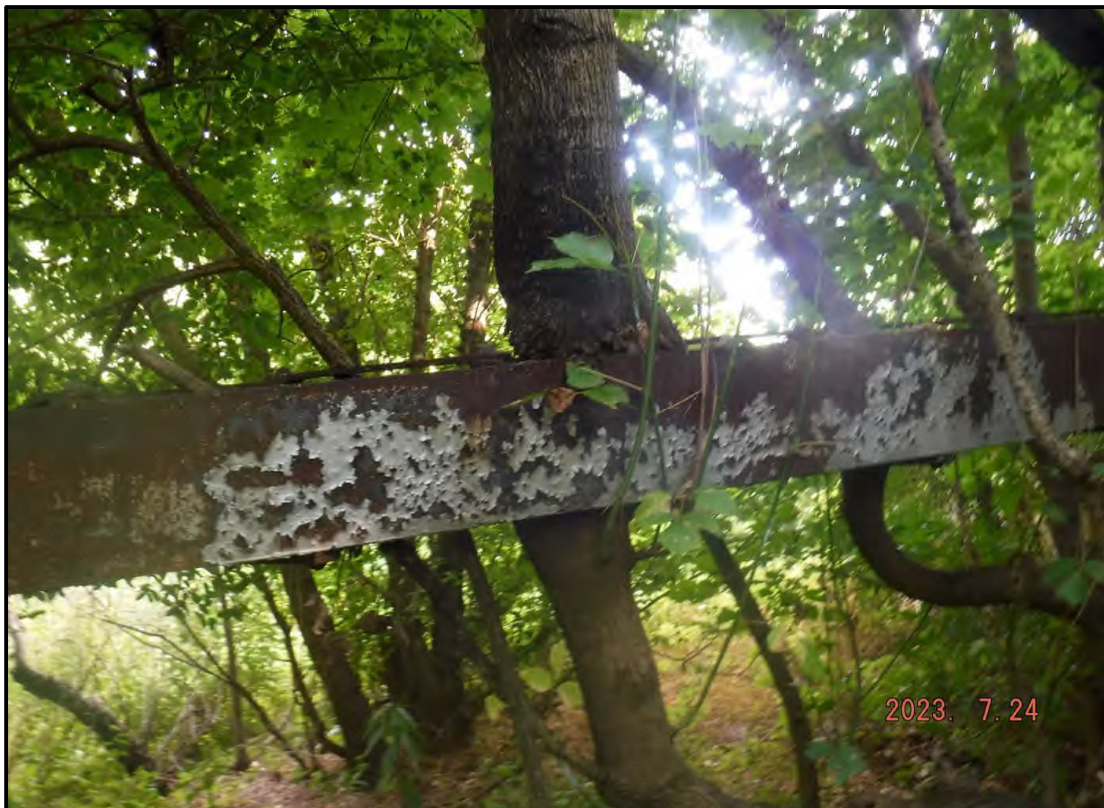
4. Riprap	n/a	
5. General Cleanliness	B-1	Debris is noted on the bridge seats and around the bearings. Vegetation is present in both approaches, under the steel trestle spans, and in/around steel bent lattice bracing.

Photo 2: Vegetation Growth in Steel Bent Tower Bracing

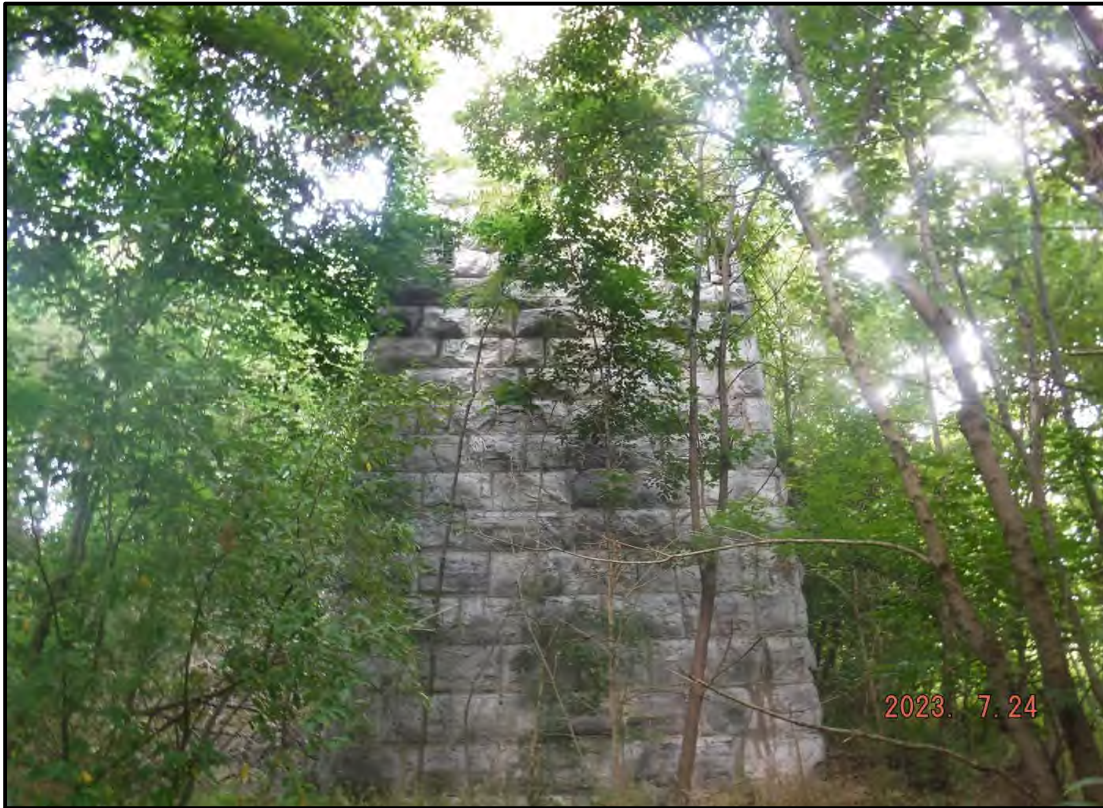
Photo 3: Typical Pier

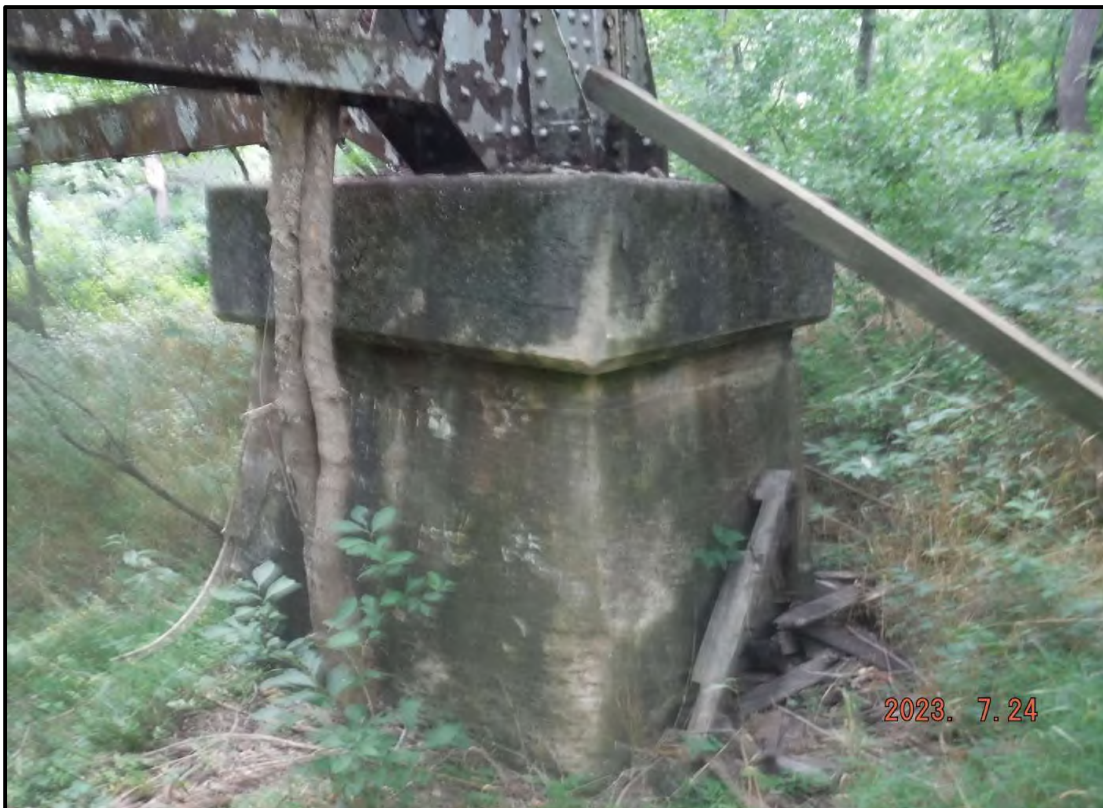
Photo 4: Typical Steel Bent Tower Pedestal

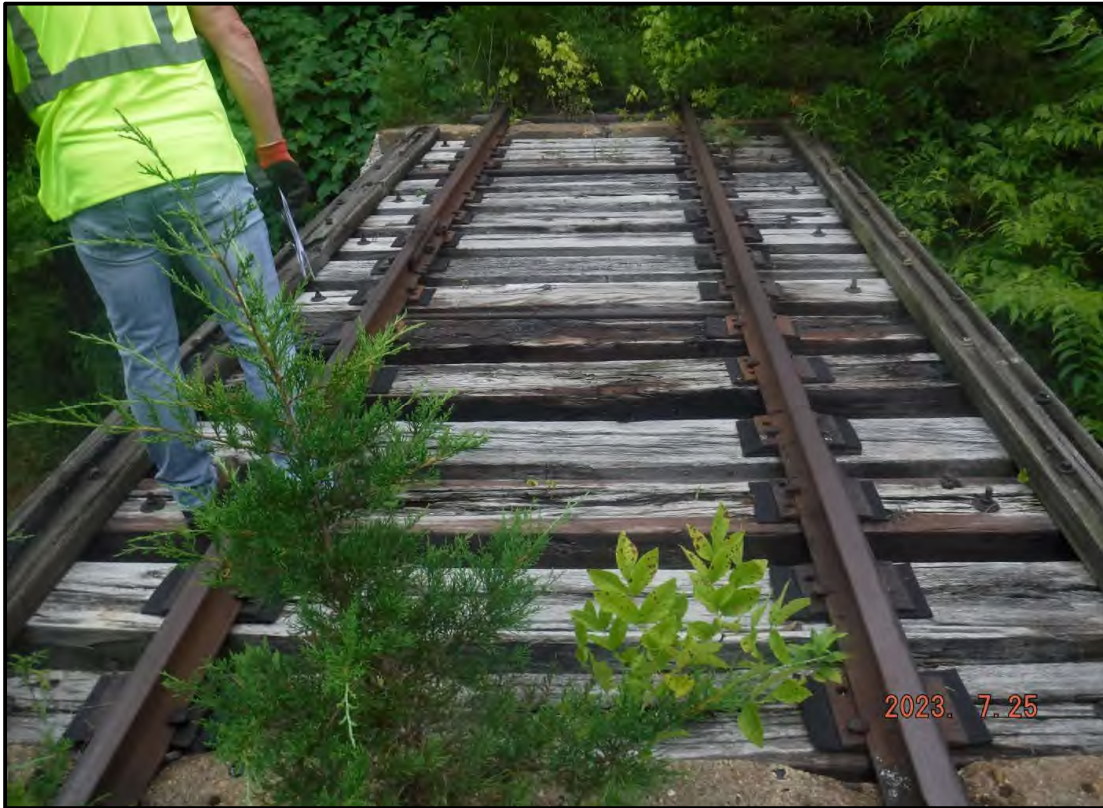
Photo 1: General Condition of Bridge Deck

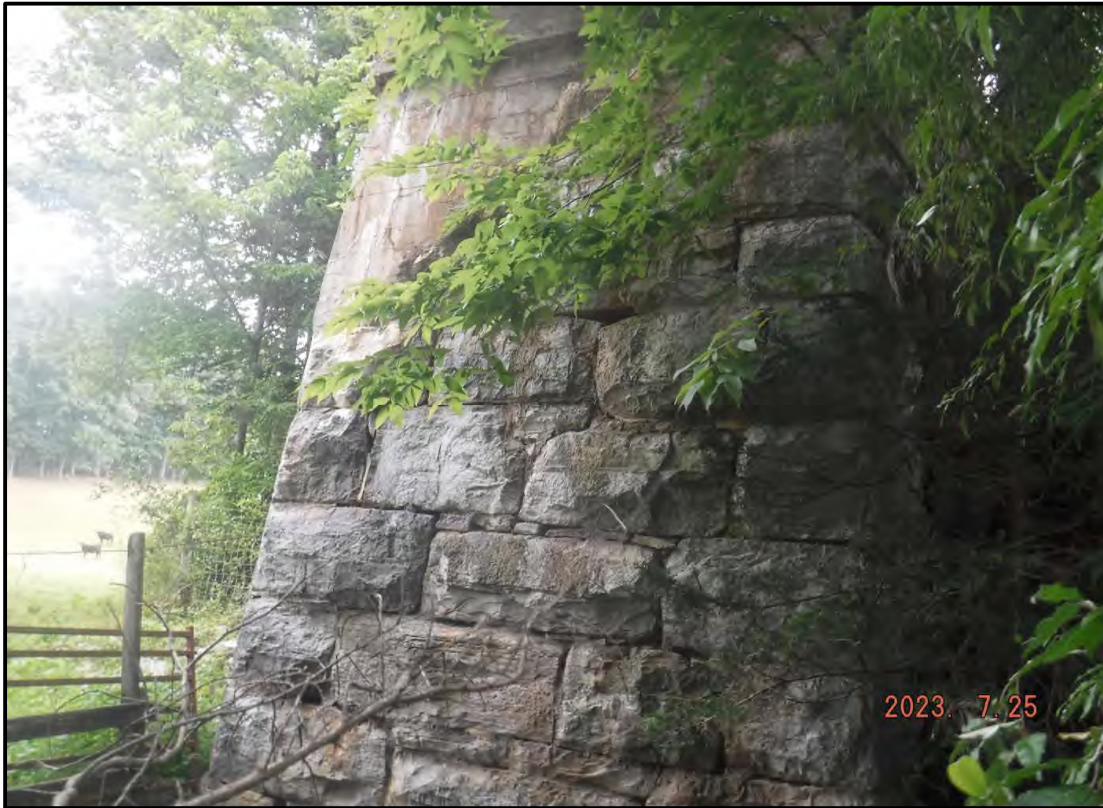
Photo 3: East Abutment

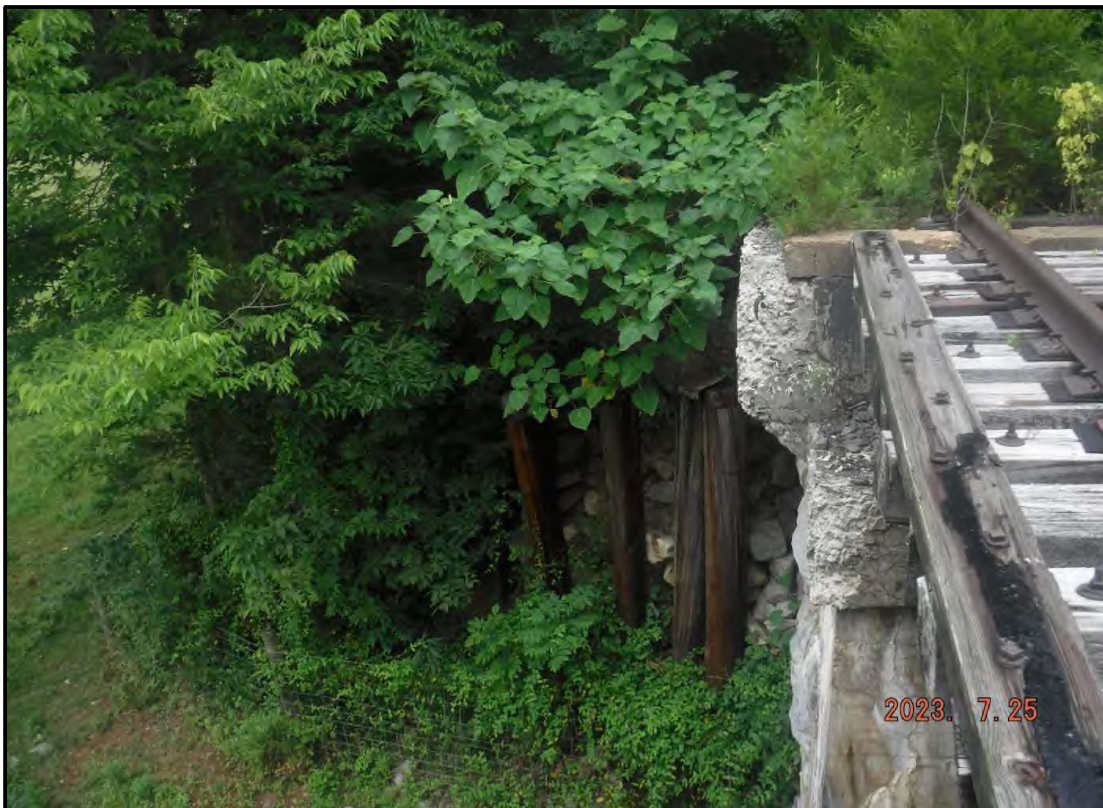
Photo 4: Typical Wingwall (NE Wing Shown)
