NORFOLK SOUTHERN RAILWAY CO. SHENANDOAH VALLEY RAIL CORRIDOR BRIDGE EVALUATION

STRASBURG, VIRGINIA
SHENANDOAH COUNTY

PROJECT NO. 23-1502.101

August 25, 2023

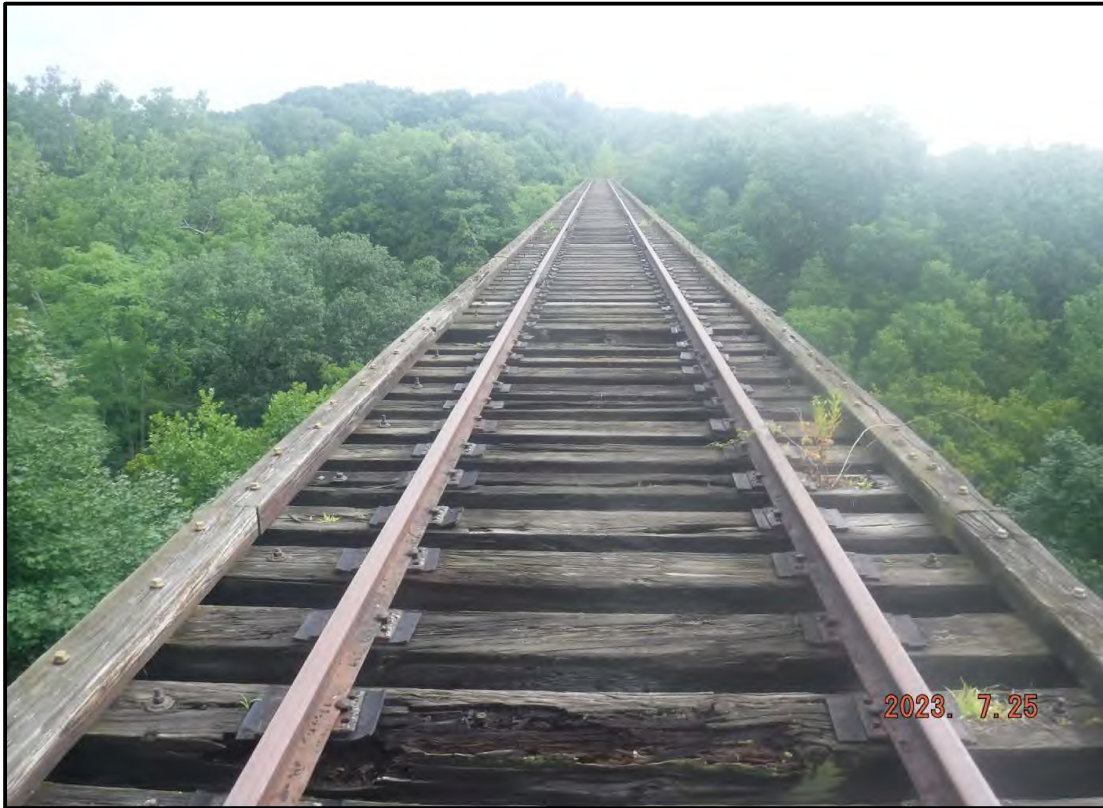
Photo 1: General Condition of Timber Tie Deck

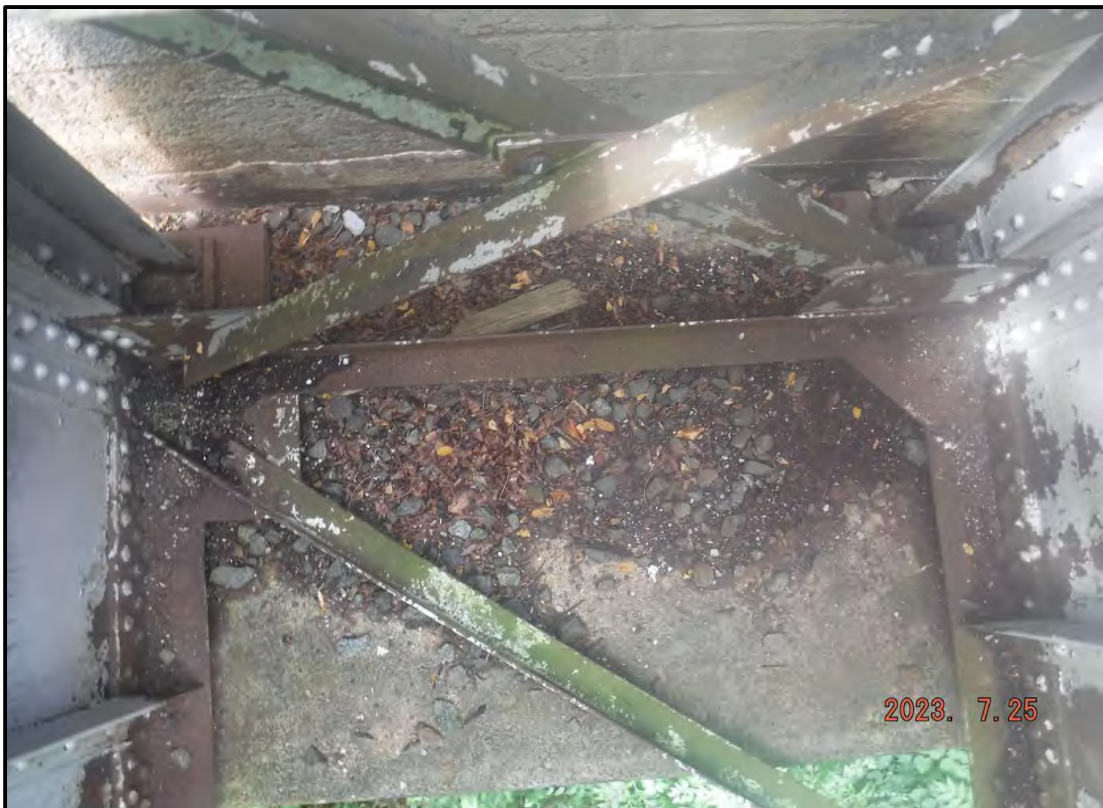
Photo 2: Typical Bridge Seat (West Abutment Shown)

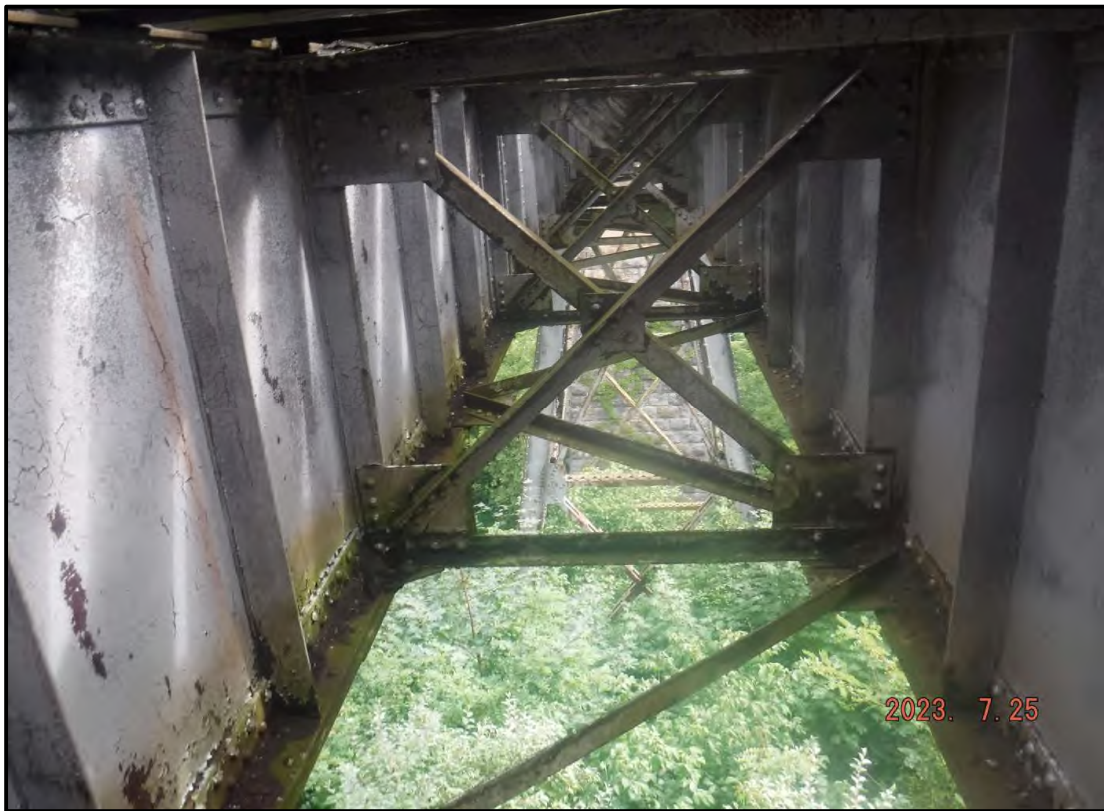
Photo 3: Through Girders (From West Abutment)

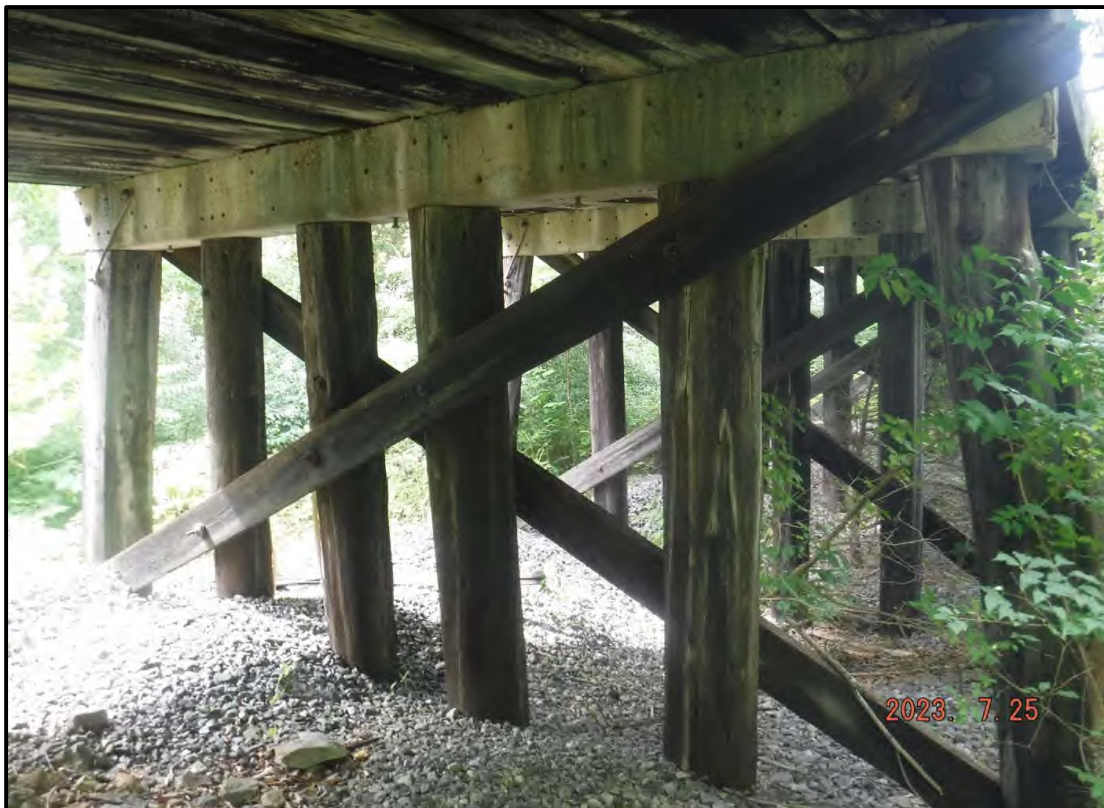
Photo 4: Typical Timber Pile Bent

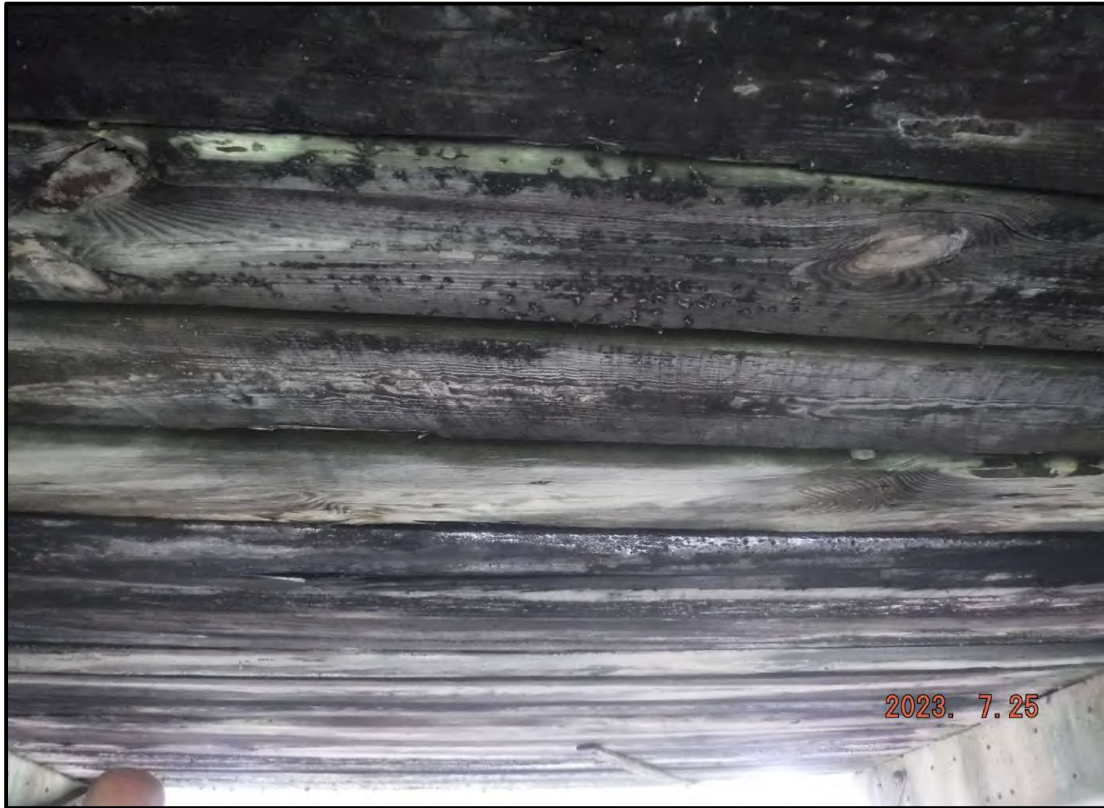
Photo 5: Typical Underside of Timber Slab

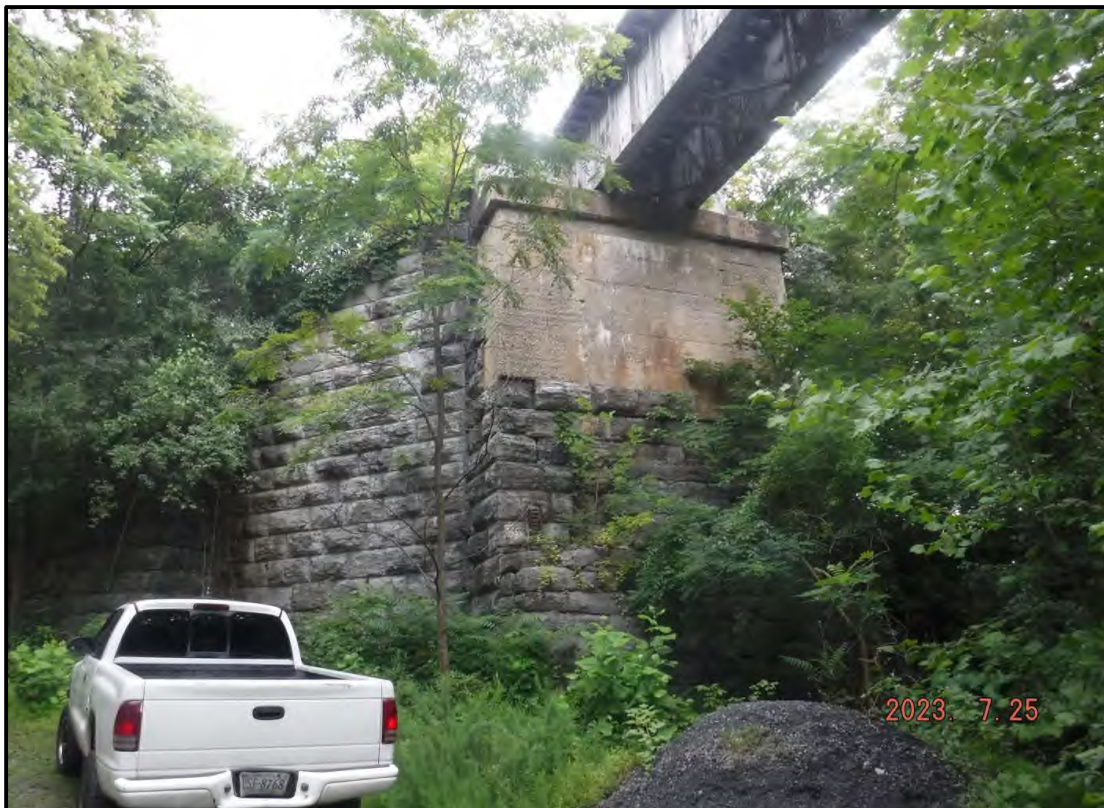
Photo 6: East Abutment

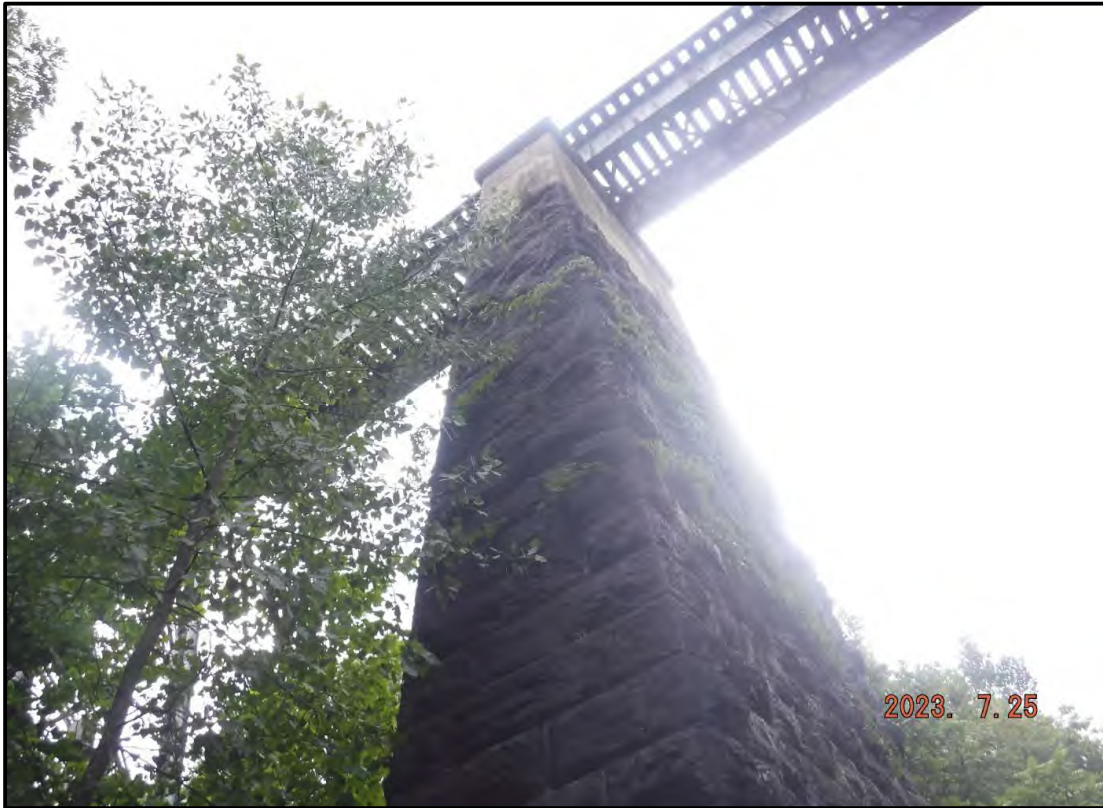
Photo 7: Typical Pier

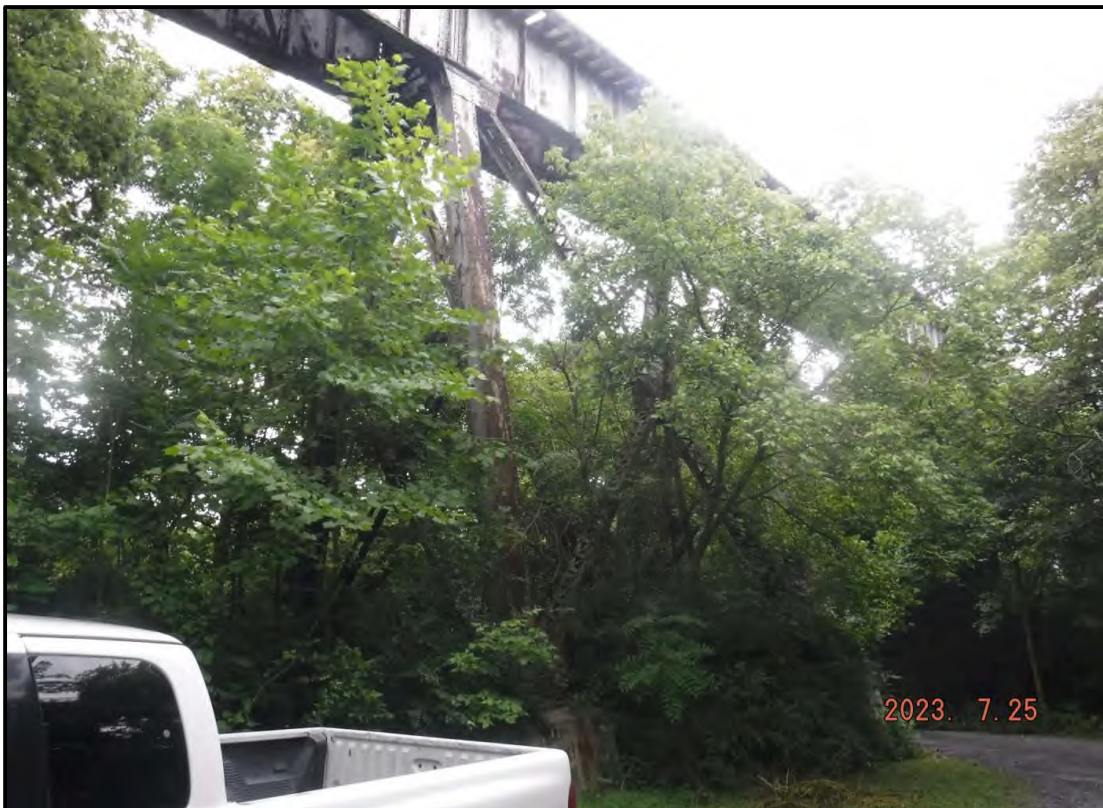
Photo 8: Typical Steel Bent Tower

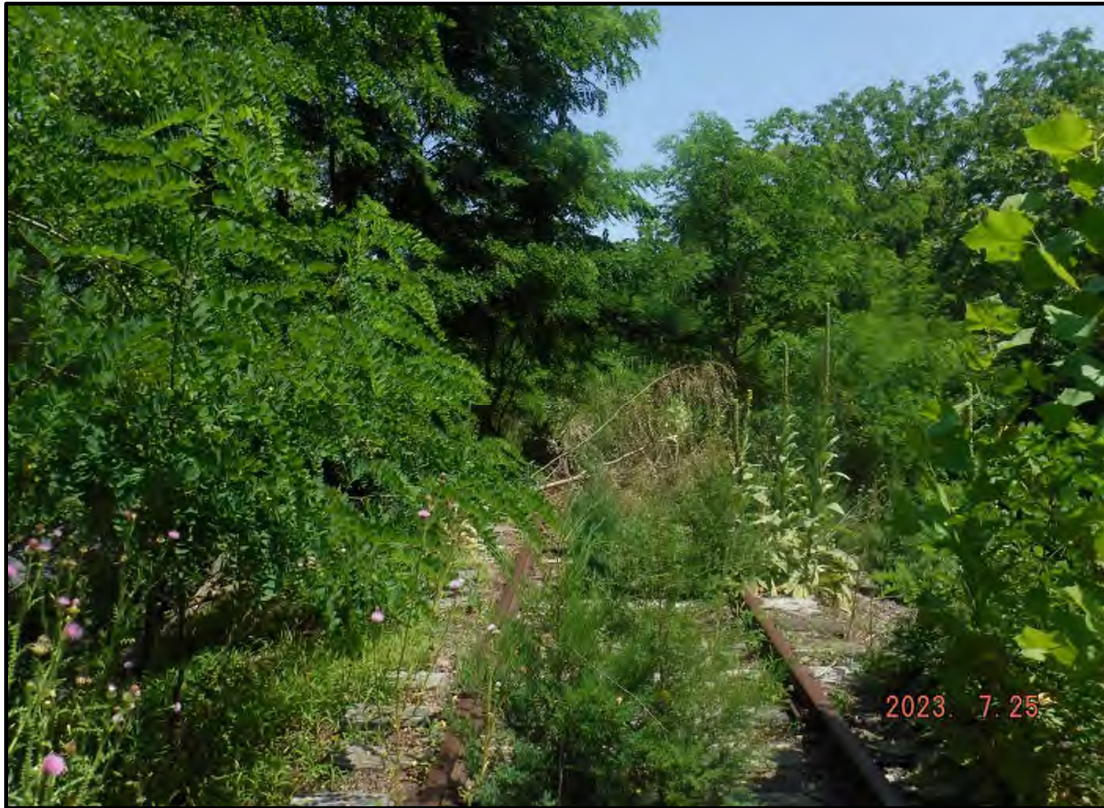
Photo 1: Track on Structure

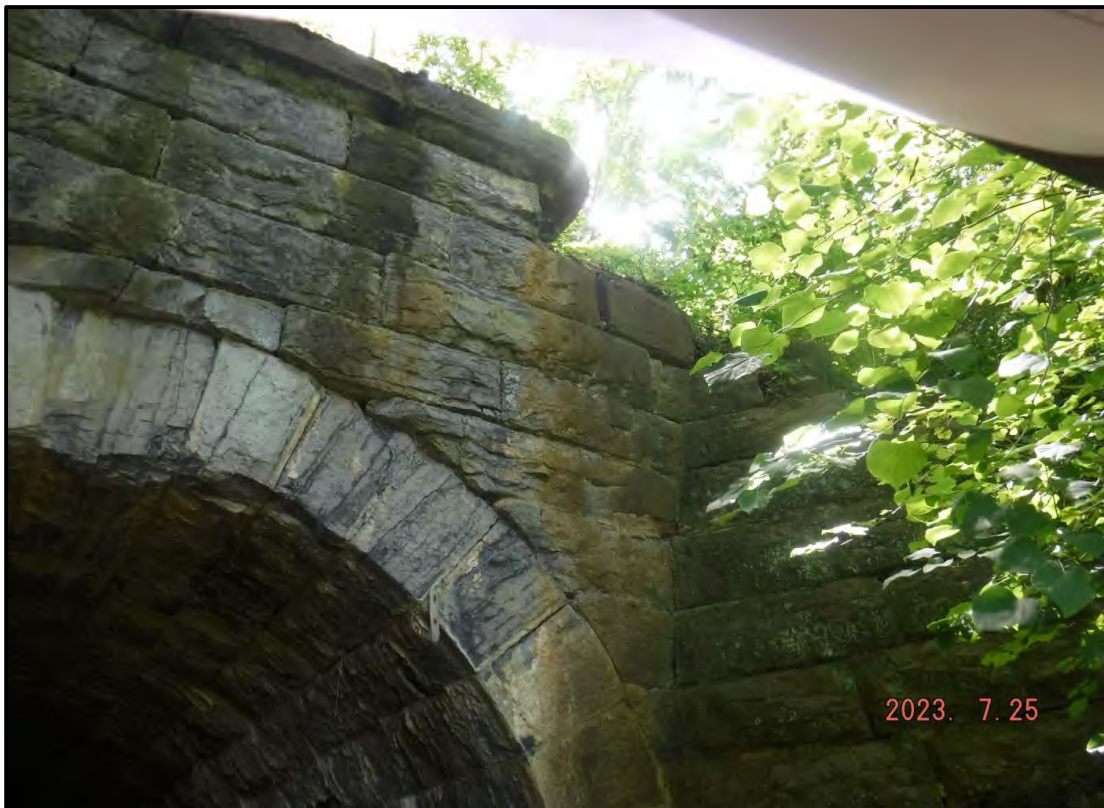
Photo 2: Missing Stones West End of North Headwall

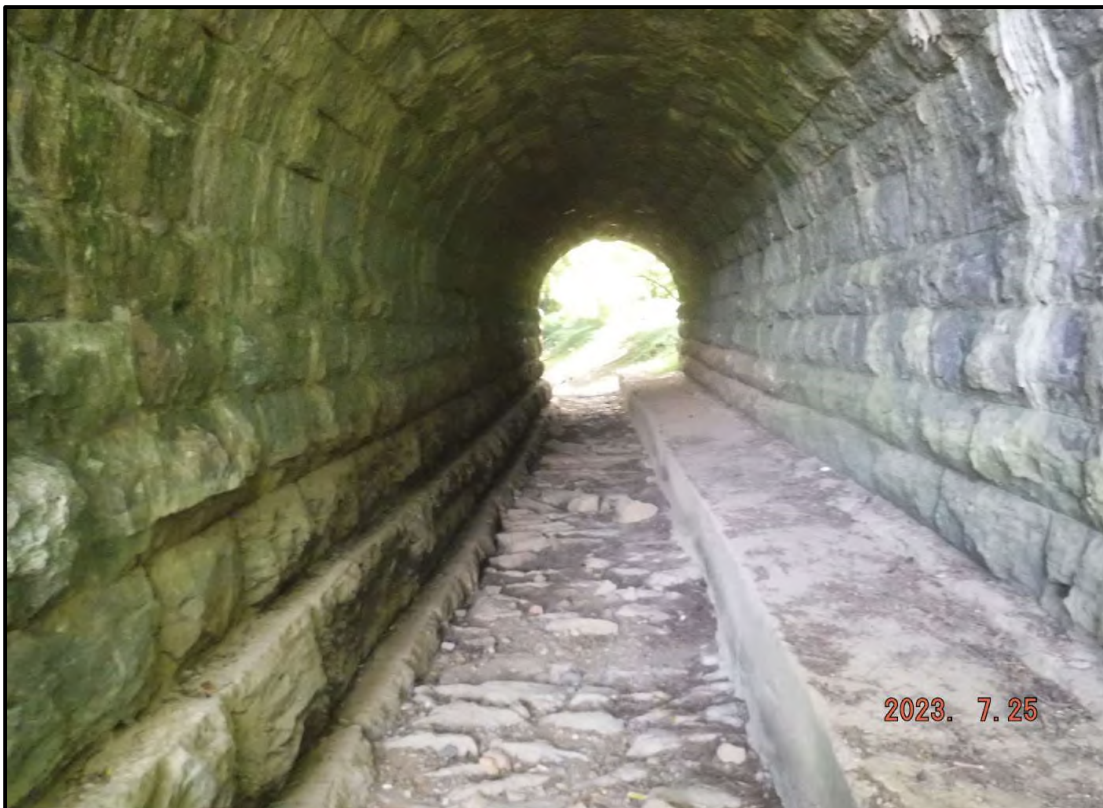
Photo 4: Through Stone Arch (From North)

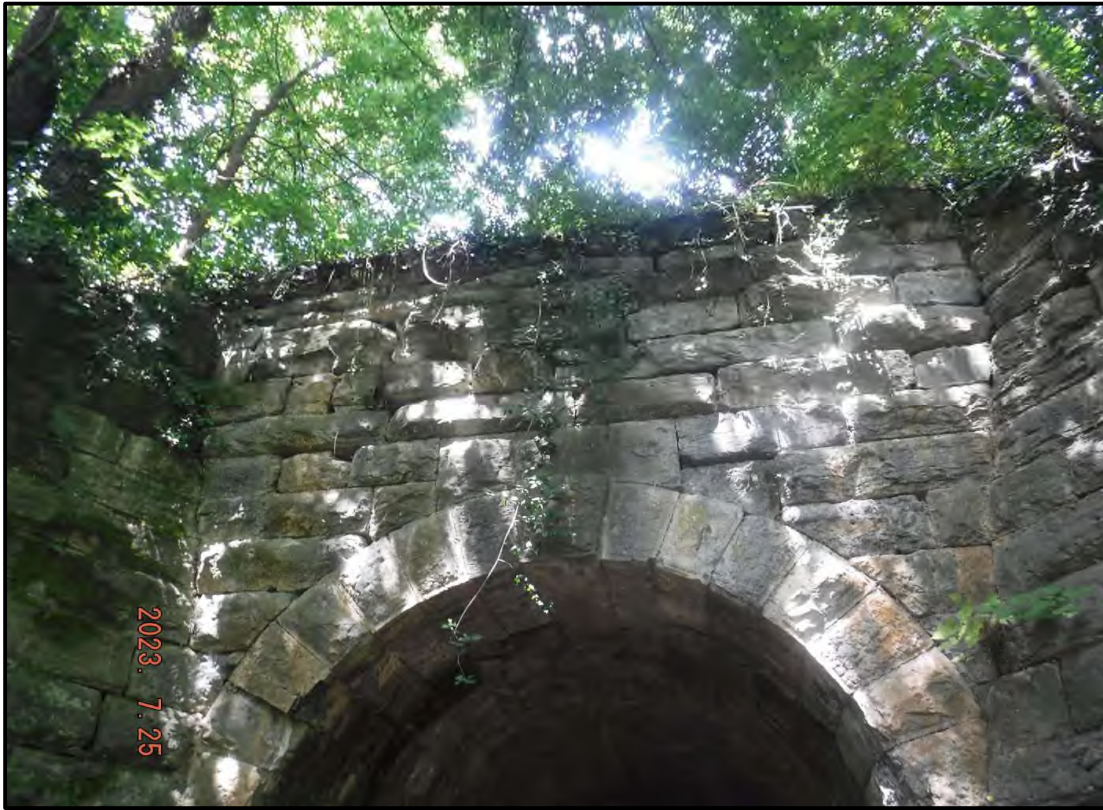
Photo 5: South Headwall

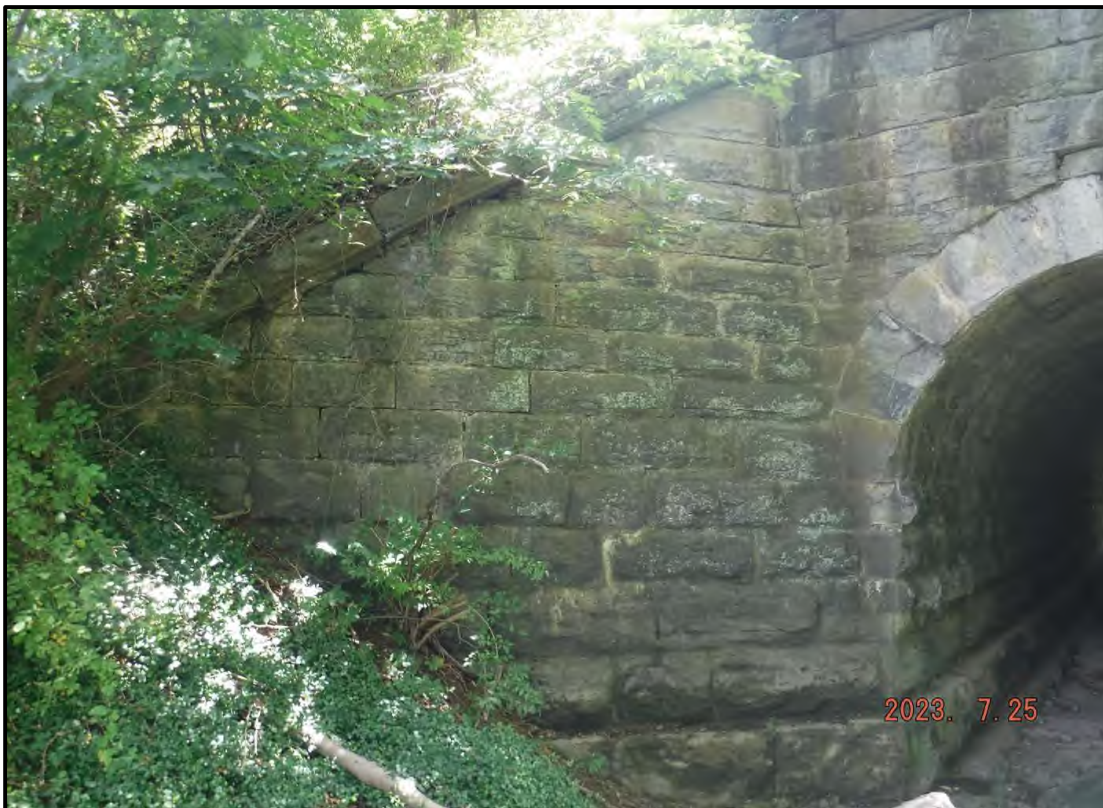
Photo 6: Typical Wingwall (NE Wing Shown)

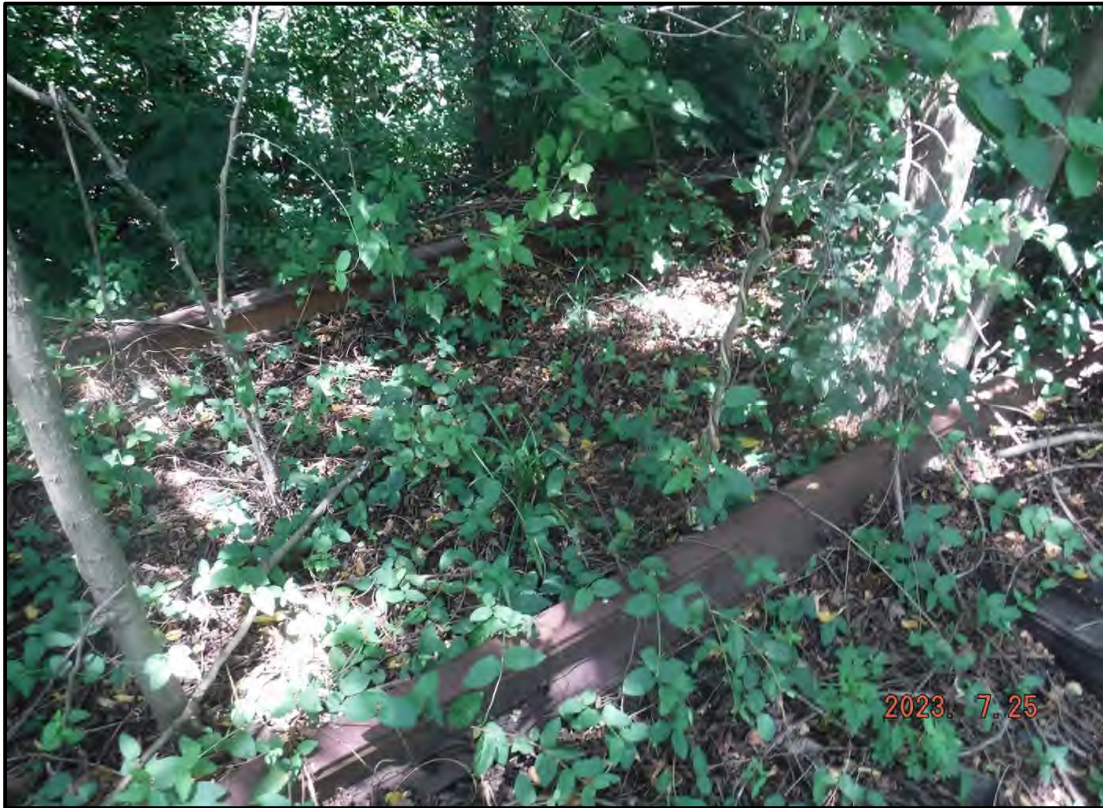
Photo 1: Track on Structure

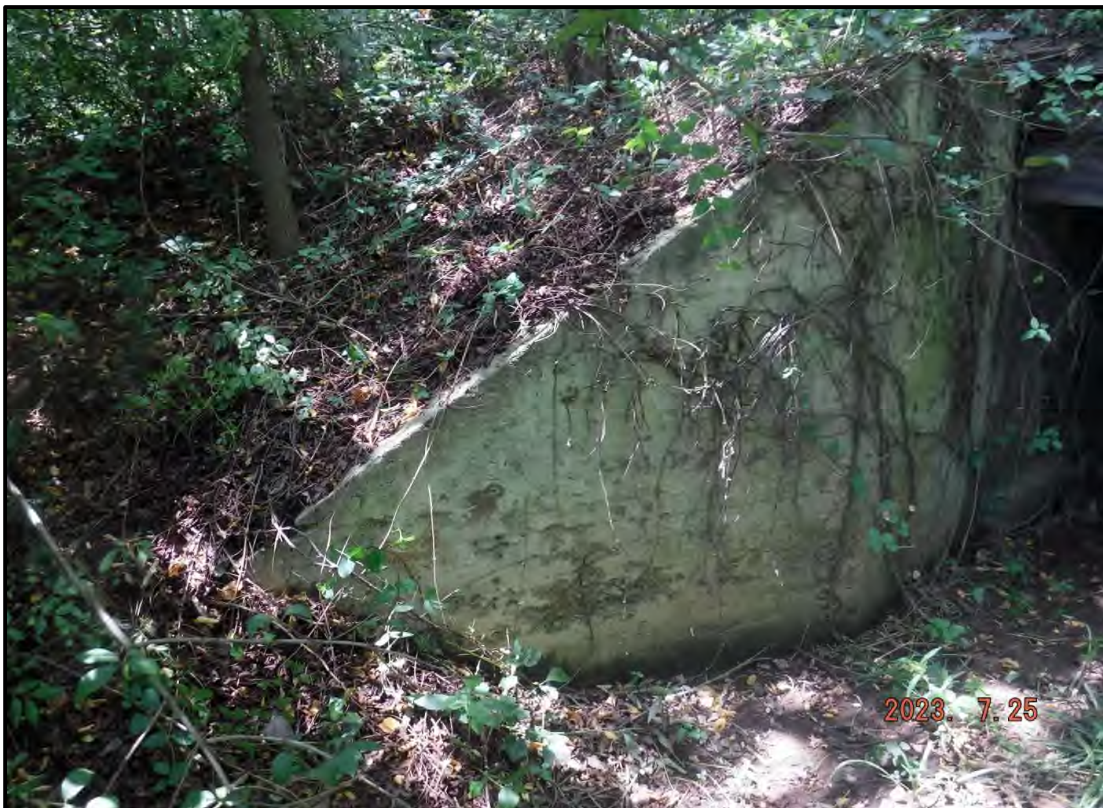
Photo 2: Typical Wingwall (SW Wing Shown)

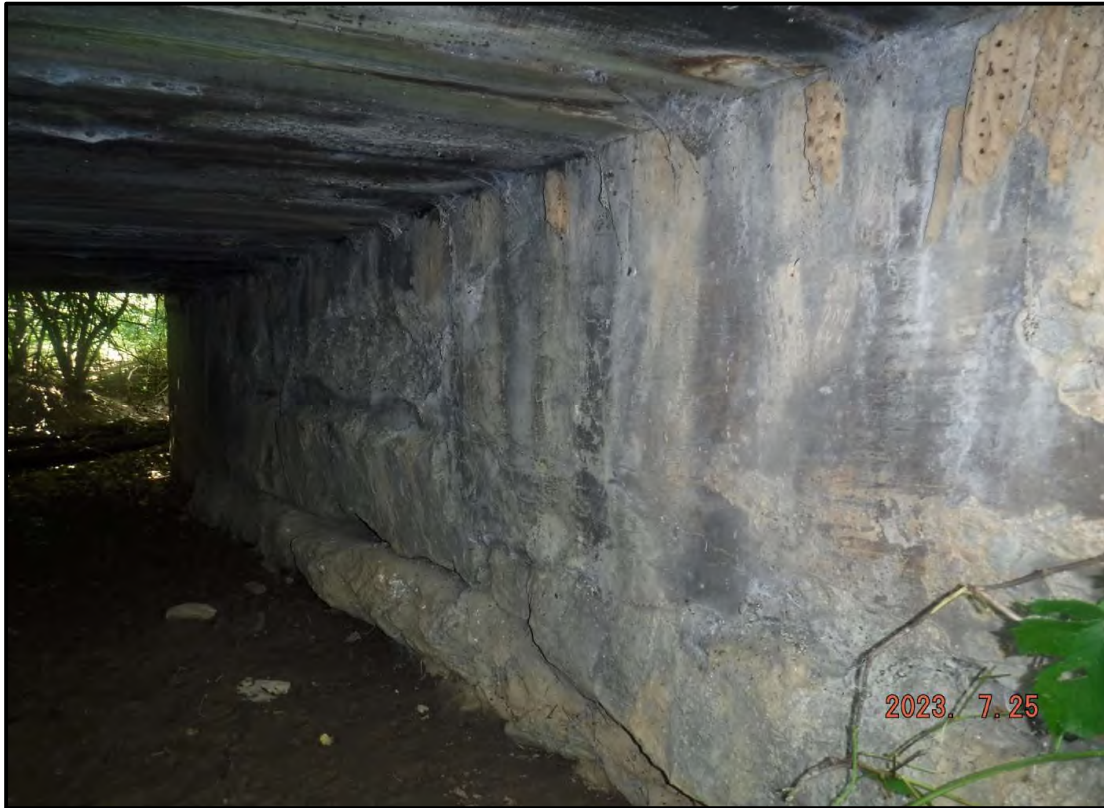
Photo 3: East Abutment (From South)

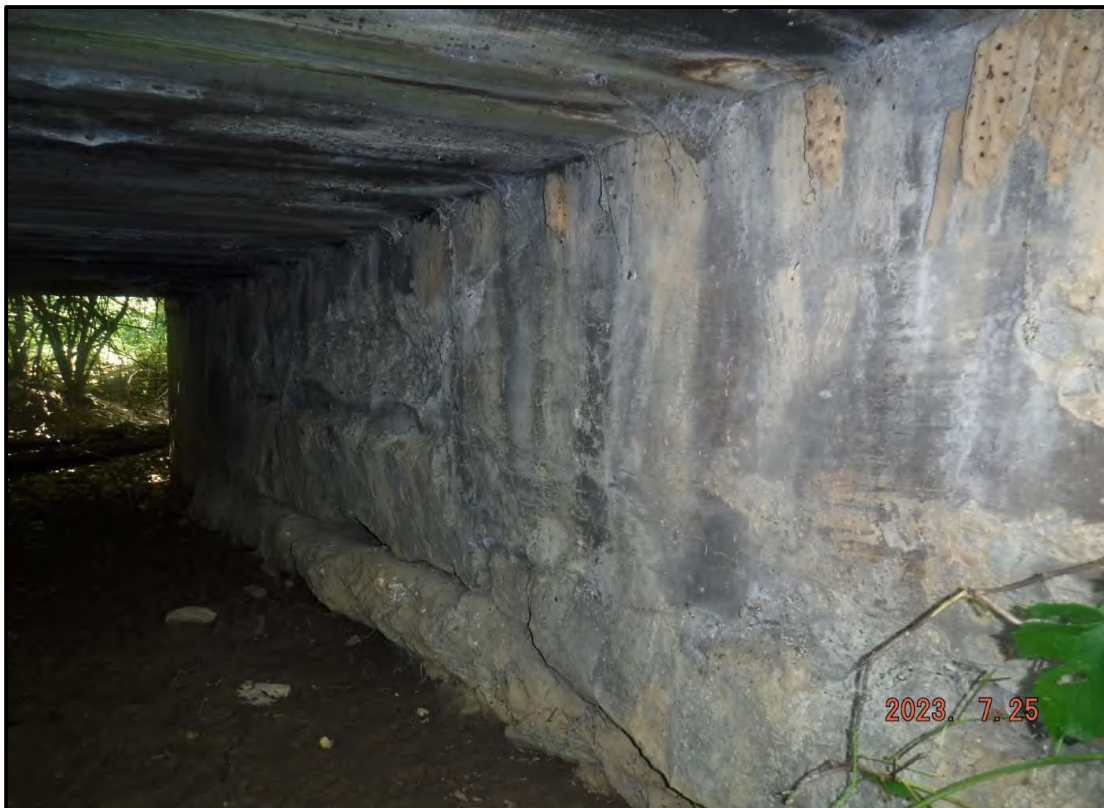
Photo 4: West Abutment (From South)

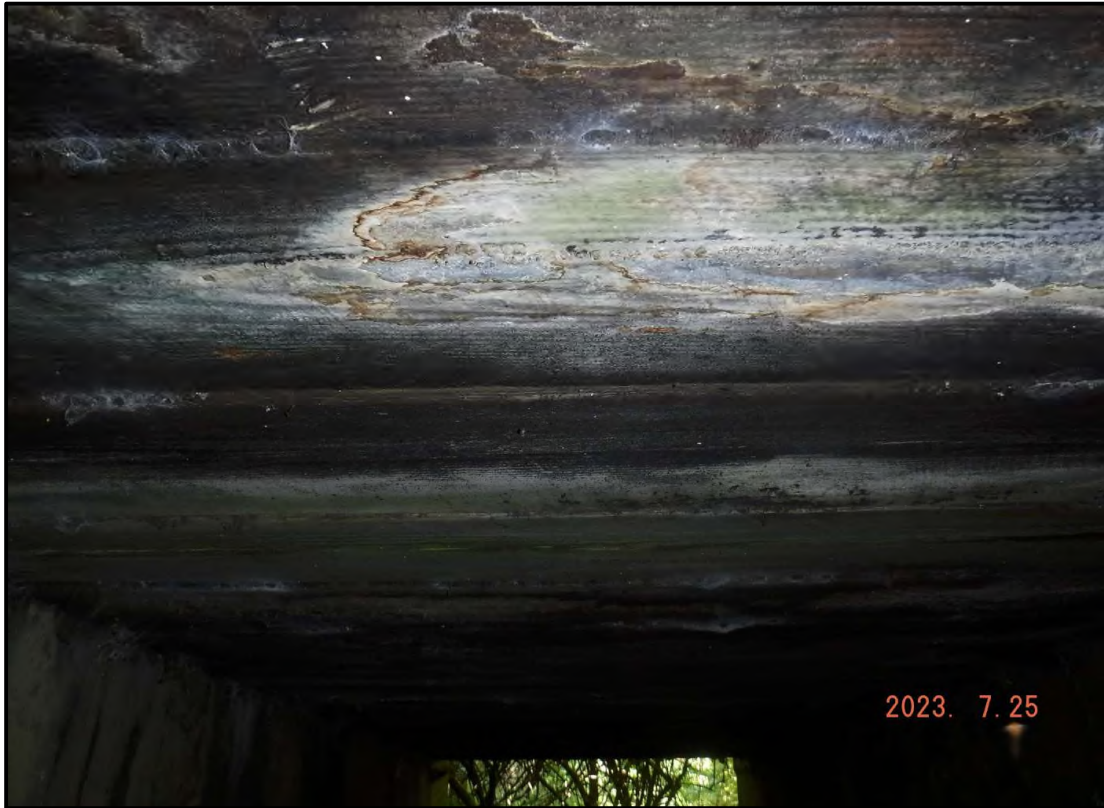
Photo 5: Typical Underside of Timber Slab

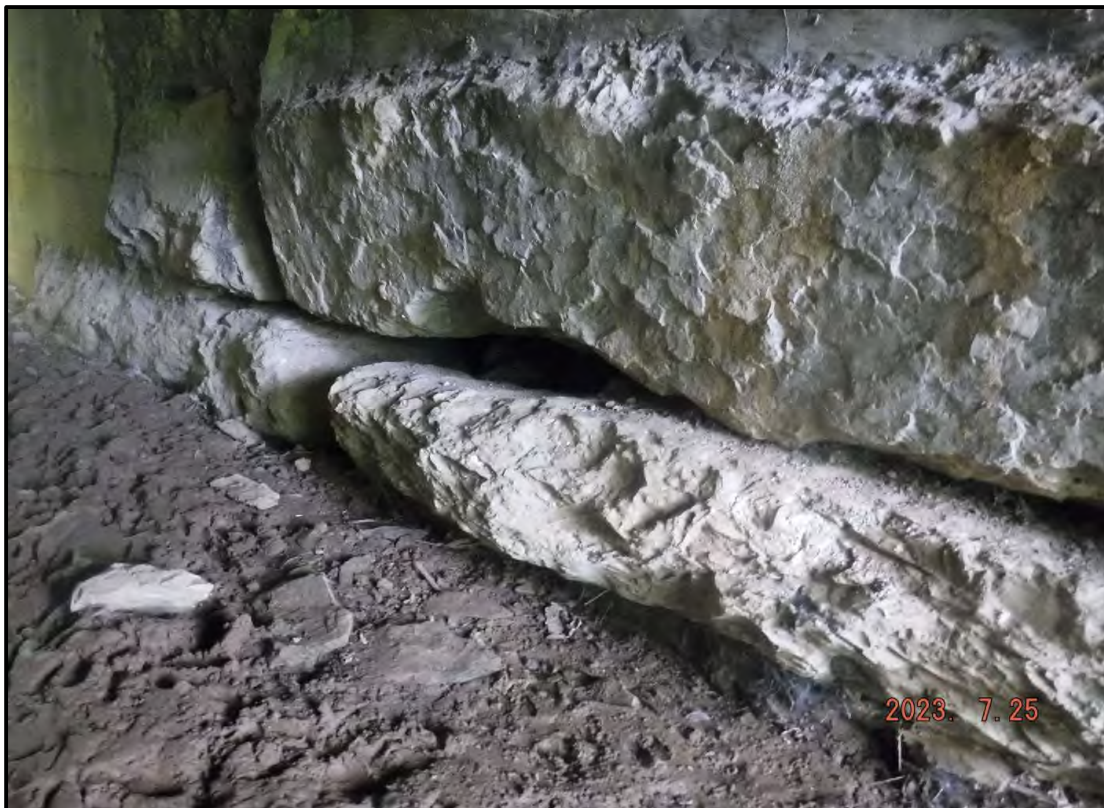
Photo 6: Typical Stone Masonry Abutment Open Joints

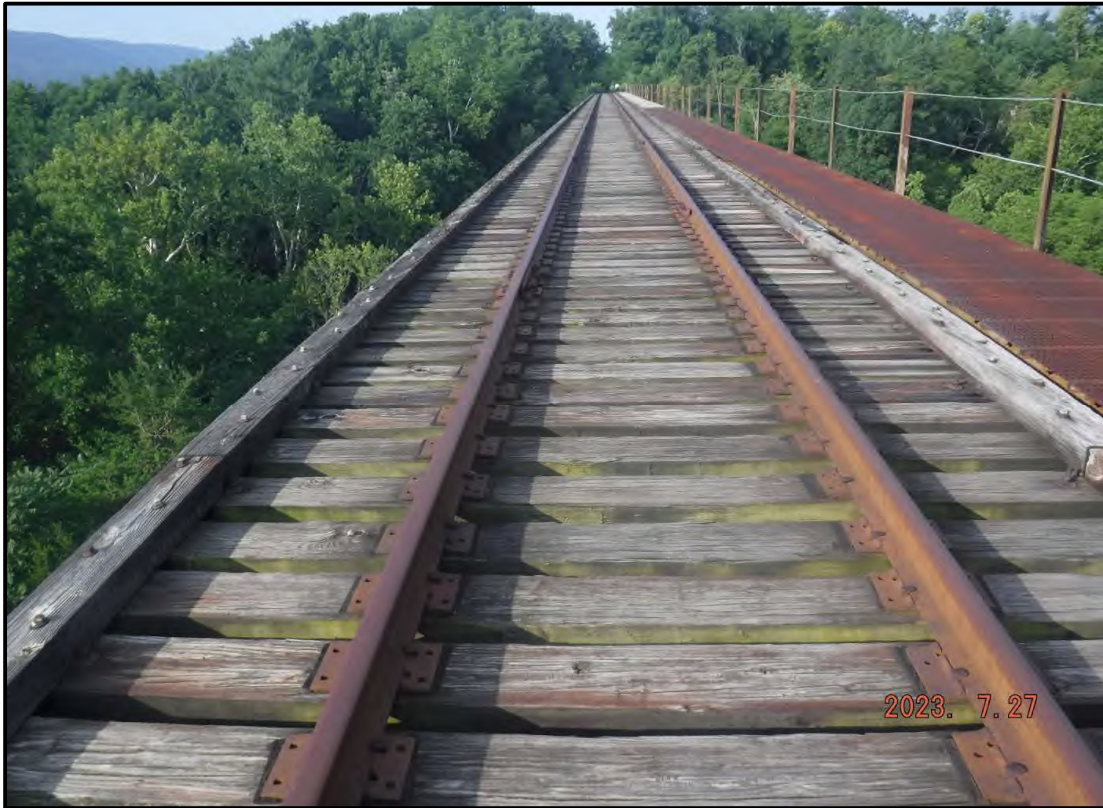
Photo 1: General Condition of Deck (Main Spans)

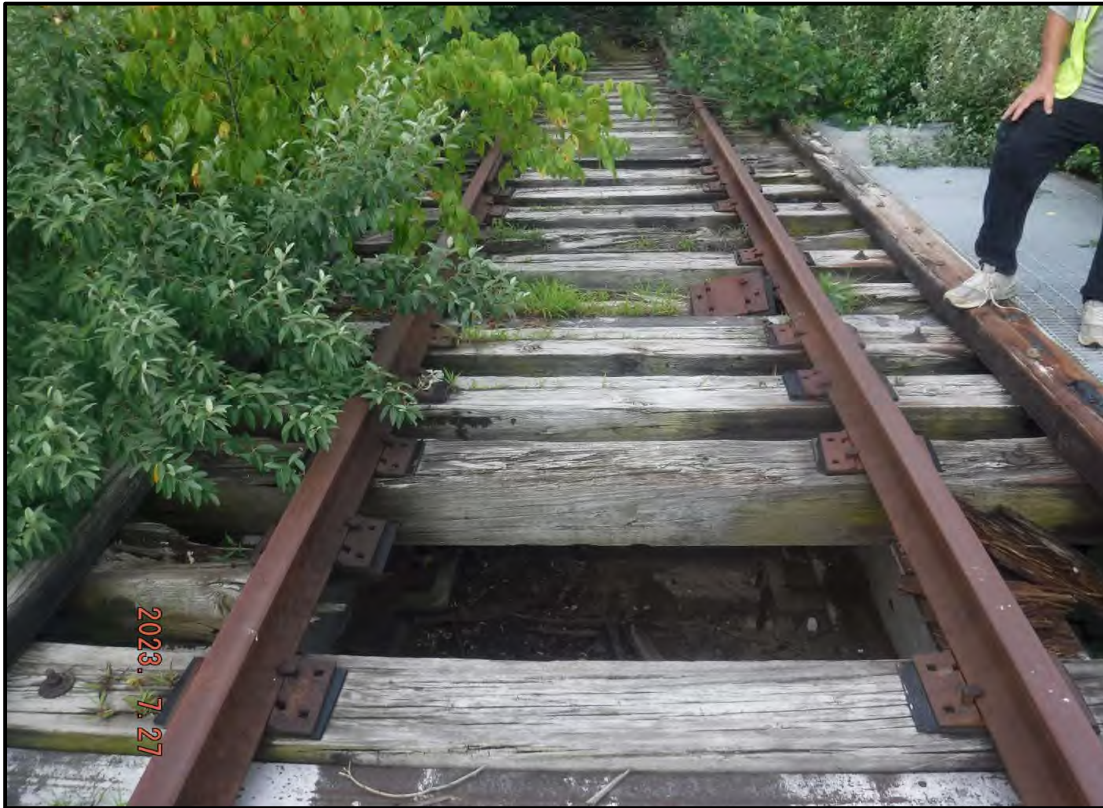
Photo 3: General Condition of Deck (Approach Spans, West Shown)

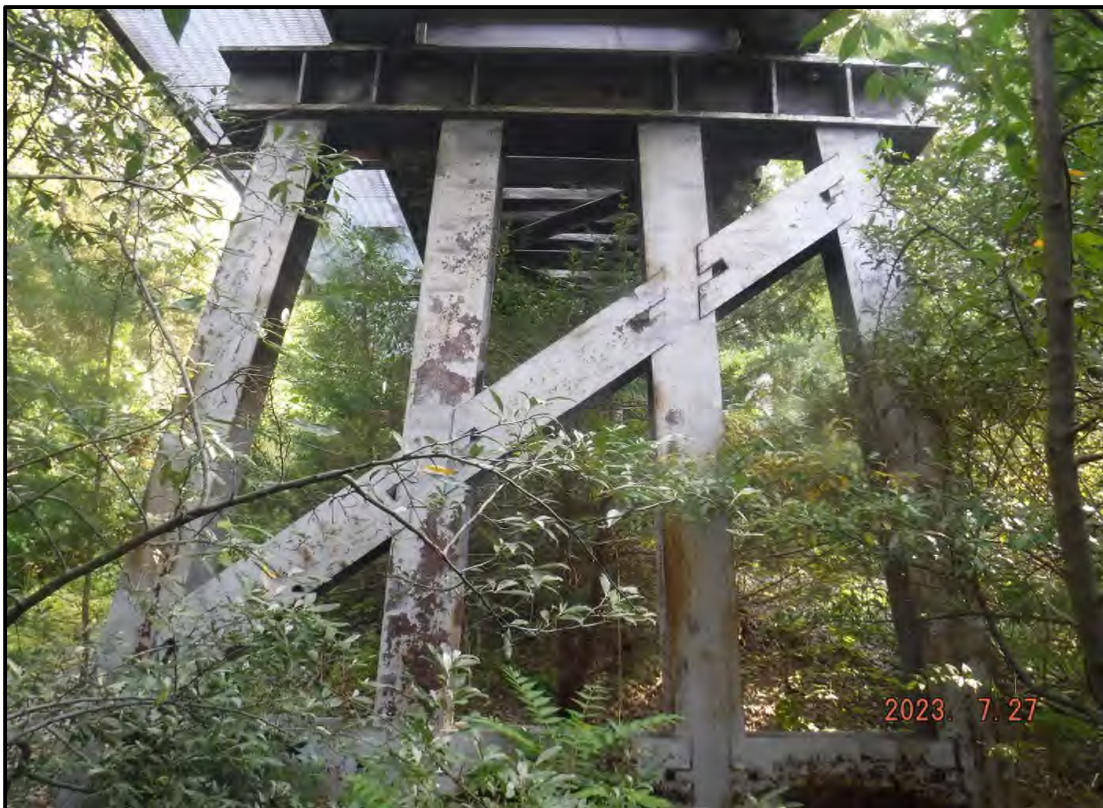
Photo 4: Typical Steel Pile Bent (Typical for Approach Spans)

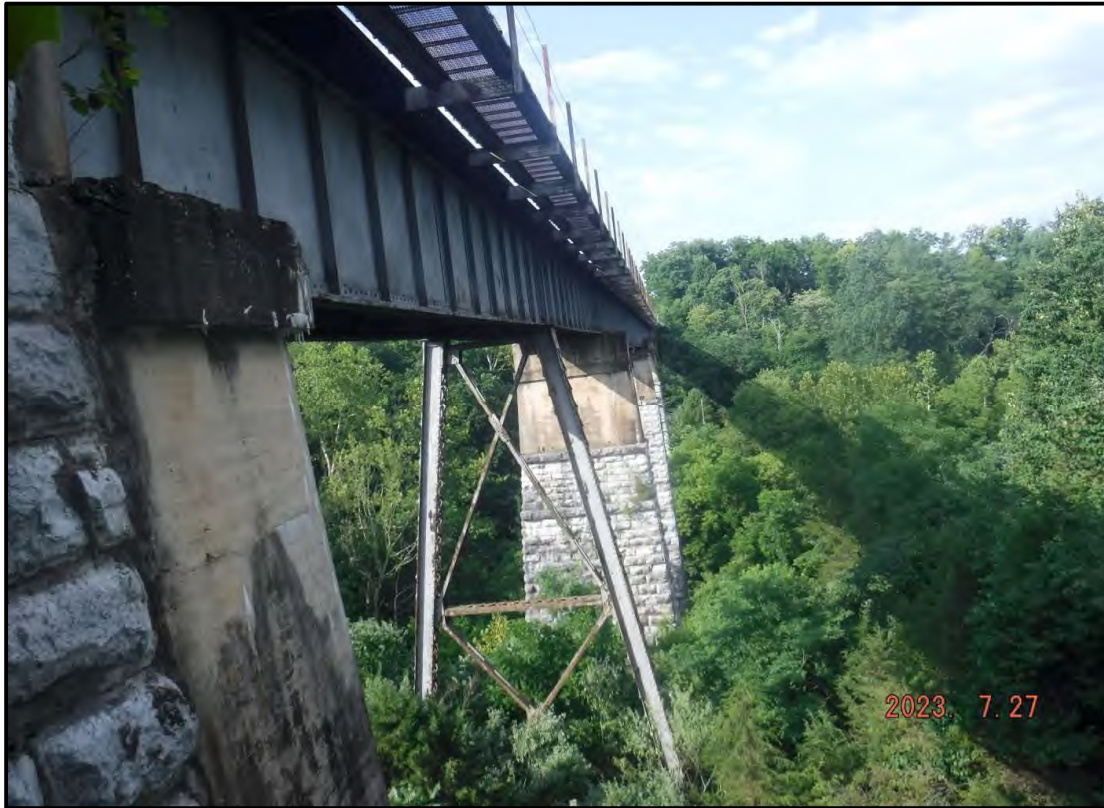
Photo 5: North Side of Main Spans (From East)

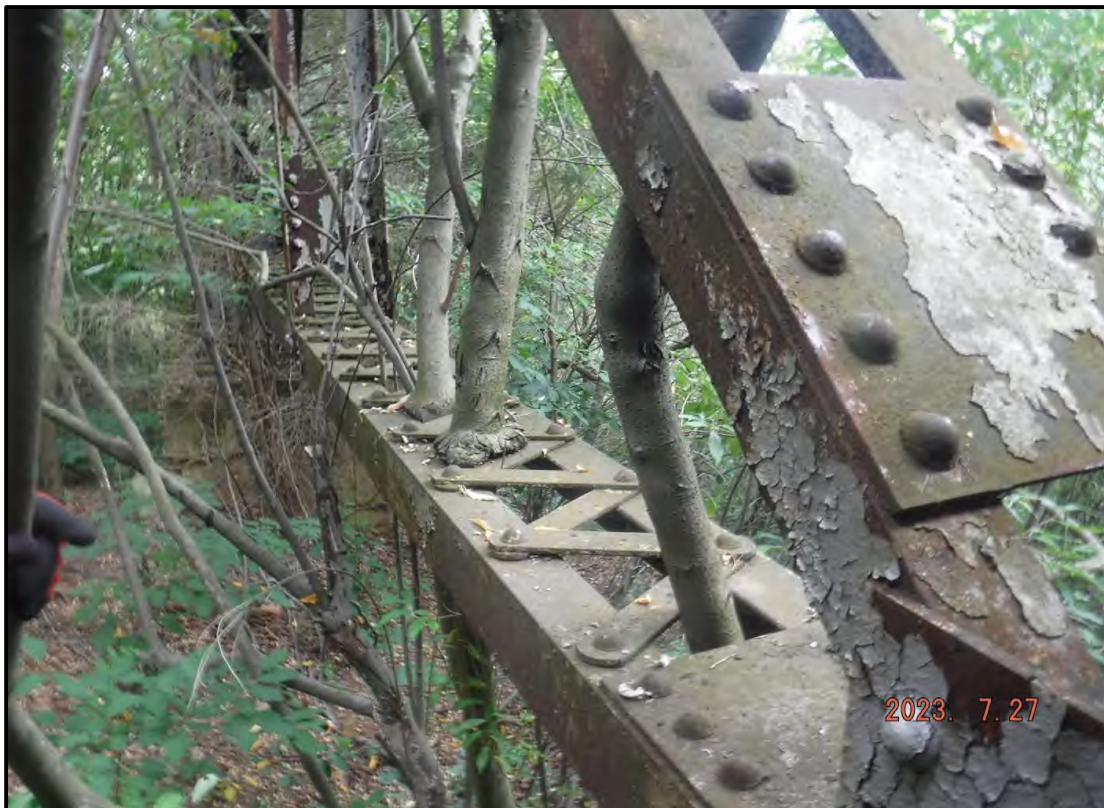
Photo 6: Typical Vegetation in Steel Bent Bracing

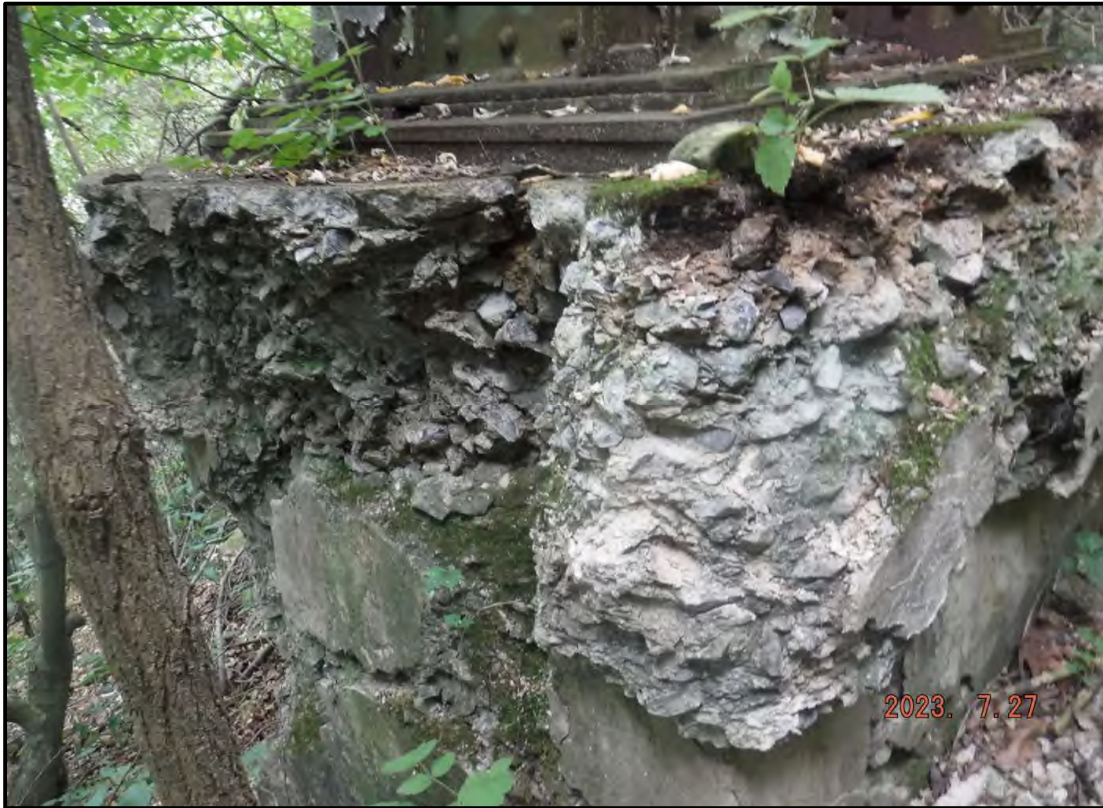
Photo 7: Spalled Concrete on Main Span Bent 2 North Pedestal
