NORFOLK SOUTHERN RAILWAY CO. SHENANDOAH VALLEY RAIL CORRIDOR BRIDGE EVALUATION

STRASBURG, VIRGINIA
SHENANDOAH COUNTY

PROJECT NO. 23-1502.101

August 25, 2023

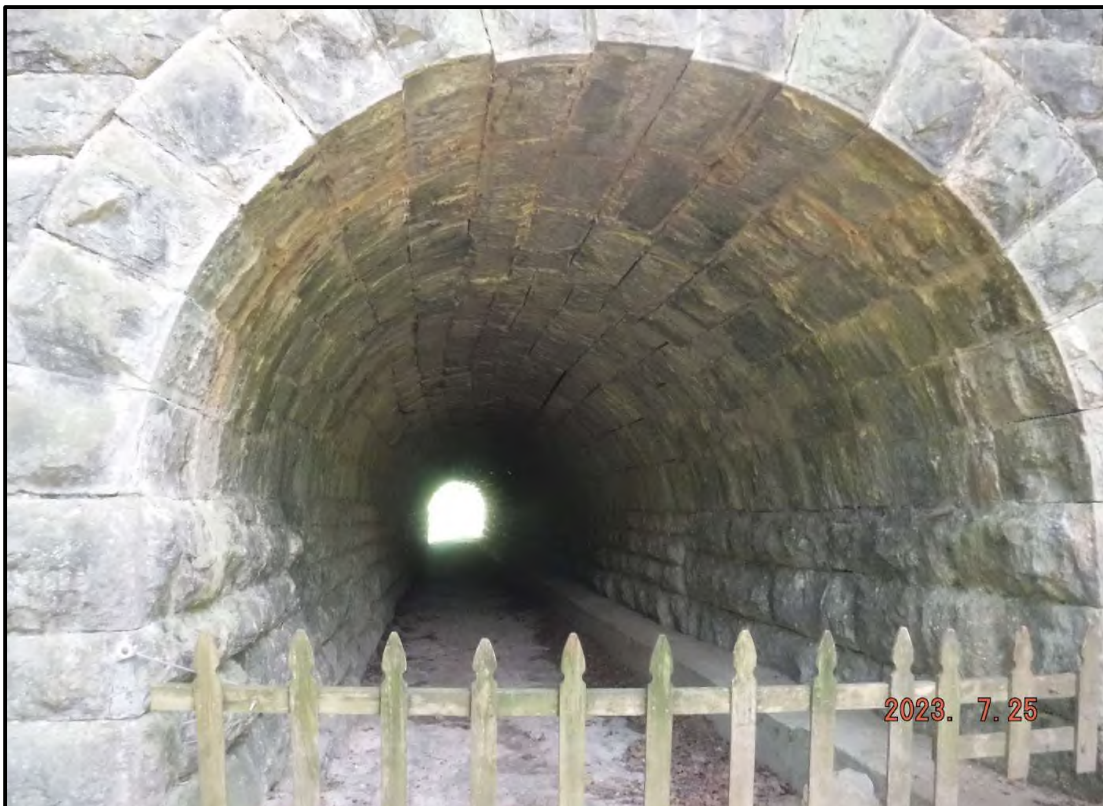
Photo 2: Through Stone Arch (From North)

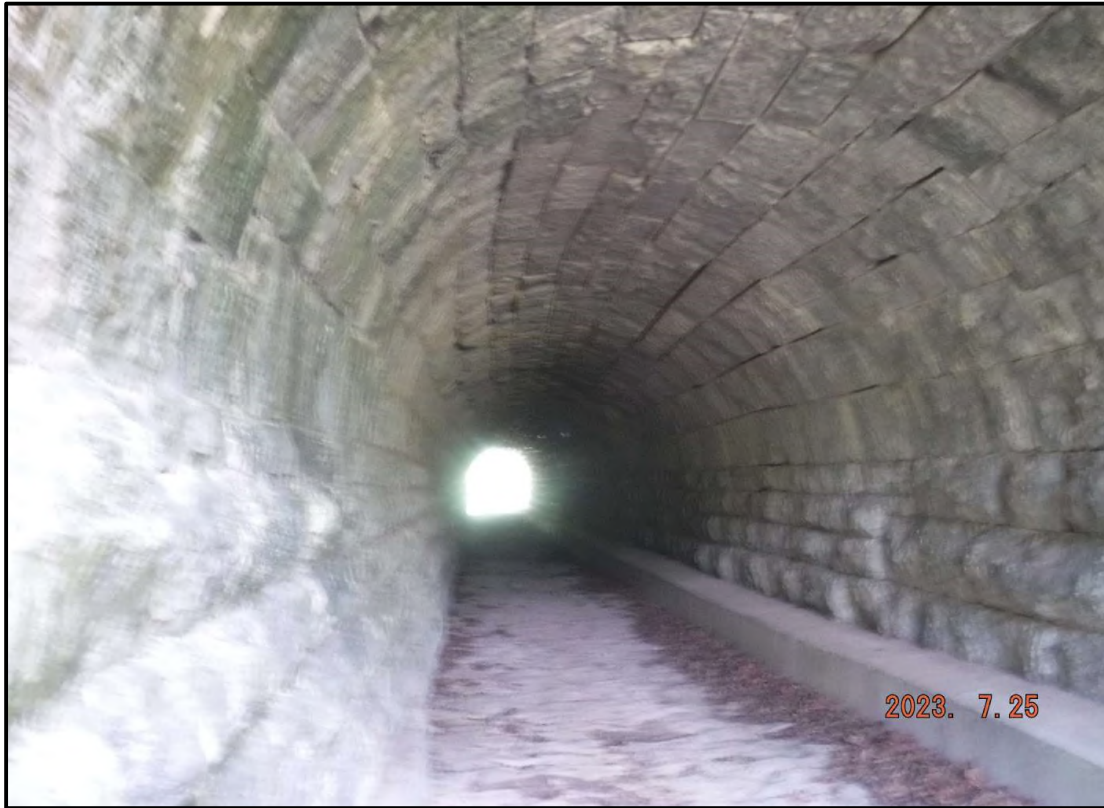
Photo 3: Through Stone Arch (From South)

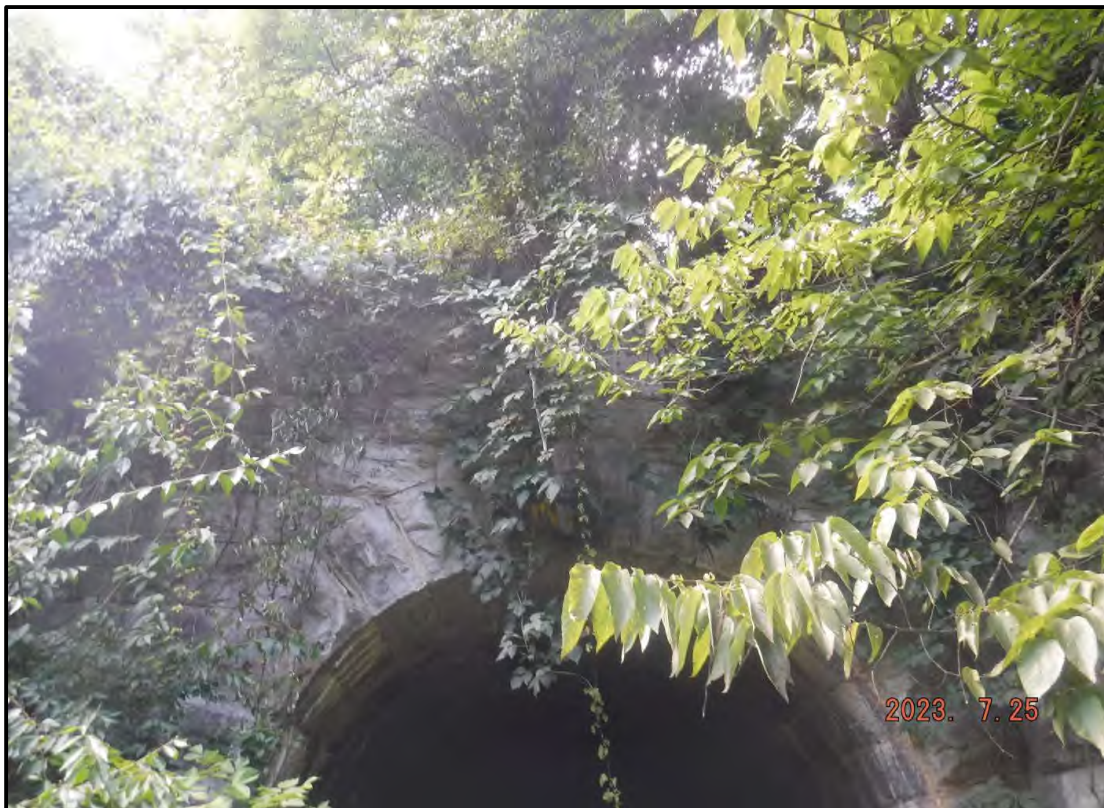
Photo 4: South Headwall

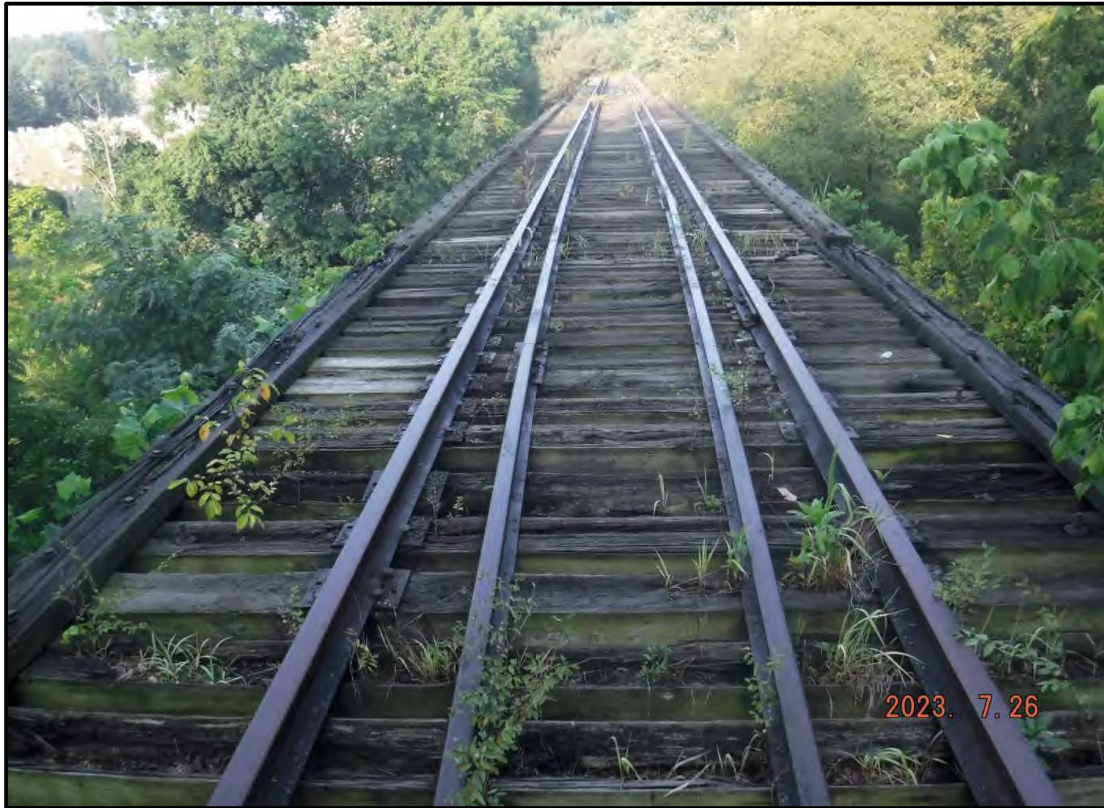
Photo 1: General Condition of Timber Tie Deck

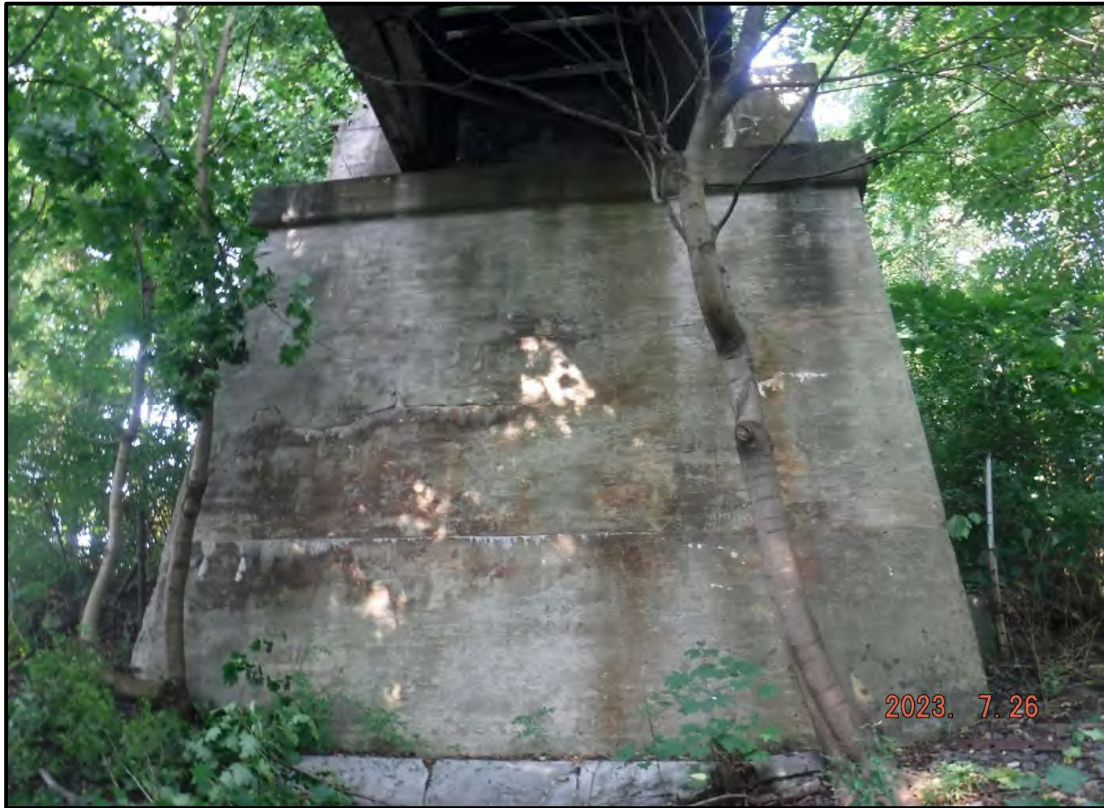
Photo 3: West Abutment

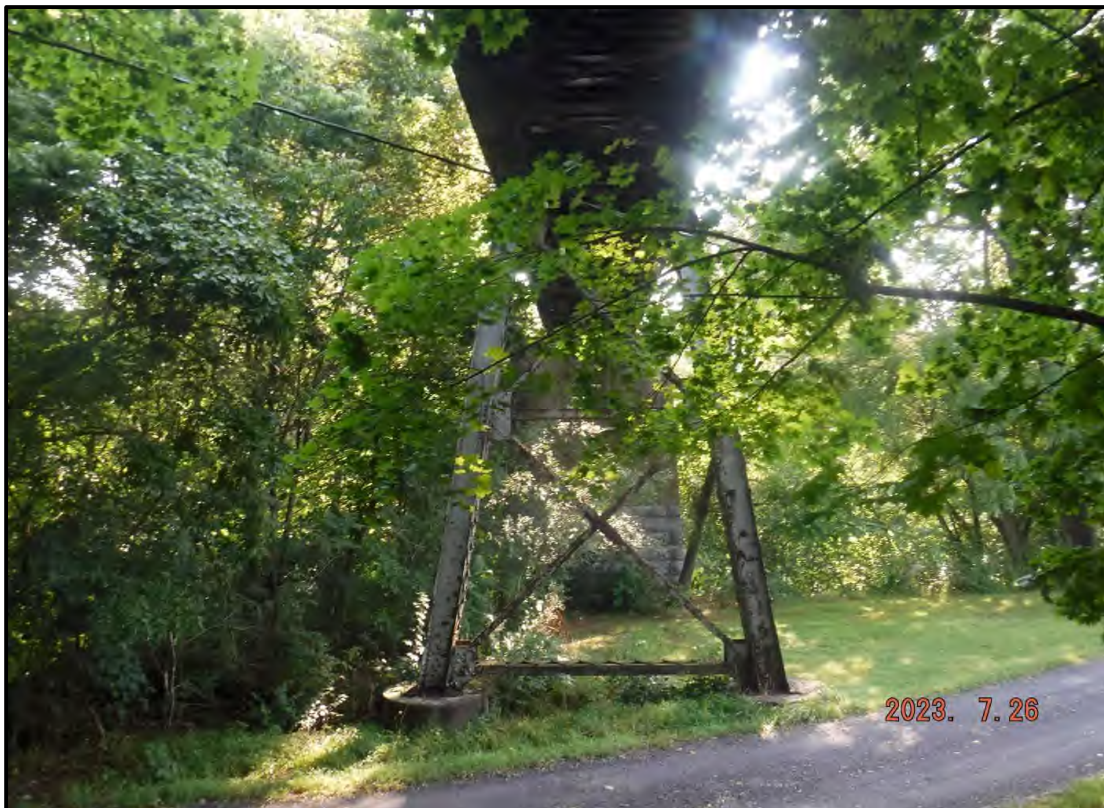
Photo 4: Typical Steel Bent (West Side of Bent 2 Shown)

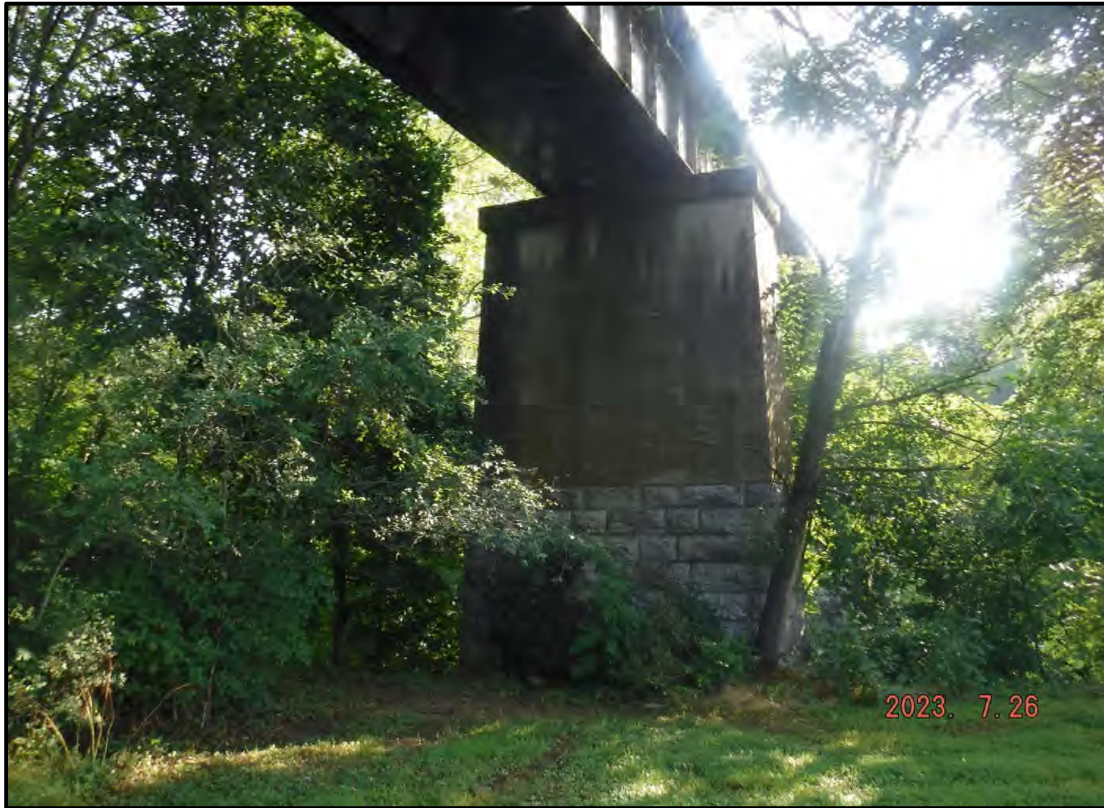
Photo 5: Typical Pier (West Side of Pier 2 Shown)

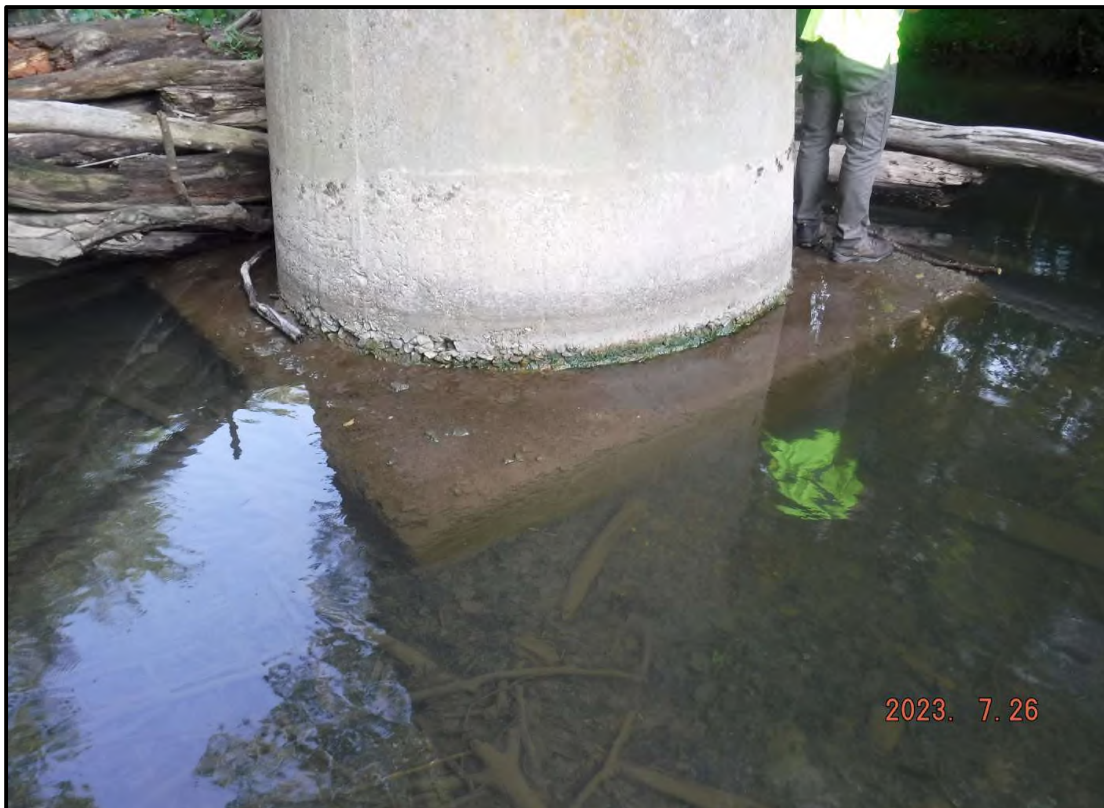
Photo 6: Typical Exposed Footing (Steel Bent Tower)

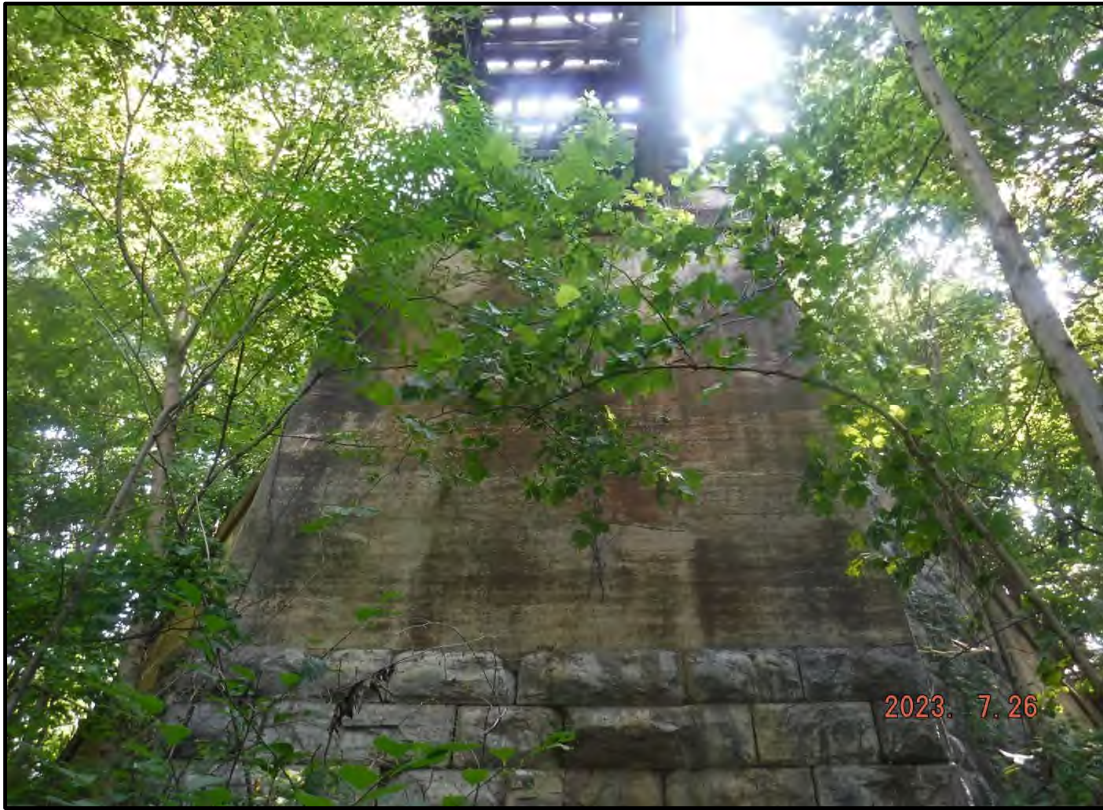
Photo 7: East Abutment

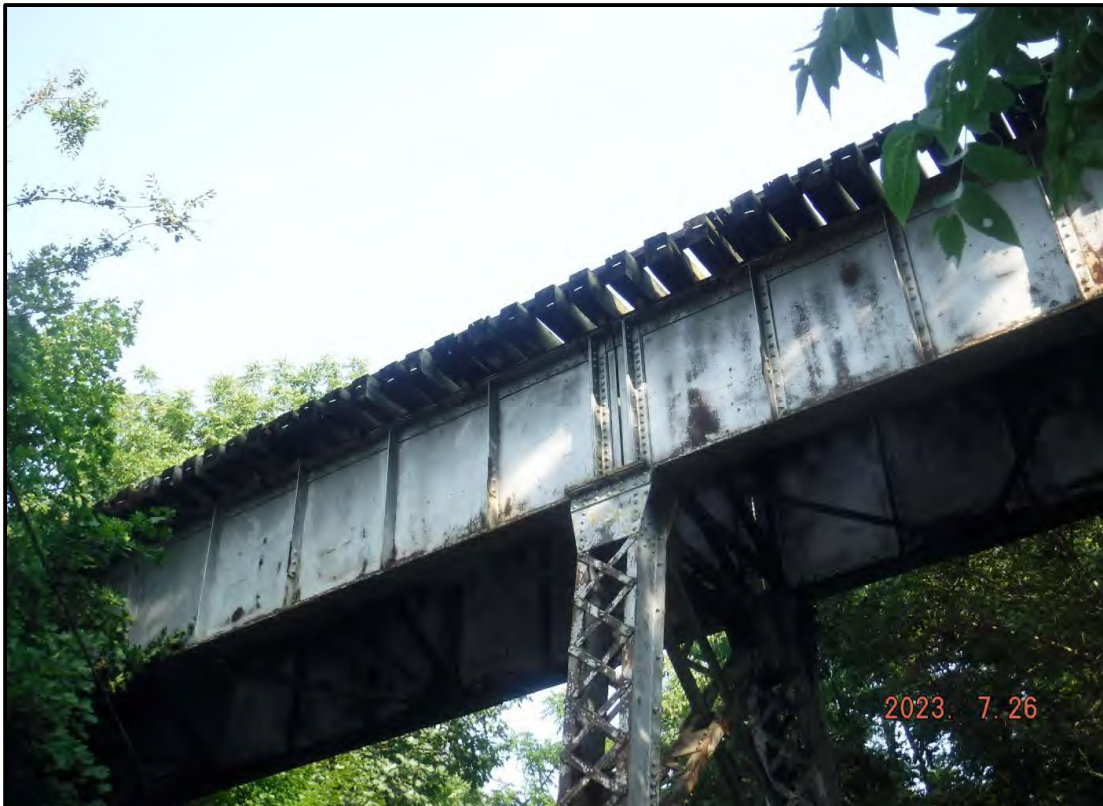
Photo 8: Typical Griders

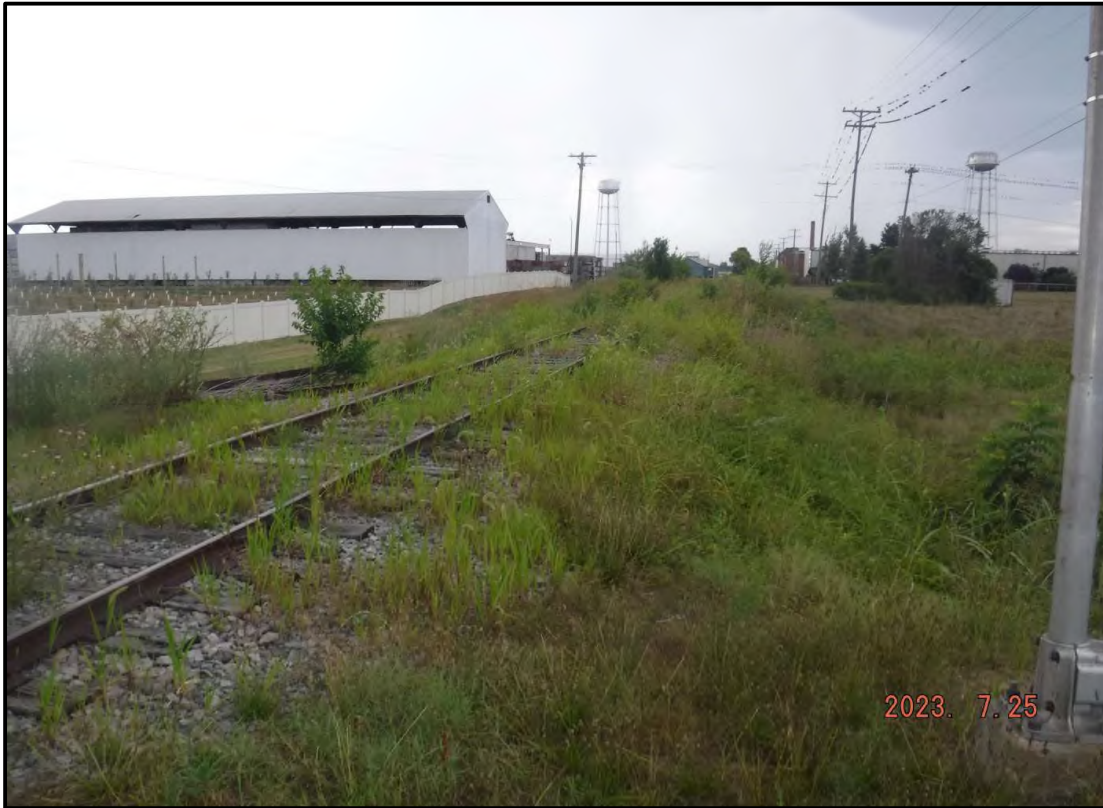
Photo 1: Track on Bridge (From Crossing to the West)

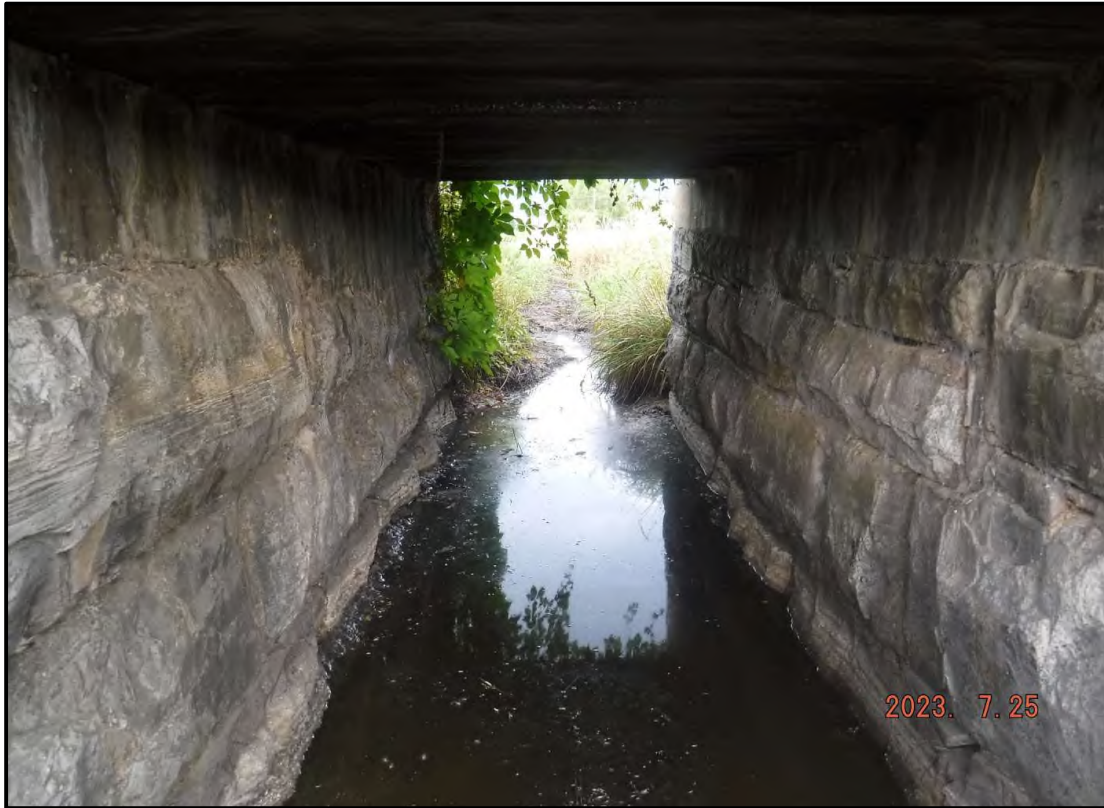
Photo 2: North Elevation

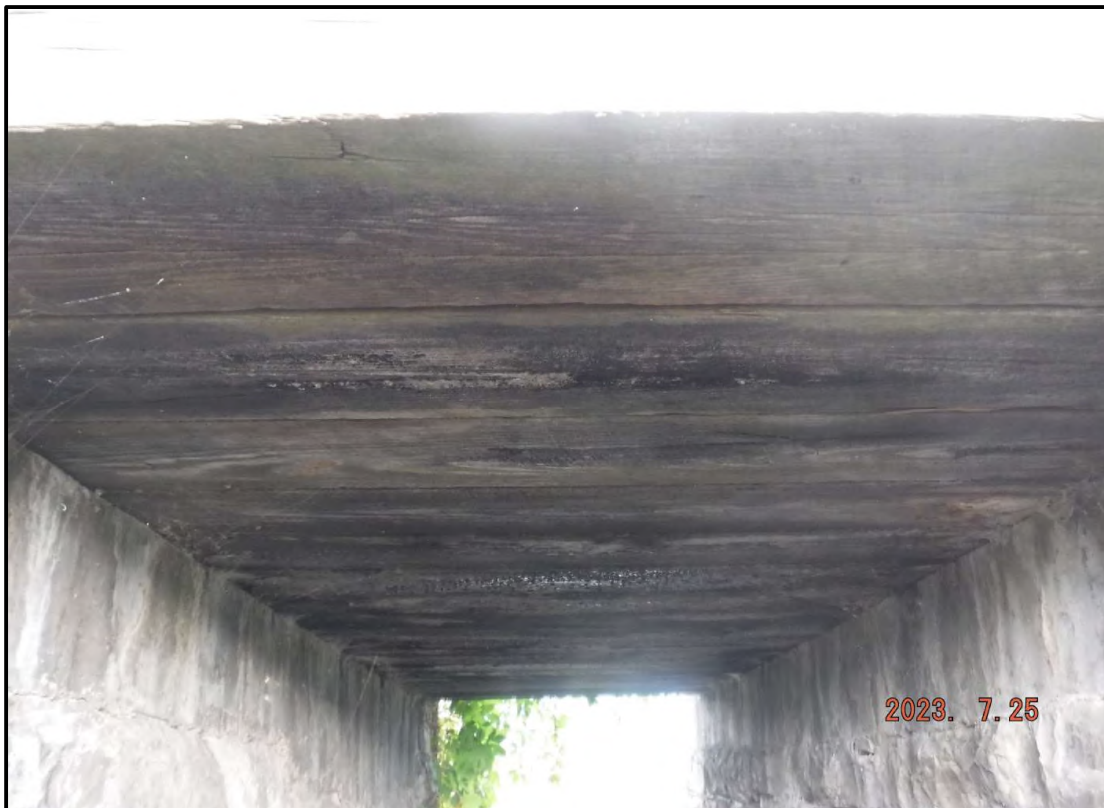
Photo 3: Through Structure (From North)

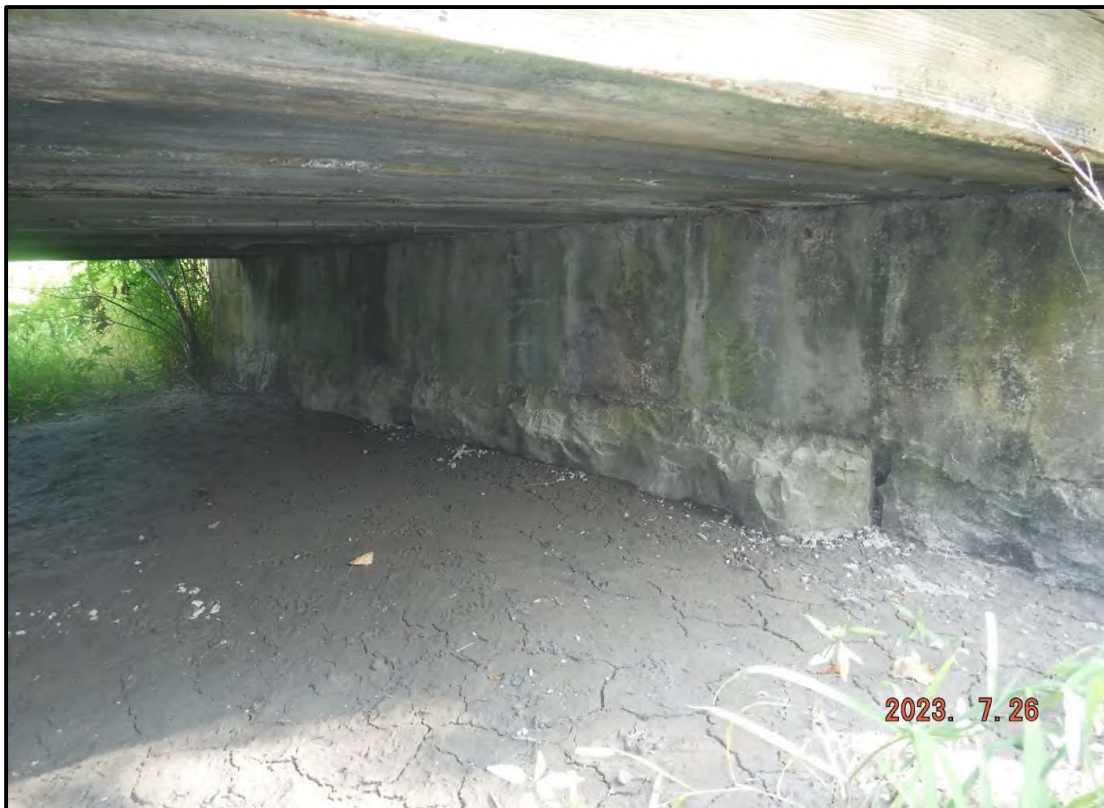
Photo 1: Through Structure (From North)

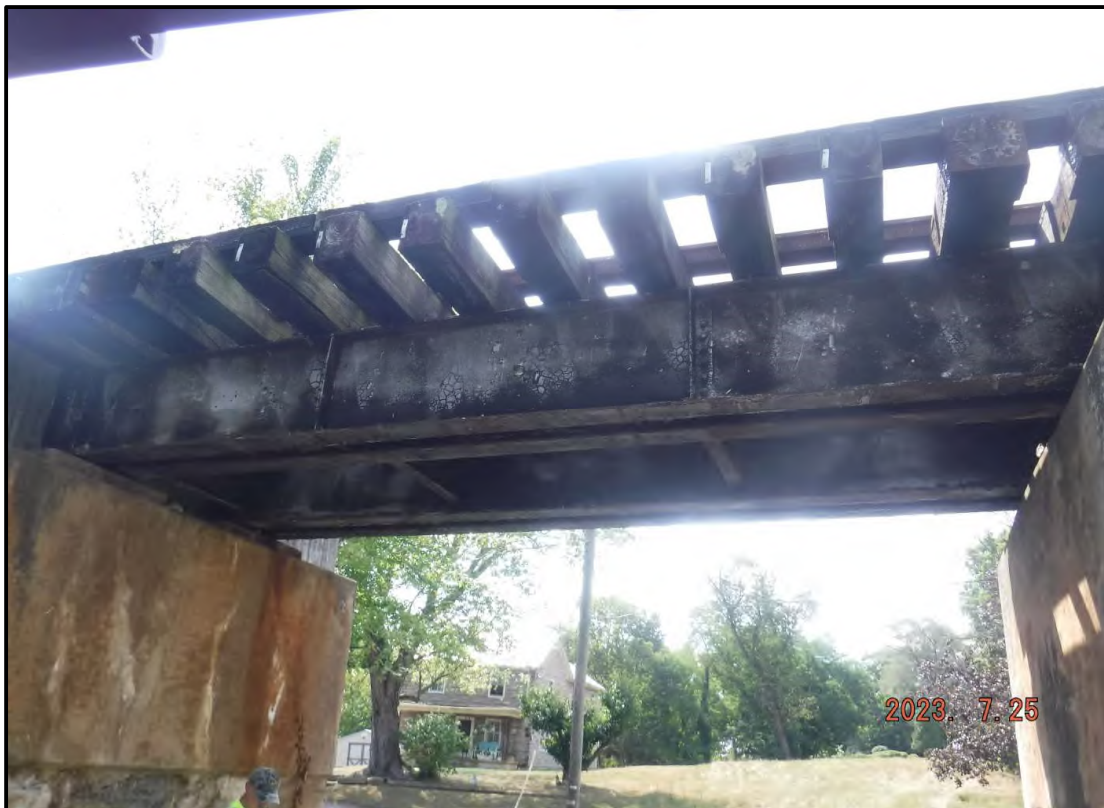
Photo 1: North Elevation of Girders

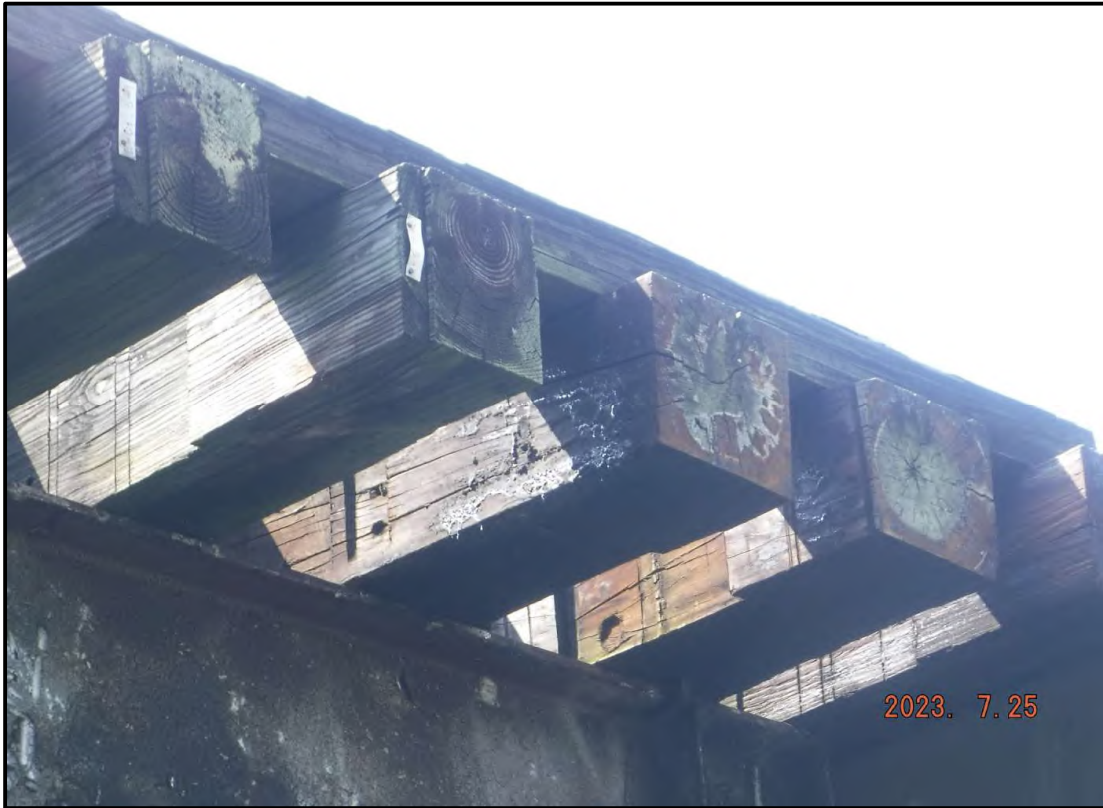
Photo 2: South Elevation of Girders

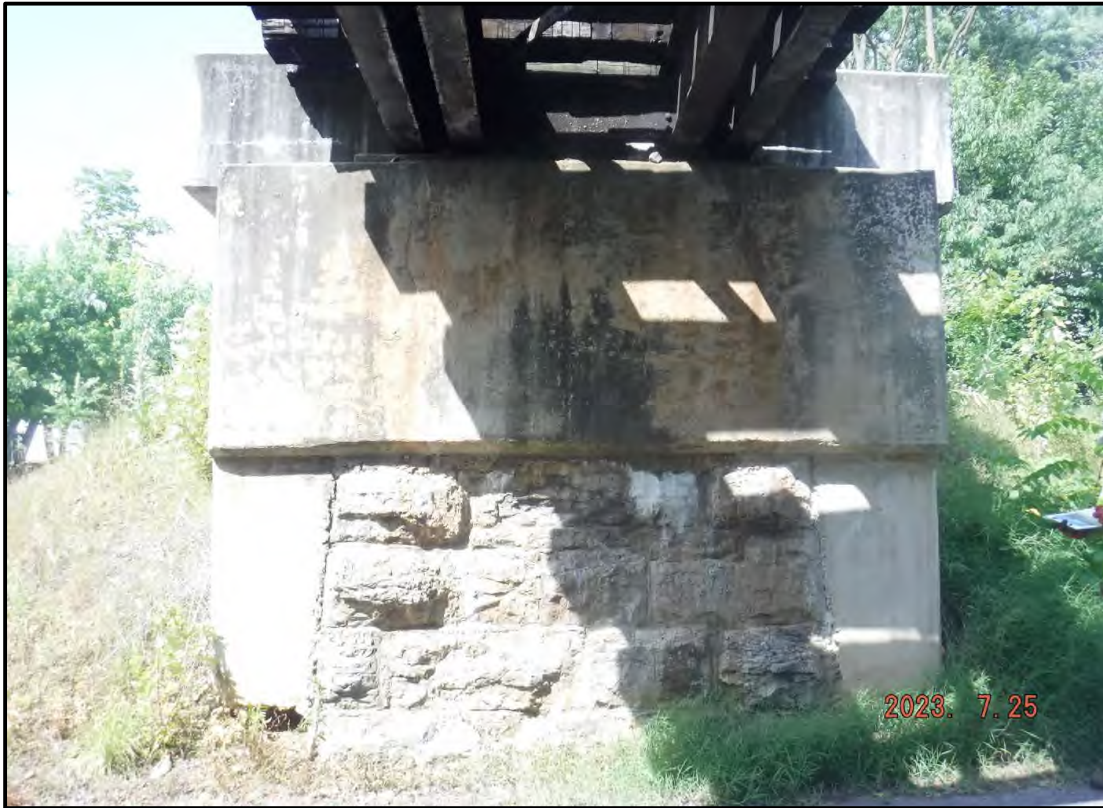
Photo 4: West Abutment

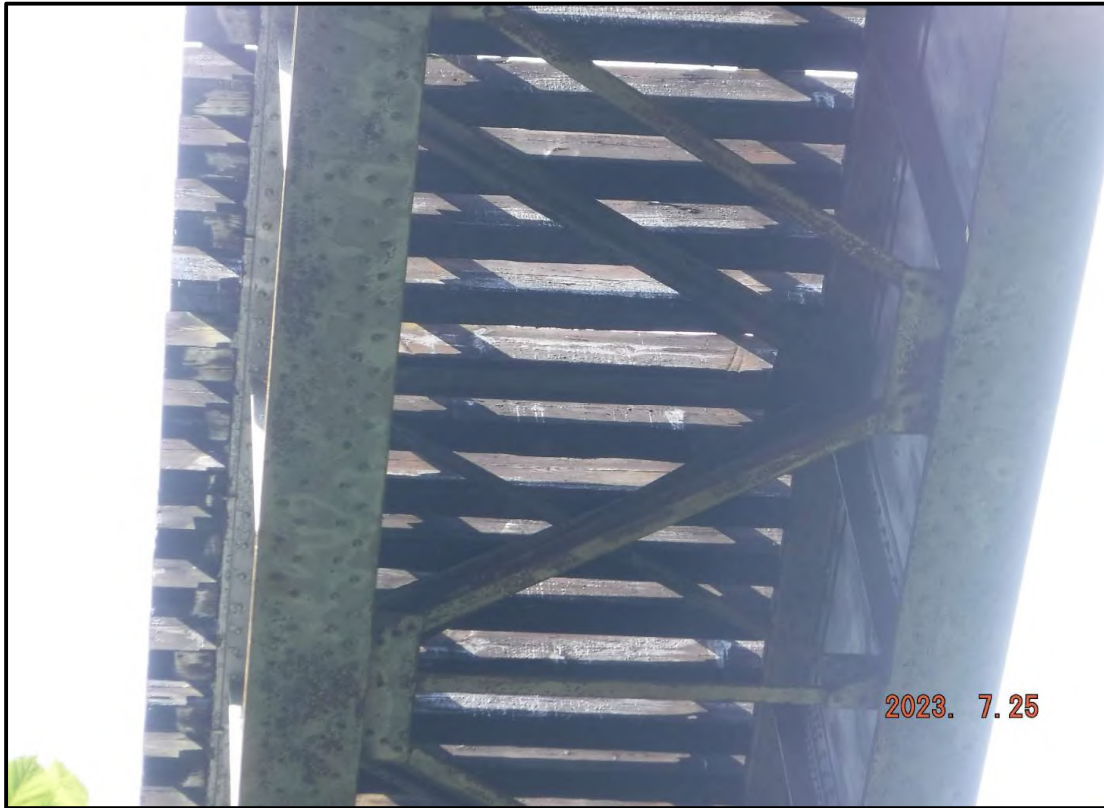
Photo 6: Underside of Span

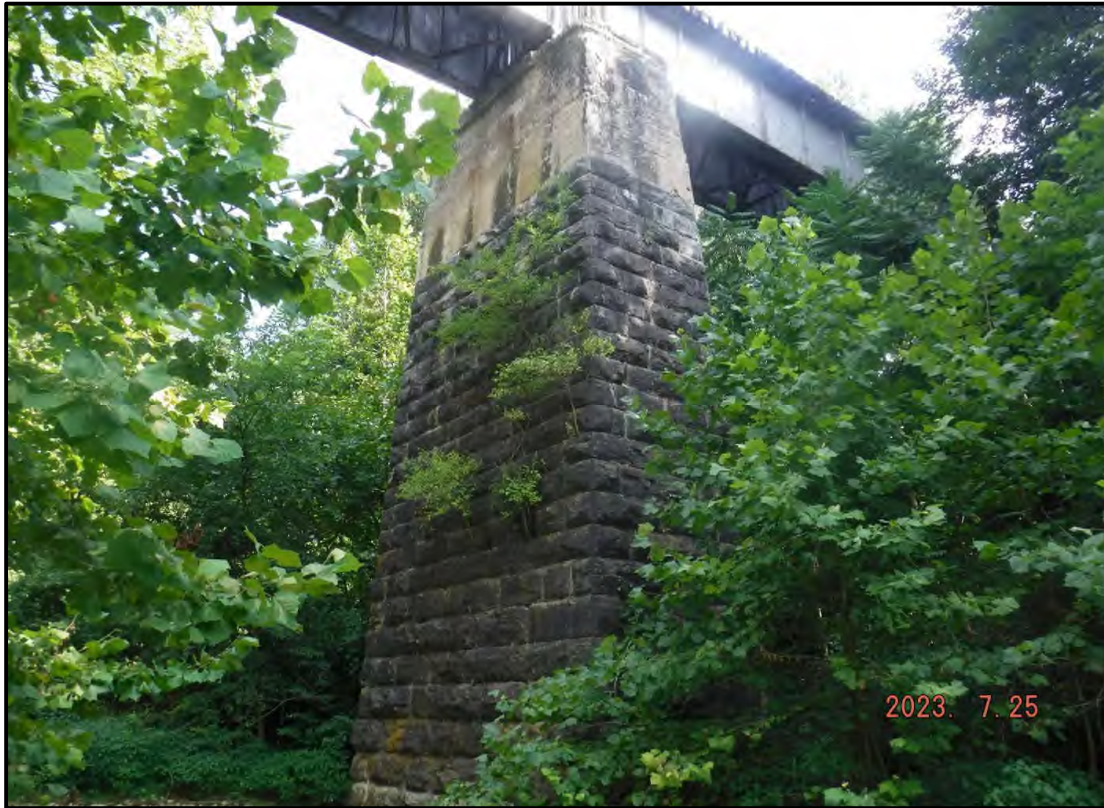
Photo 2: East Abutment

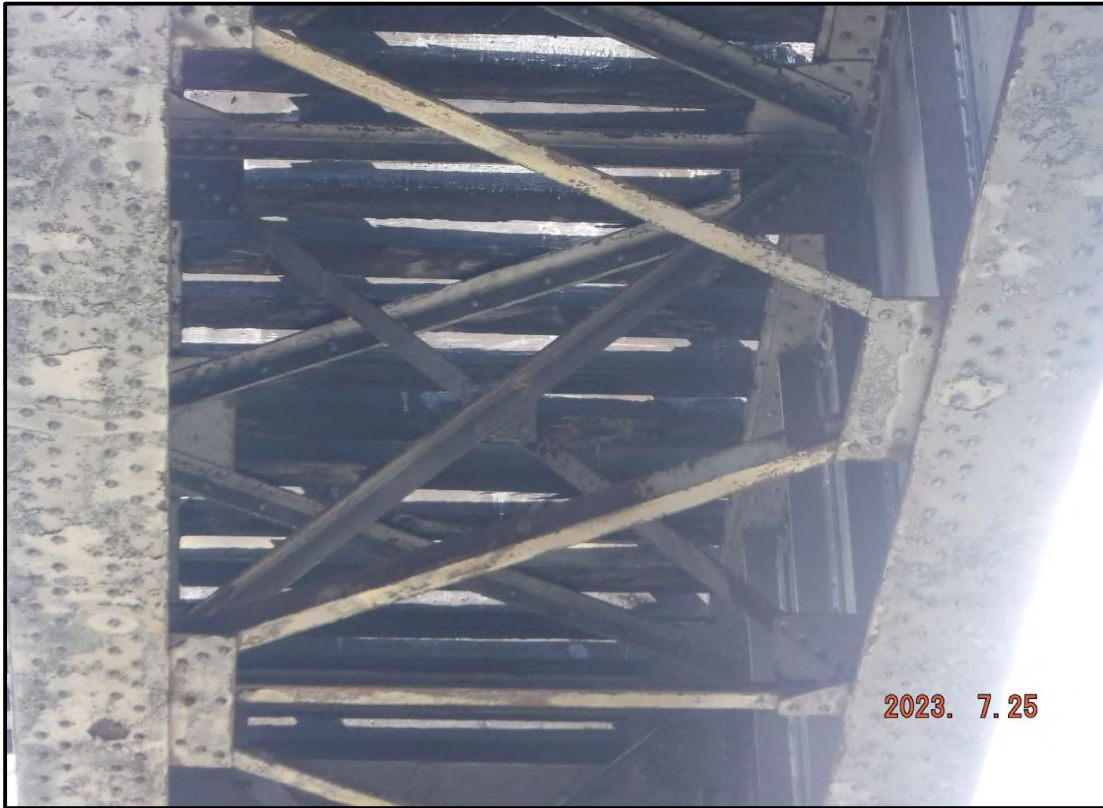
Photo 4: Typical Bearing and West Abutment Bridge Seat (From South)

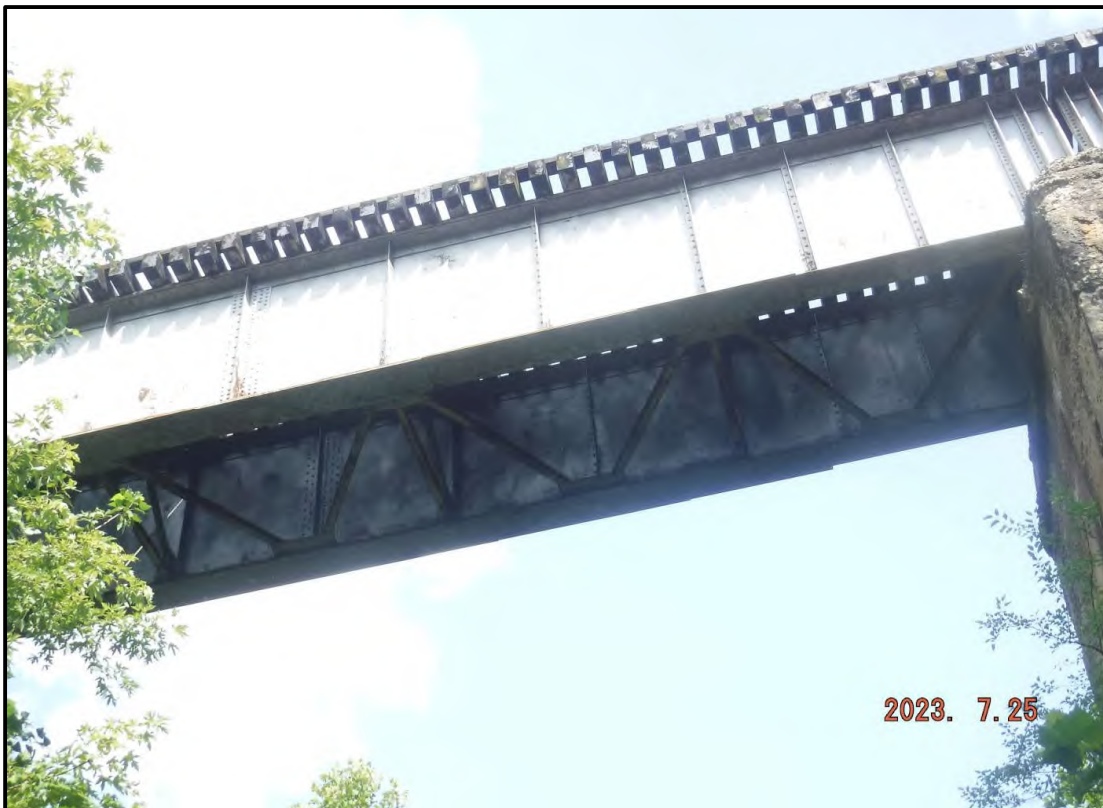
Photo 5: Typical Underside of Span

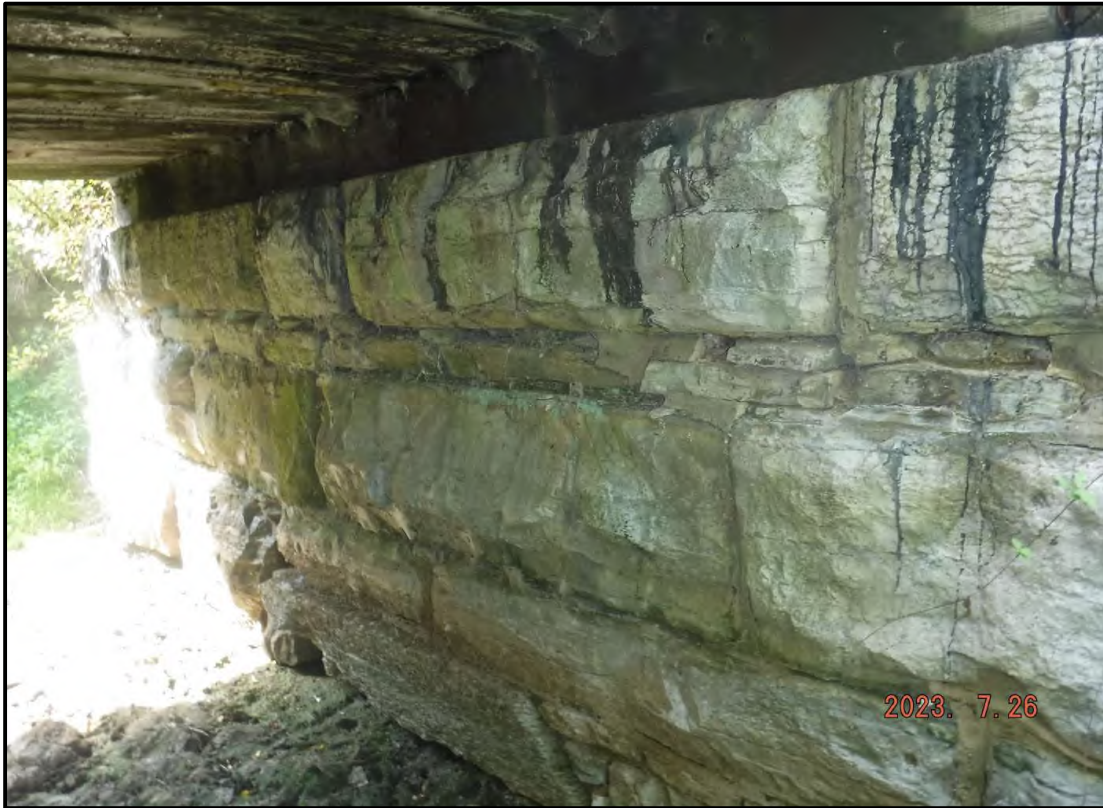
Photo 6: Typical Girders

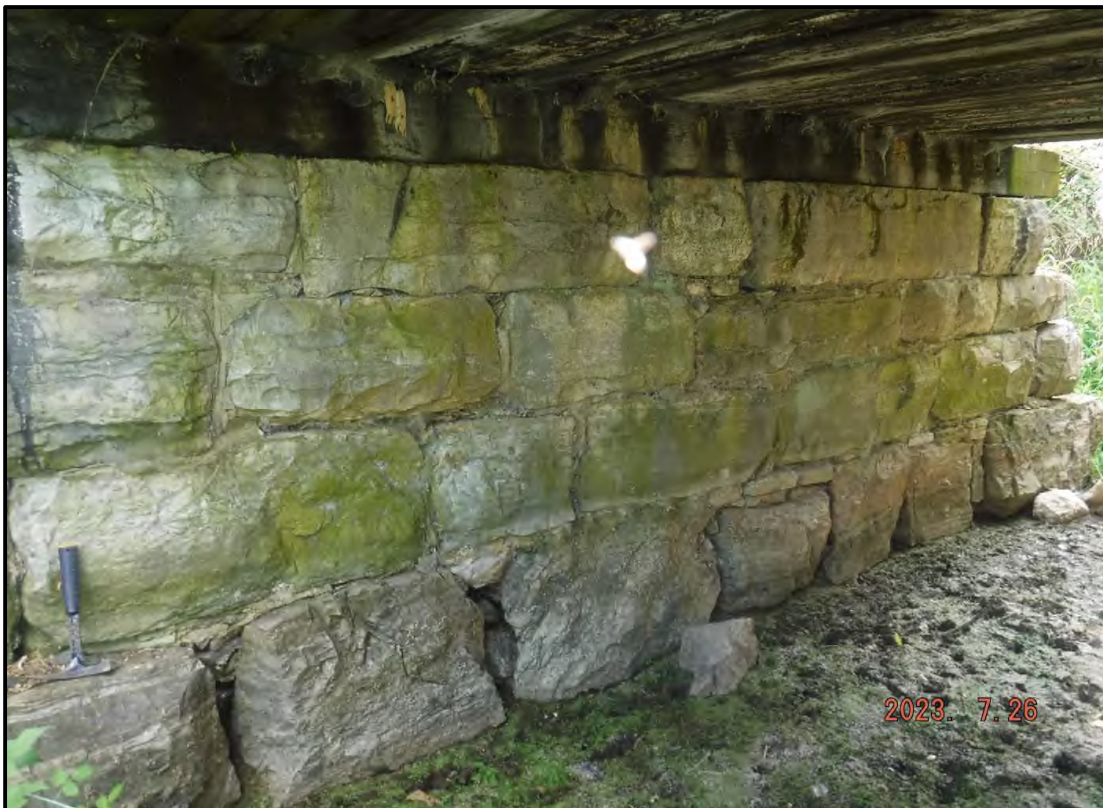
Photo 1: East Abutment (From South)

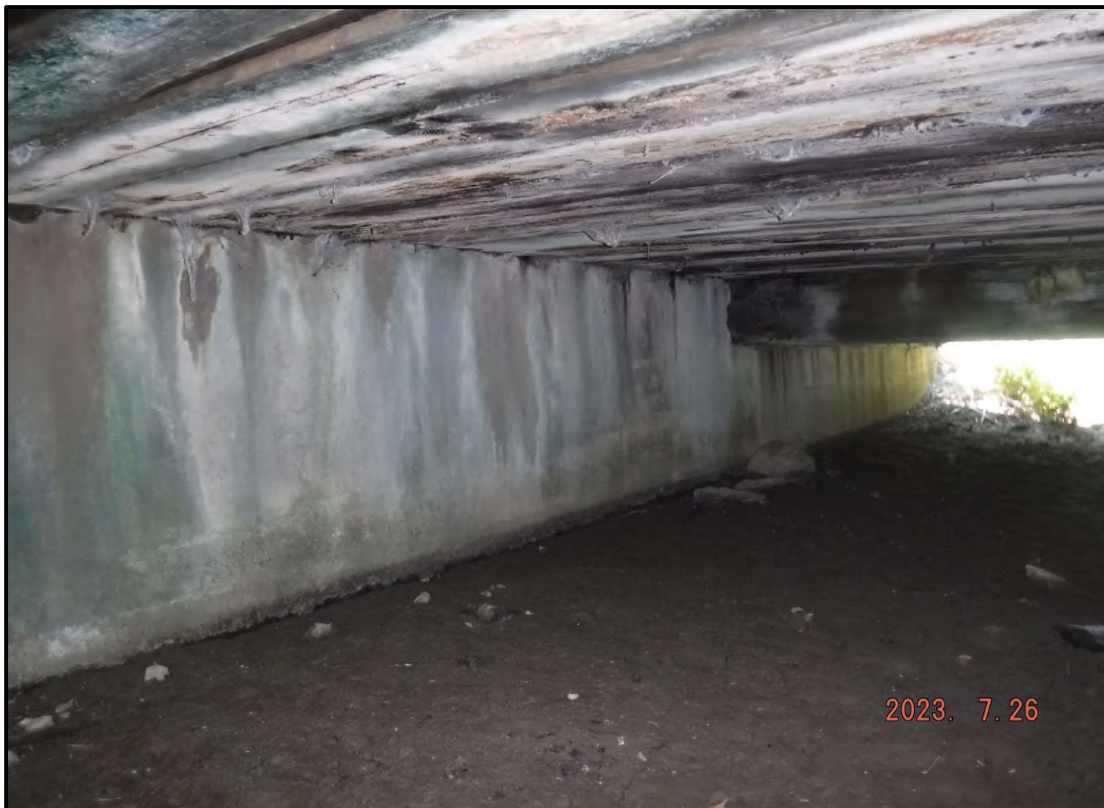
Photo 1: East Abutment (From South)

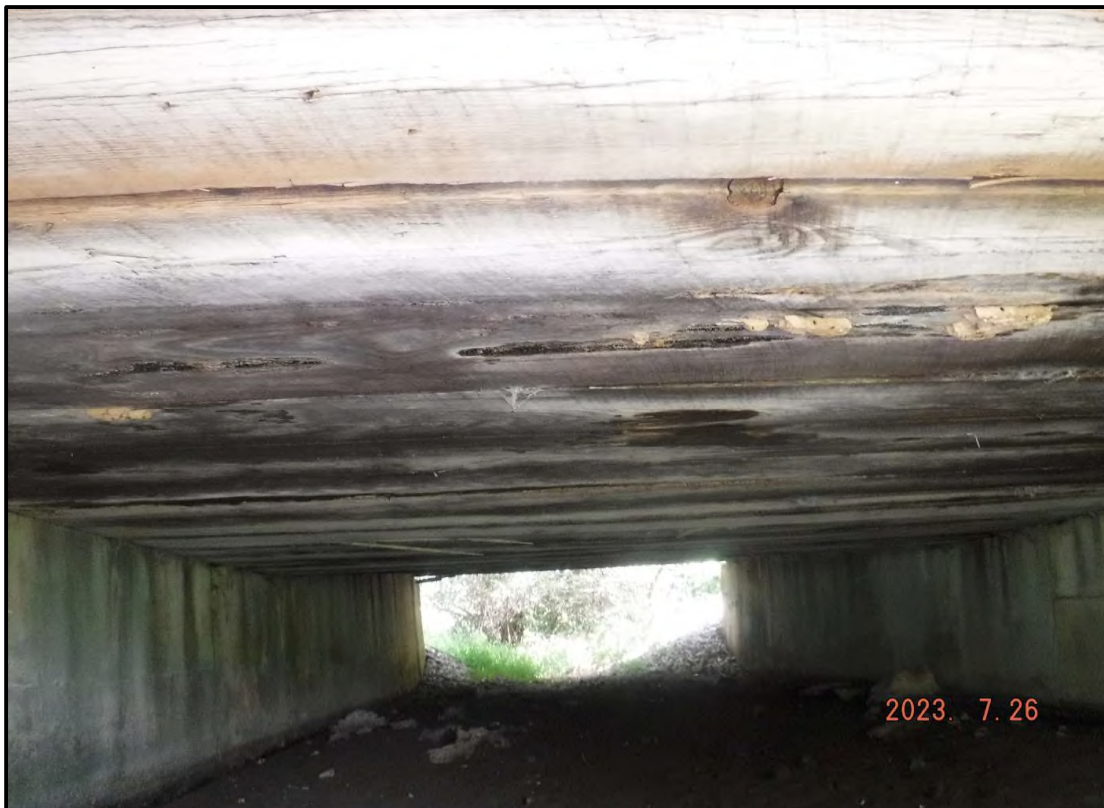
Photo 3: Typical Timber Slab (From South)
