NORFOLK SOUTHERN RAILWAY CO. SHENANDOAH VALLEY RAIL CORRIDOR BRIDGE EVALUATION

STRASBURG, VIRGINIA
SHENANDOAH COUNTY

PROJECT NO. 23-1502.101

August 25, 2023

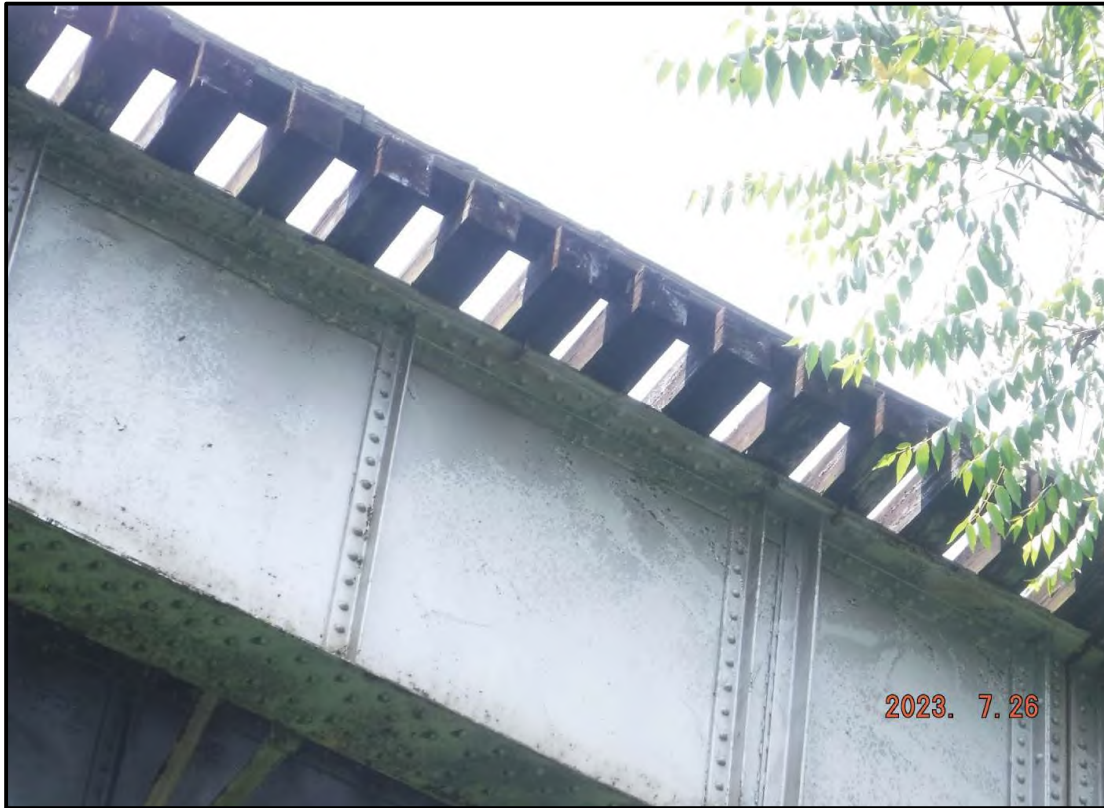
Photo 4: Typical Timber Slab (From North)

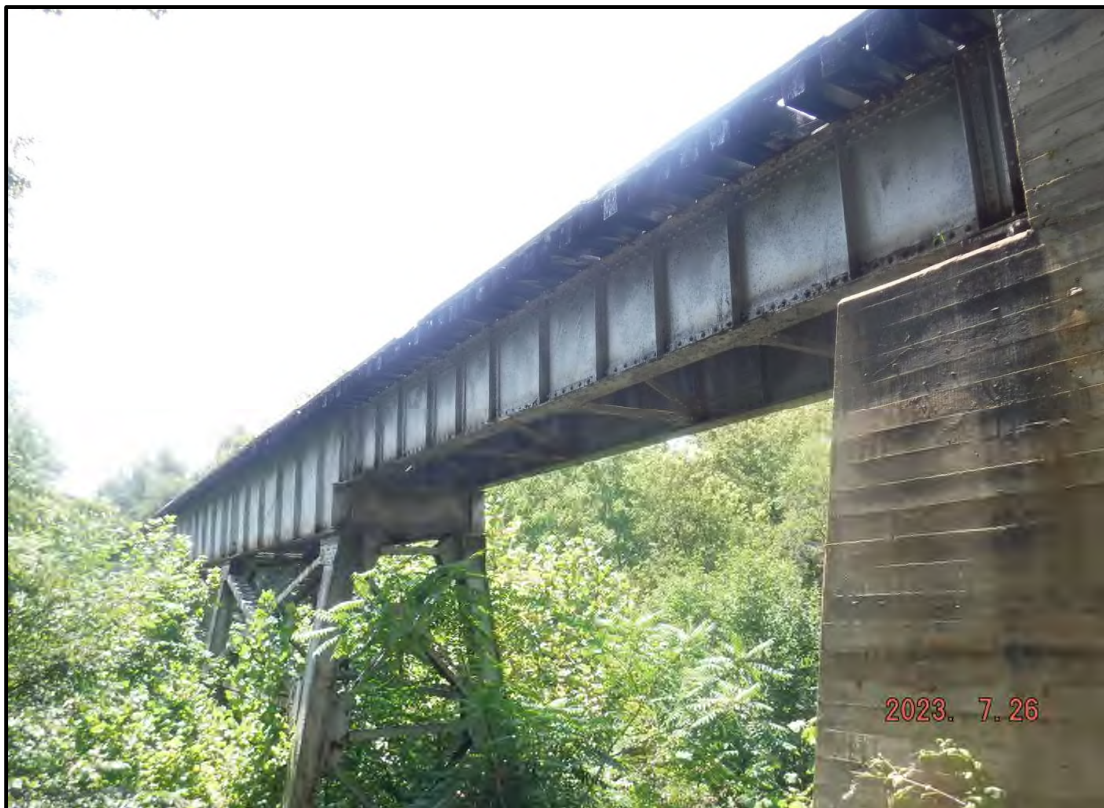
Photo 1: General Condition of Timber Tie Deck

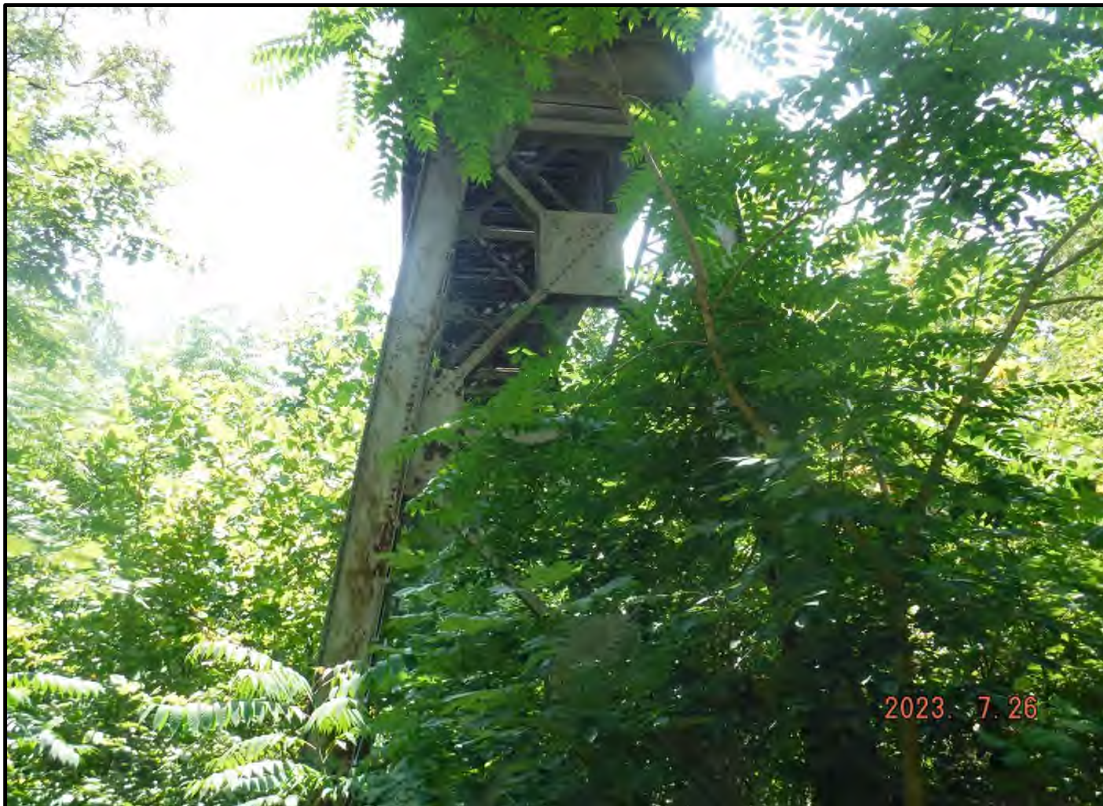
Photo 3: Typical Pier (West Side of Pier 1 Shown)

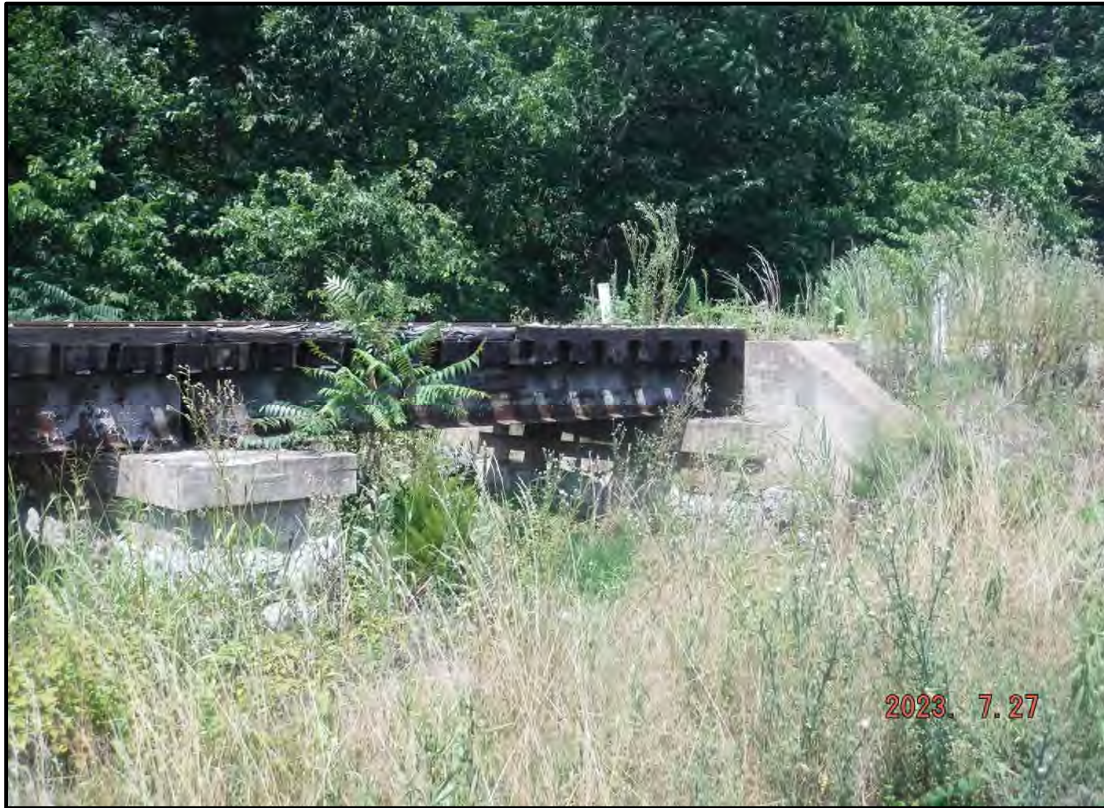
Photo 2: South Elevation

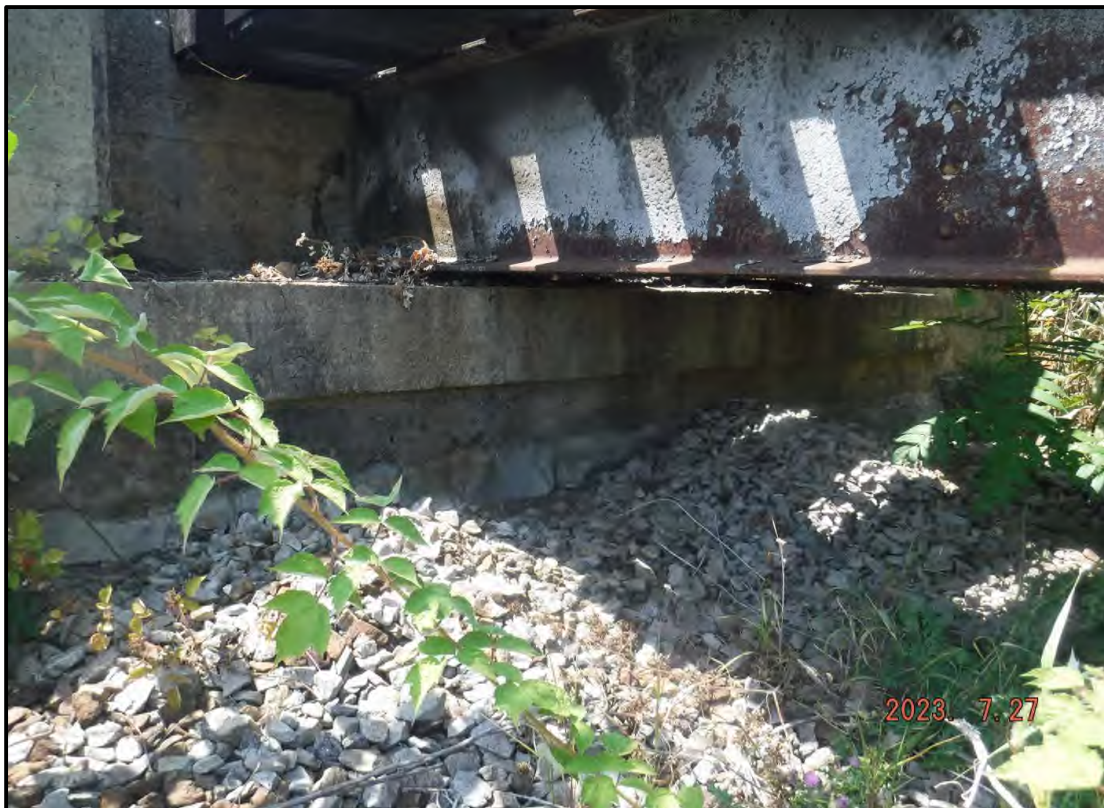
Photo 3: East Abutment

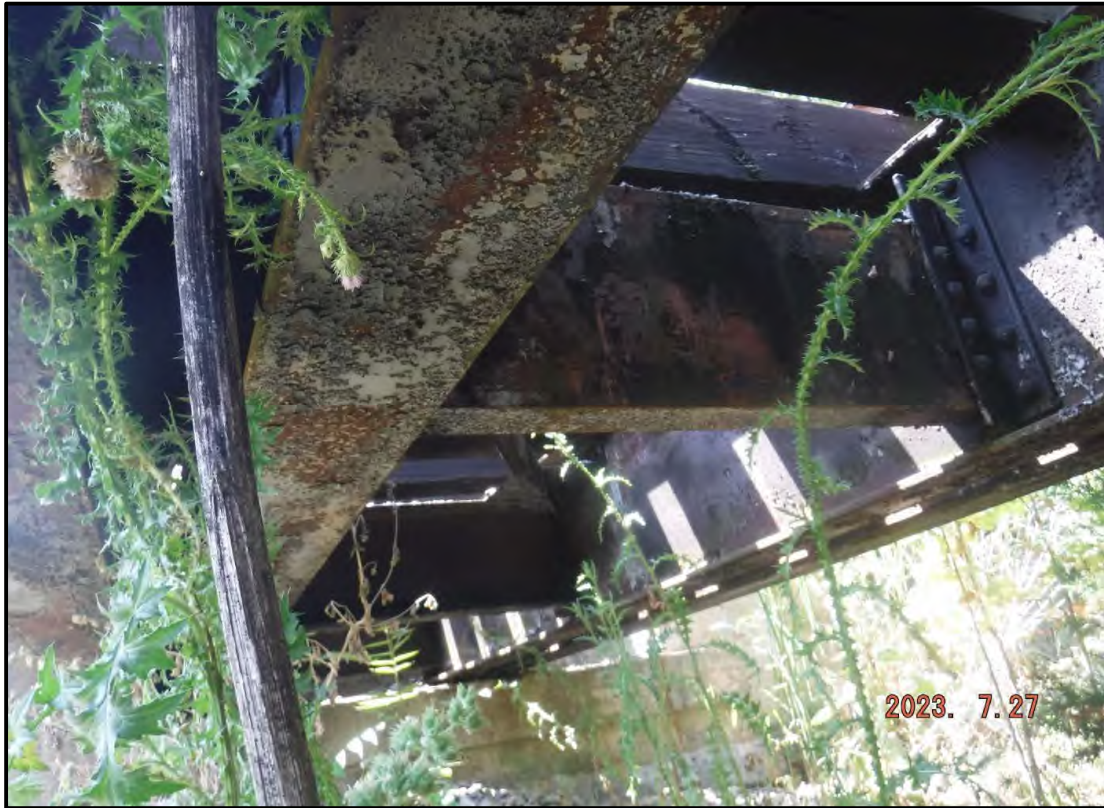
Photo 4: West Abutment

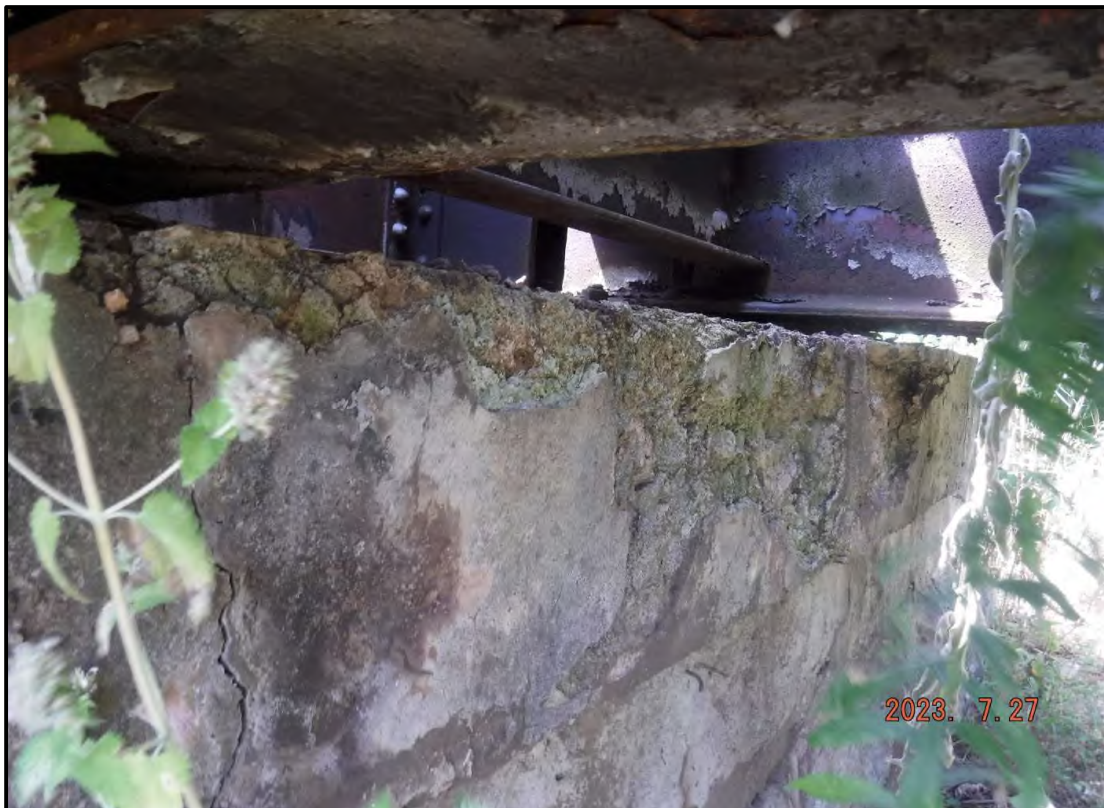
Photo 5: Typical Underside of Span

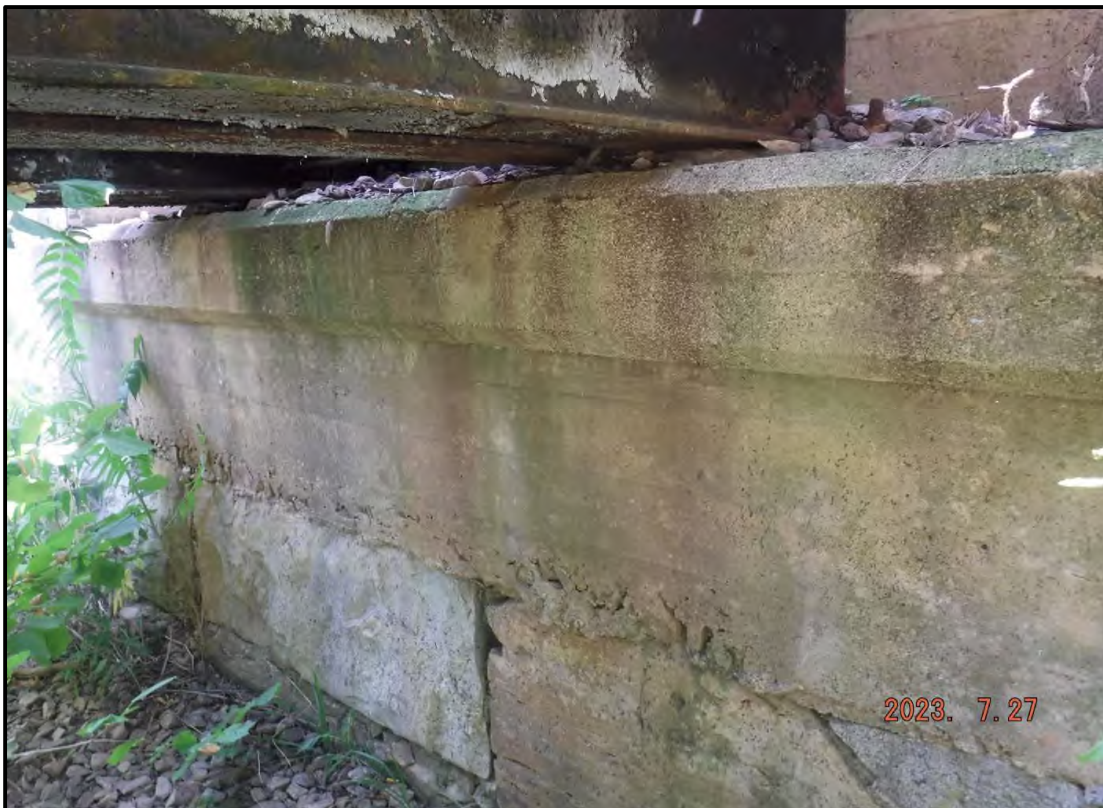
Photo 1: General Condition of Timber Tie Deck

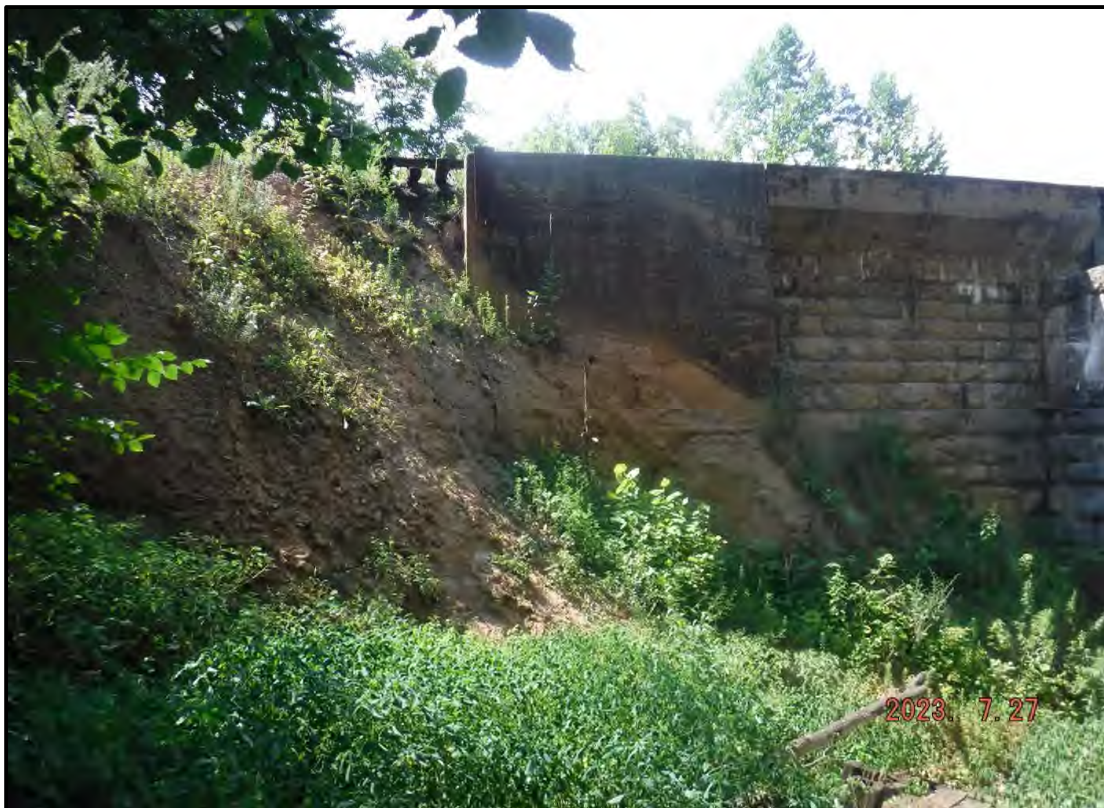
Photo 1: Erosion/Washout at SW Corner of Structure

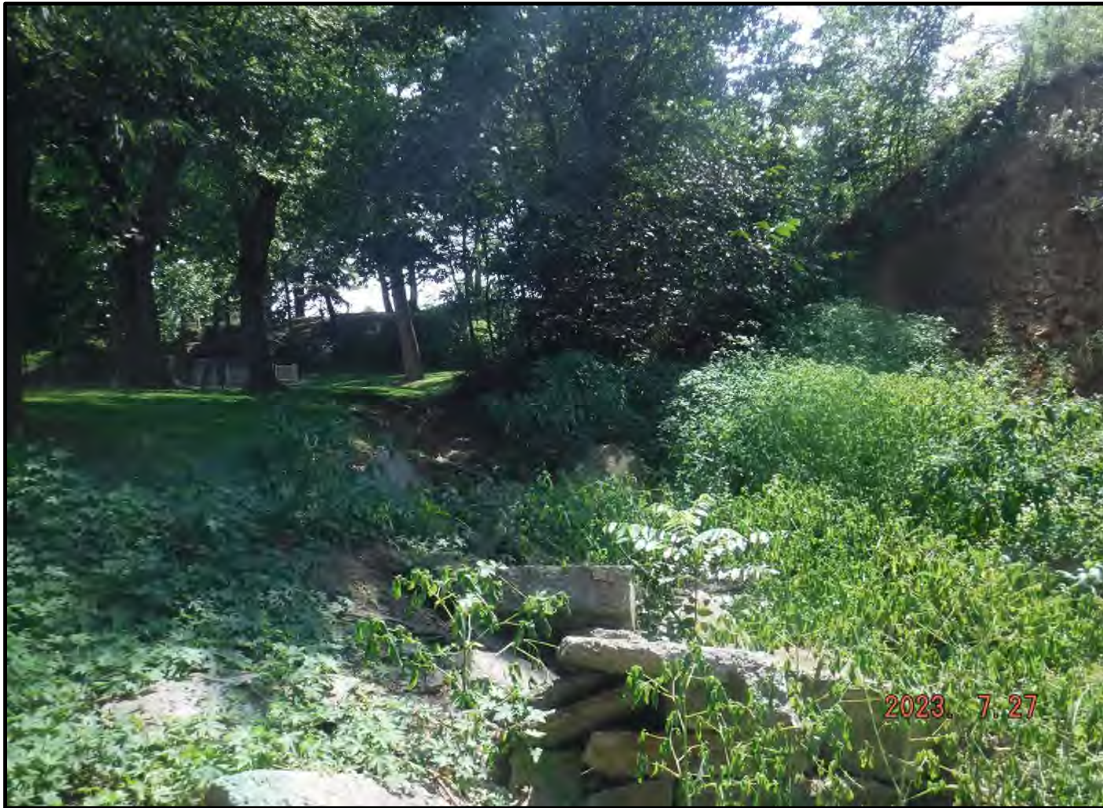
Photo 2: Erosion/Washout at SW Corner of Structure

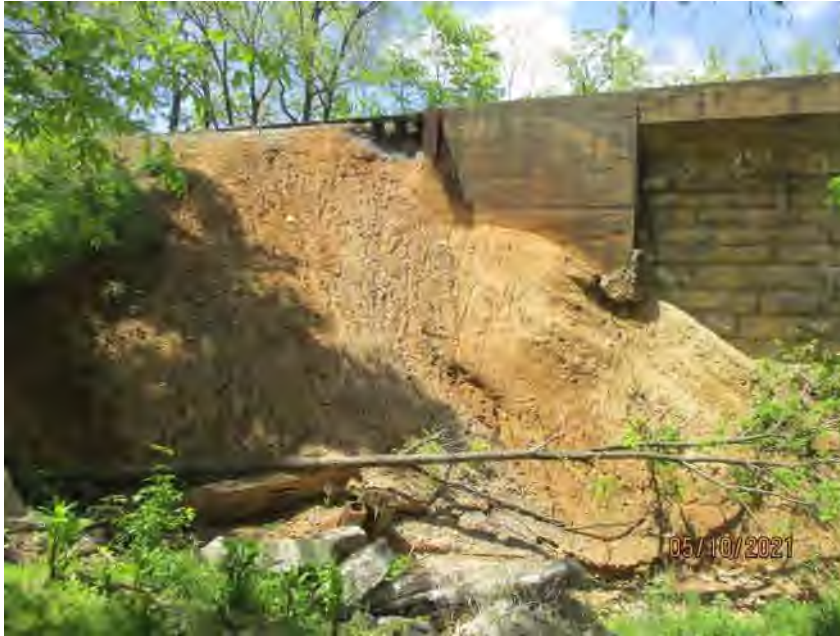
Photo #5

Abutment A downstream side.

Area of erosion:
40' long x 35' wide x 6' high

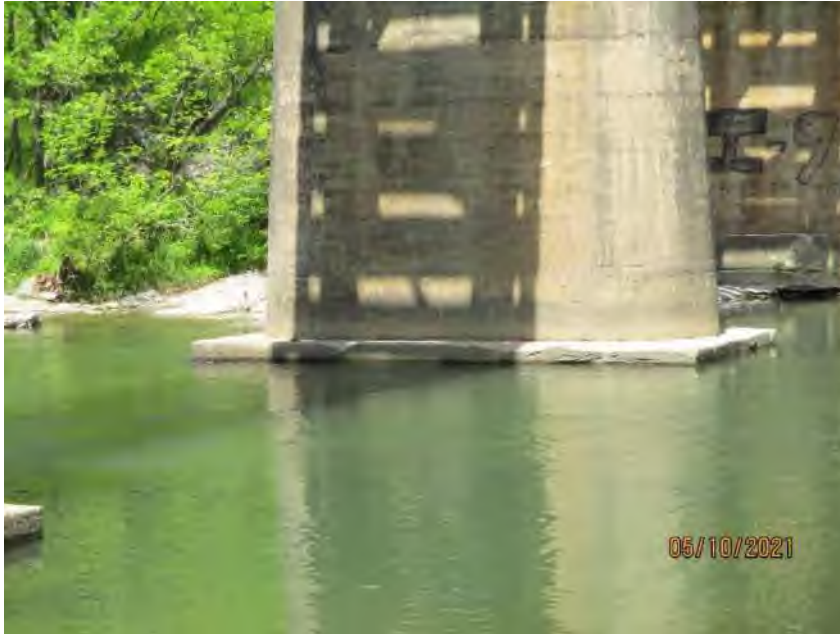
Photo #7

Looking north at Pier 2.

Footing of pier is exposed up to 10".

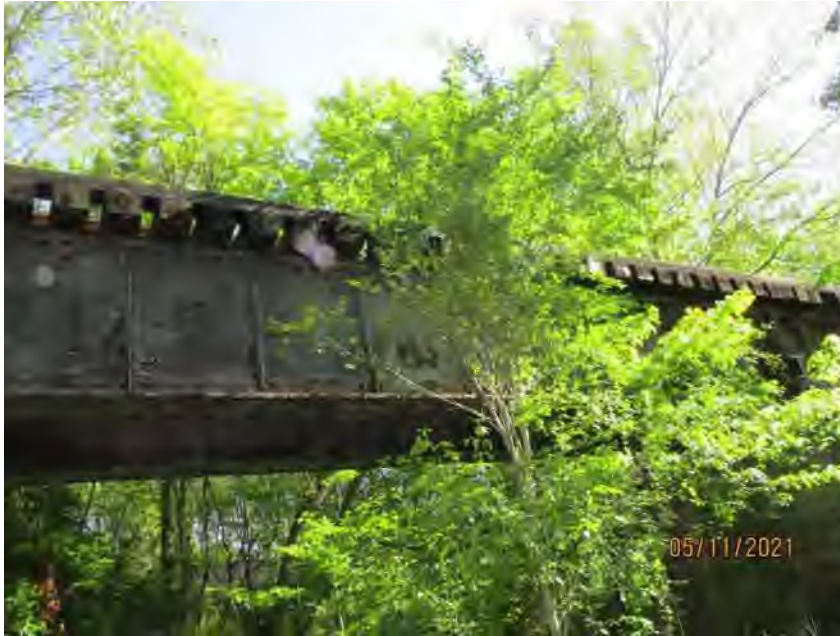
Photo #3

Looking at downstream side of Span 1.

Dense vegetation growth in span encroaching structure.

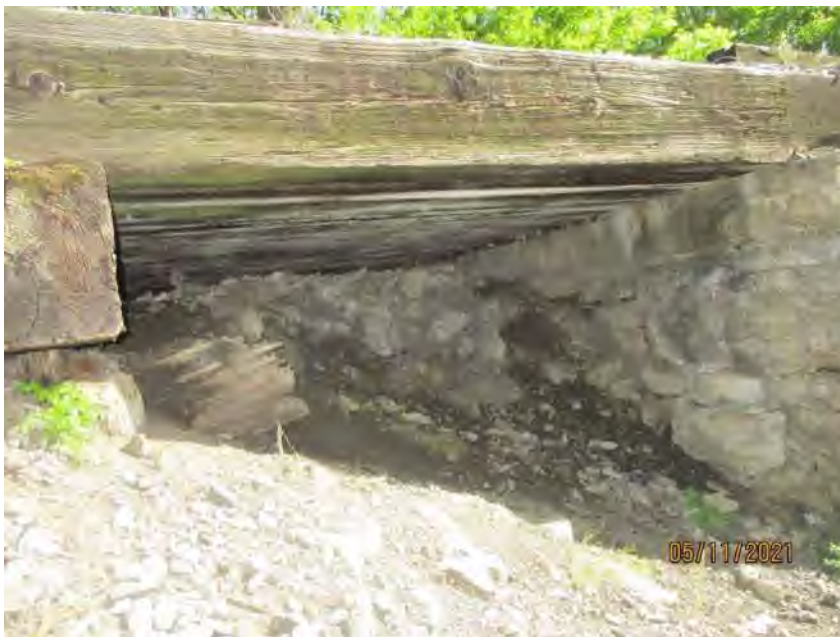
Photo #6

Abutment A downstream side.

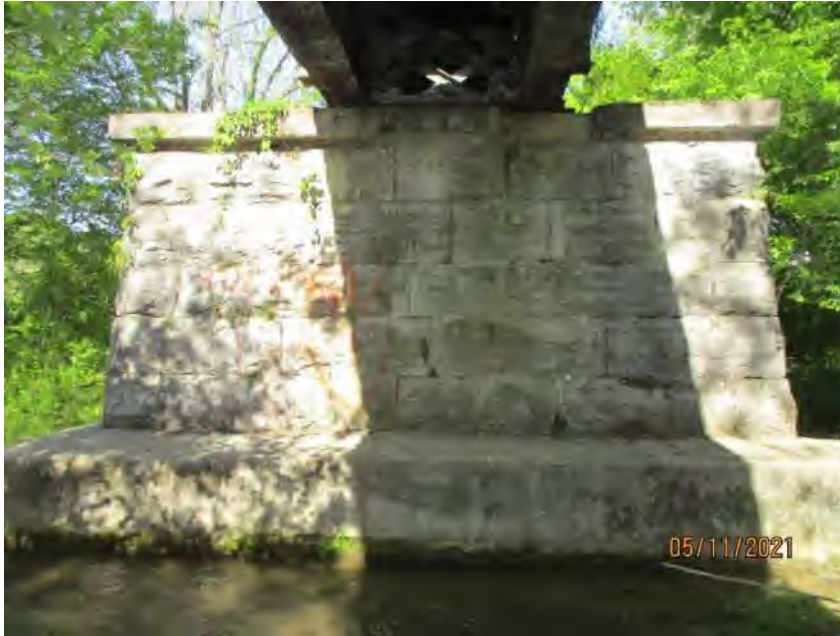
Photo #7

Looking at Pier 1 on Span 2 side.

Top of footing is exposed up to 3' high.

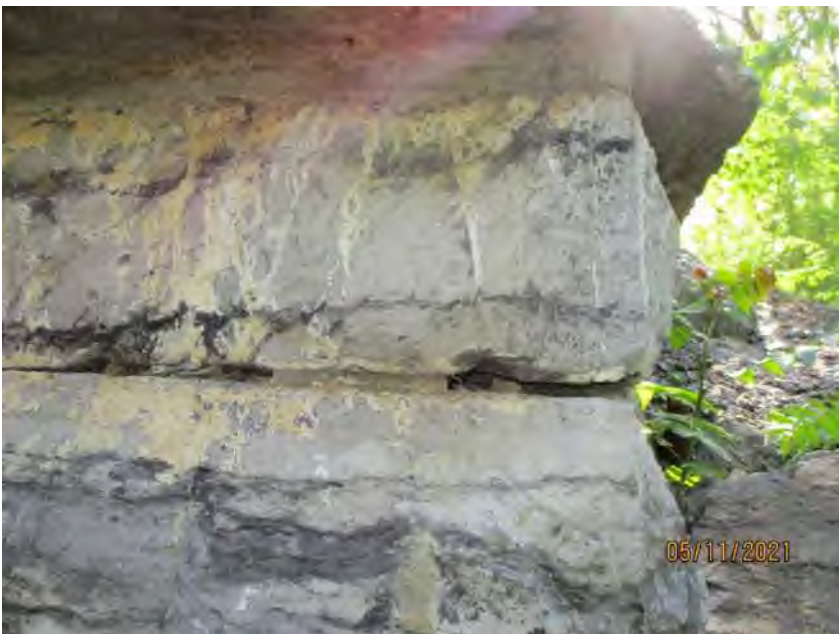
Photo #8

Looking at Abutment B.

Some mortar missing between stones.

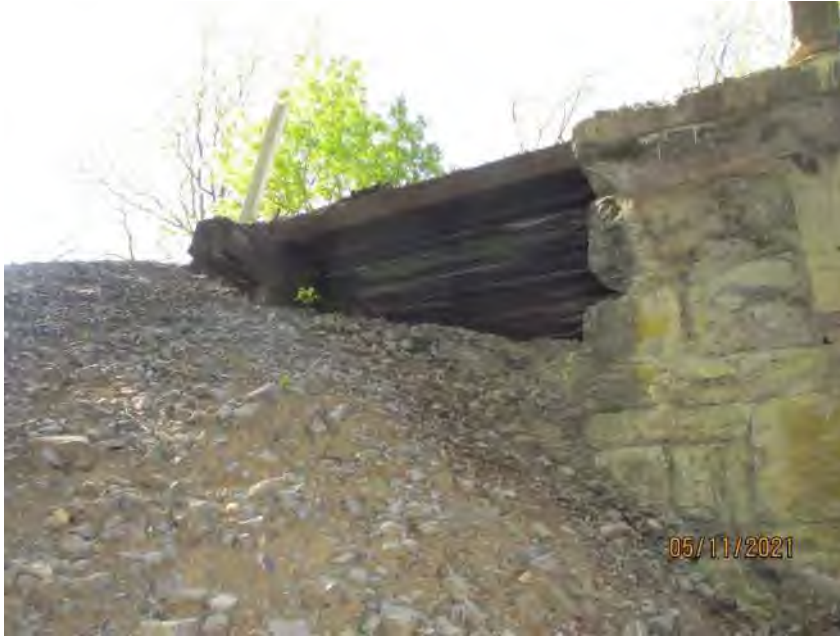
Photo #9

Abutment B at approach ties
behind abutment.

Area of erosion:
21.8' long x 3.75' wide x 17" high.
Undermined full width

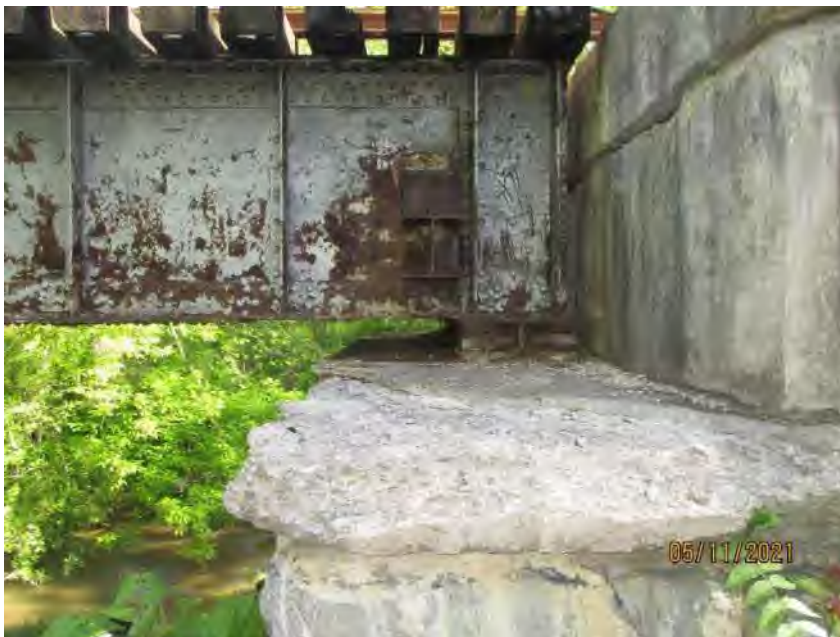
Photo #10

Looking at Abutment B top of
pedestal downstream side.

Area of spall:
4' long x 9" high x 6" deep.

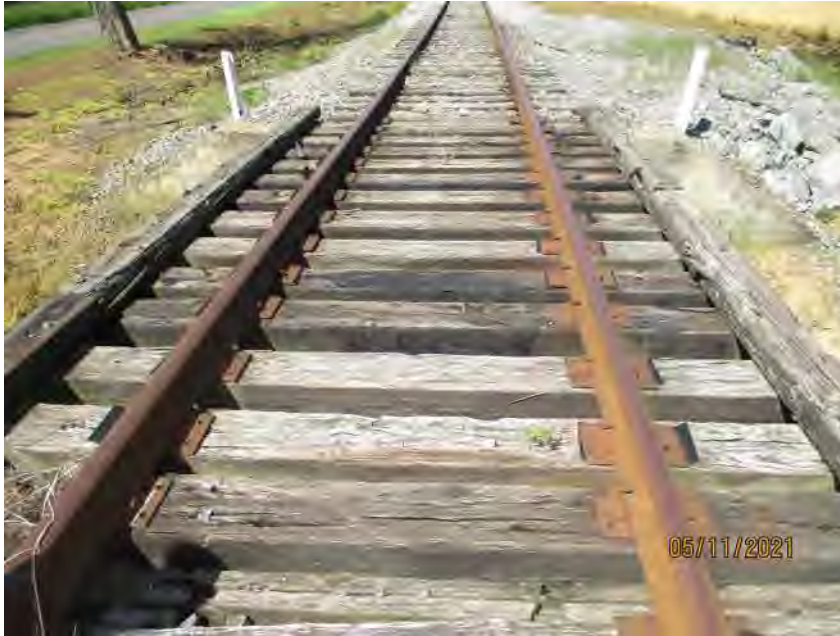
Photo #1

The conditions of the timber railroad ties are mildly deteriorated. See Photo #1.

Looking west toward Abutment A.

- Remove railroad ties and install new timber deck planks.
- Repair/seal cracks in abutments.
- Repair spalls in abutments.
- Install a suitable transition from the gravel railroad bed at both ends of the structure, including grade transitions and installation of a safety guardrail at the transition to the structure.
- Install a pedestrian railing that meets current safety standards.
- Preparation and painting of the entire superstructure is recommended.
- Clean bearing areas.

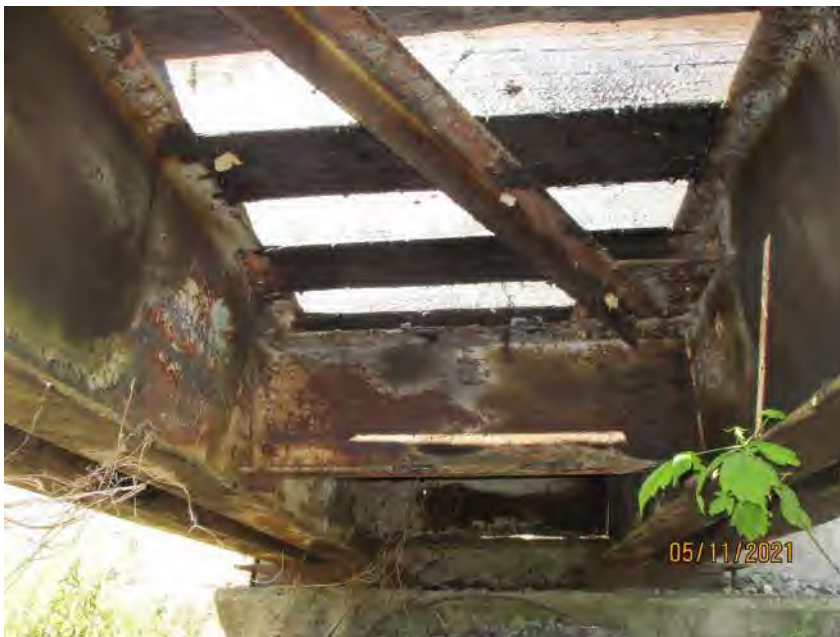
Photo #2

In general, the steel superstructure elements are in good condition. Surface rust exists on all steel members. The superstructure exhibits a protective coating that is failing throughout. At the time of inspection, no measurable section loss was observed to members. There is mild vegetation growth in span encroaching on structure. See Photos #2-#3.

Looking at typical view of
superstructure toward Abutment B.Superstructure exhibits surface
rust with failed protective coating.

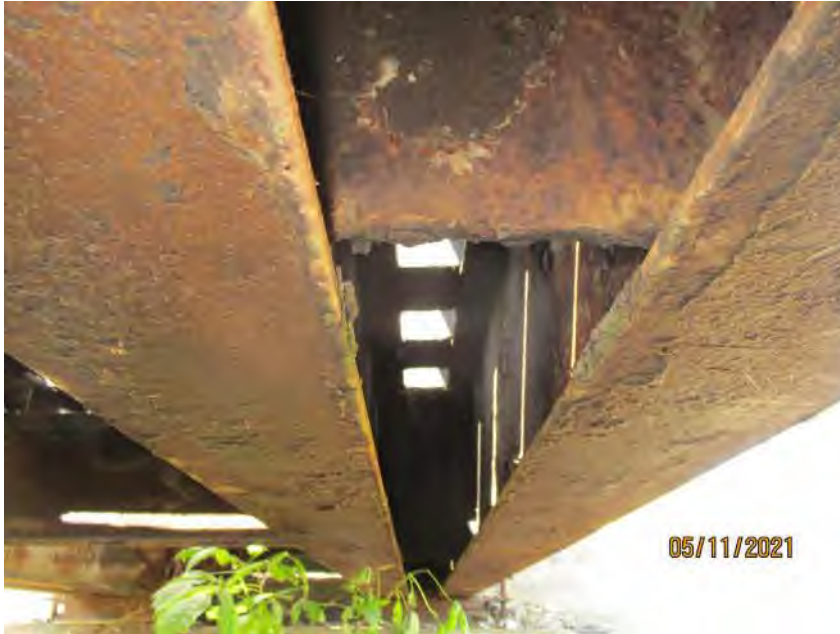
Photo #3

Looking at G3 and G4

Beams exhibit surface rust with no
measurable section loss.

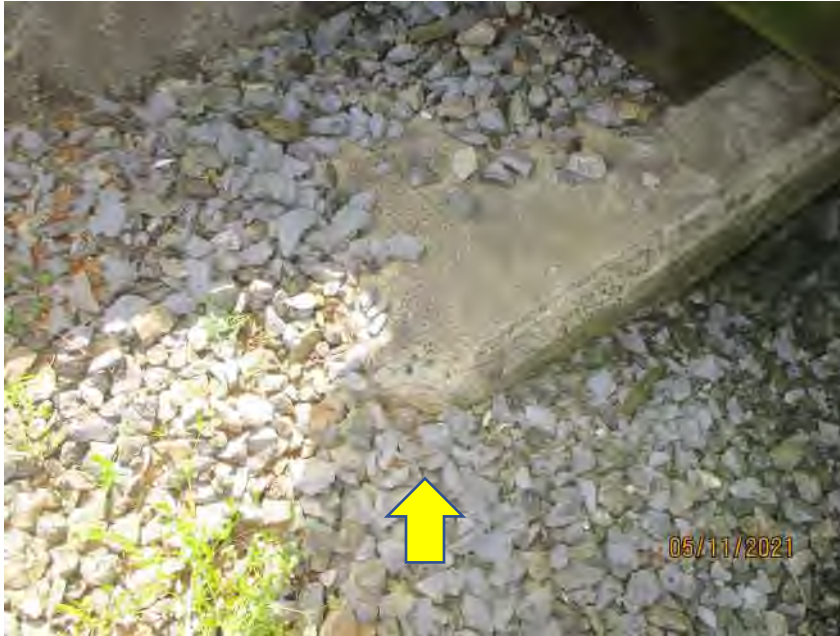
Photo #5

Abutment B is in good condition. Spall near G1 on upstream side 3" long x 3" wide x 2" deep. See Photo #5.

Looking at Abutment B.

Spall 3" long x 3" wide x 2" deep.

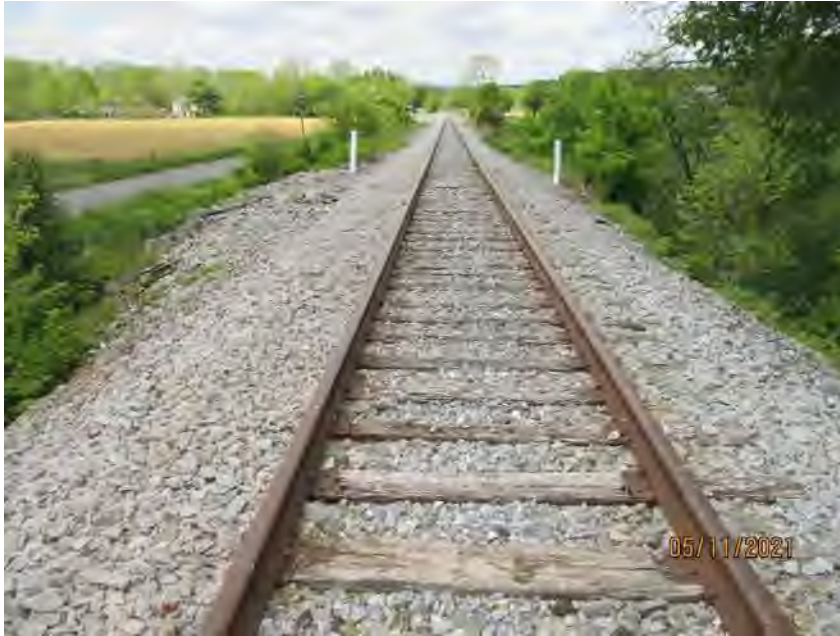
Photo #1

The condition of the timber railroad ties is mildly deteriorated. See Photo #1.

Top of rail above culvert.

Timber rails are mildly deteriorated.

- Remove railroad ties.
- Repair/seal cracks in wingwalls and barrel.
- Repair spalls in wingwalls and headwalls.
- Install a pedestrian railing integrated into the existing culvert along the opening that meets current safety standards.

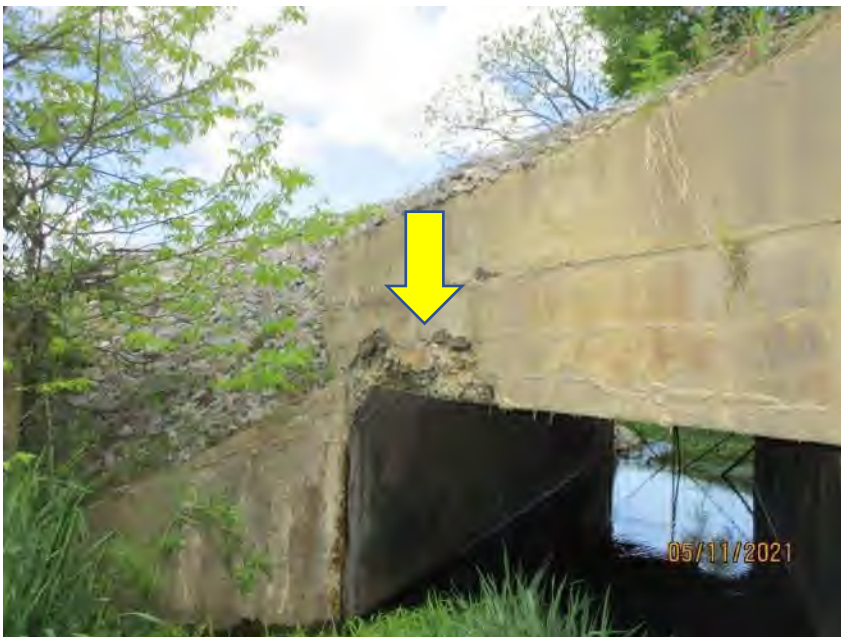
Photo #2

Headwalls are in fair condition. The downstream headwall has a spall 5' long x 1.5' high x up to 10" deep and cracking 4' long x 1/16" wide. The upstream headwall has a spall 5' long x 9.5" high x 3" deep on. See Photos #2-#4.

Downstream headwall at southwest corner.

Area of spall:
5' long x 1.5' high x up to 10" deep

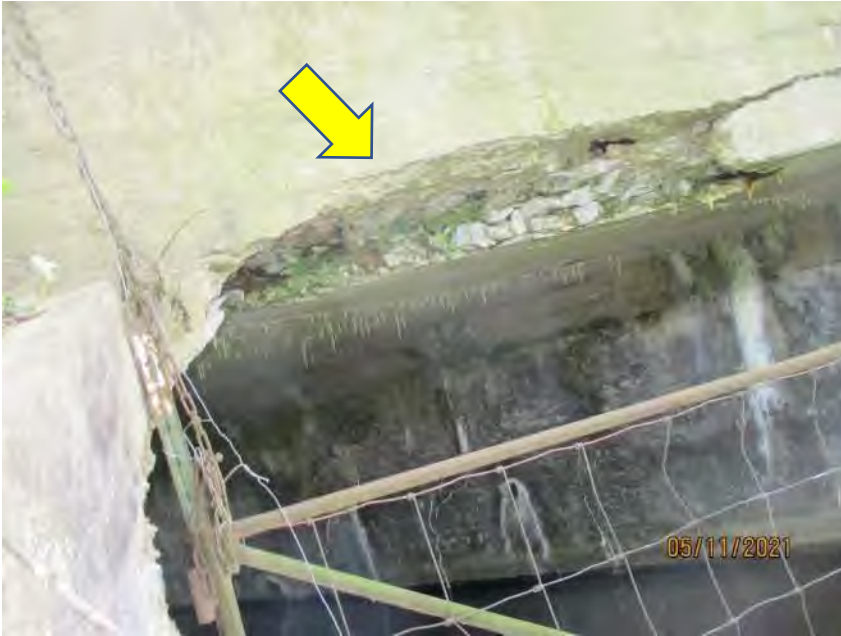
Photo #3

Upstream headwall

Area of spall:
5' long x 9.5" high x 14" wide x 3"
deep

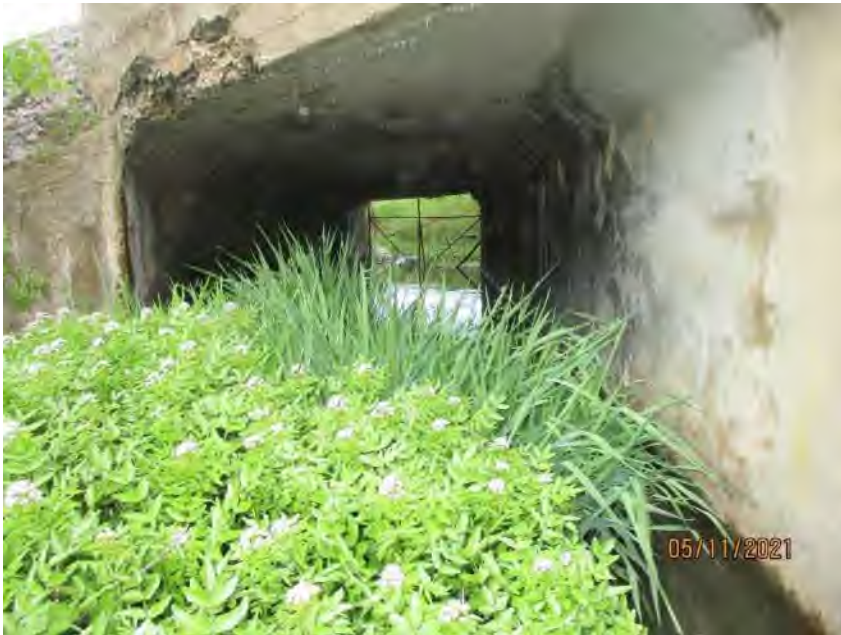
Photo #6

Wingwalls are in fair condition with minor spalling and cracking. The downstream southeast wingwall has a spall 6" high x 3" wide x 2" deep. The spall on the upstream side of the northeast wingwall measured 6" long x 5" wide x 1" deep. See Photo #6.

Southeast wingwall on downstream end.

Area of spall:
6" high x 3" wide x 2" deep

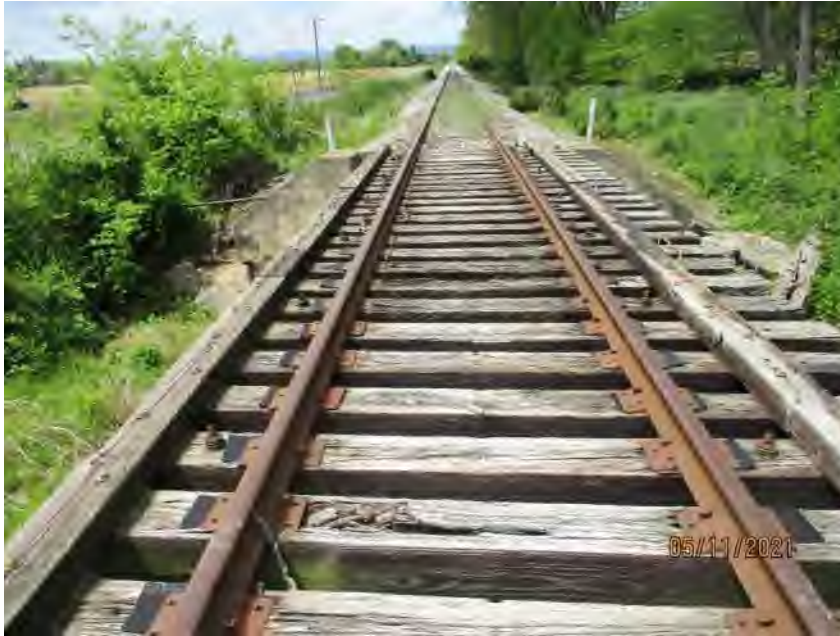
Photo #1

The conditions of the timber railroad ties vary from highly deteriorated (with some missing) to mildly deteriorated. See Photo #1.

Looking west at top of structure toward Abutment A.

Timber railroad ties deteriorated.

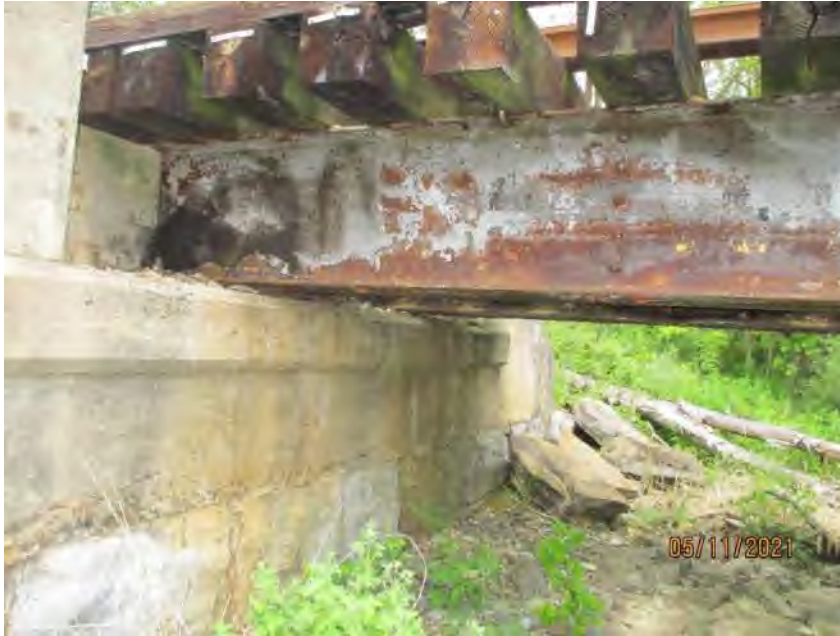
Photo #3

In general, the condition of the steel superstructure elements is in good condition. Surface rust exists on all steel members. The superstructure exhibits trace evidence of paint with no protective value remaining. At time of inspection no measurable section loss was observed to members. See Photos #2-#3.

Span 1, Girder G4 at Abutment A.

Surface rust on girders and superstructure elements with failed coating.

Accumulation of debris on bearing seat.

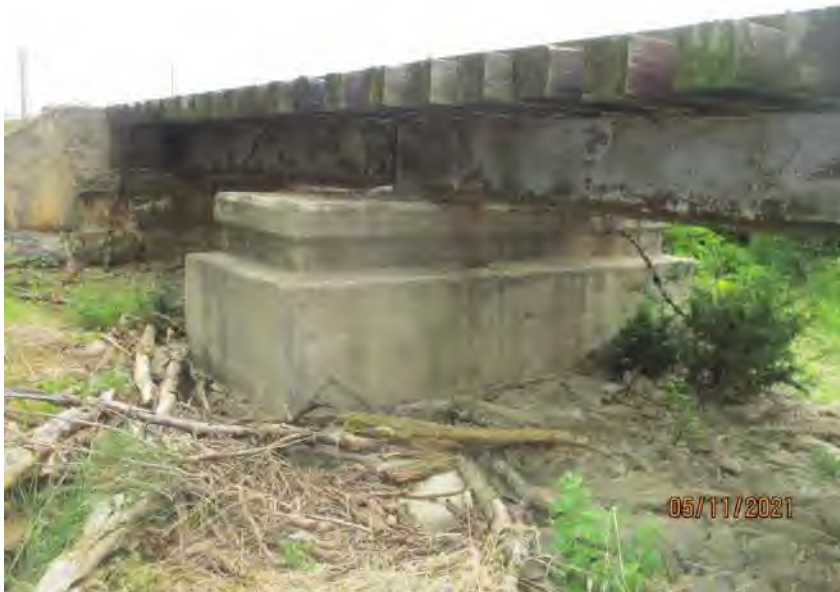
Photo #4

The concrete abutments are in fair condition with minor cracking, some with efflorescence. Abutment A has minor cracking at both wingwalls. There is also accumulation of debris on top of the bearing seat. Abutment B has spalling and delamination full width x up to 6' high x 3" deep. See Photos #5-#6. Stone portions of the abutments are in fair condition with minor loss of mortar. The pier is in fair condition with minor cracking and some minor spalls. Accumulation of debris on upstream side of the pier is present. See Photo #4.

Looking at Pier on upstream side.

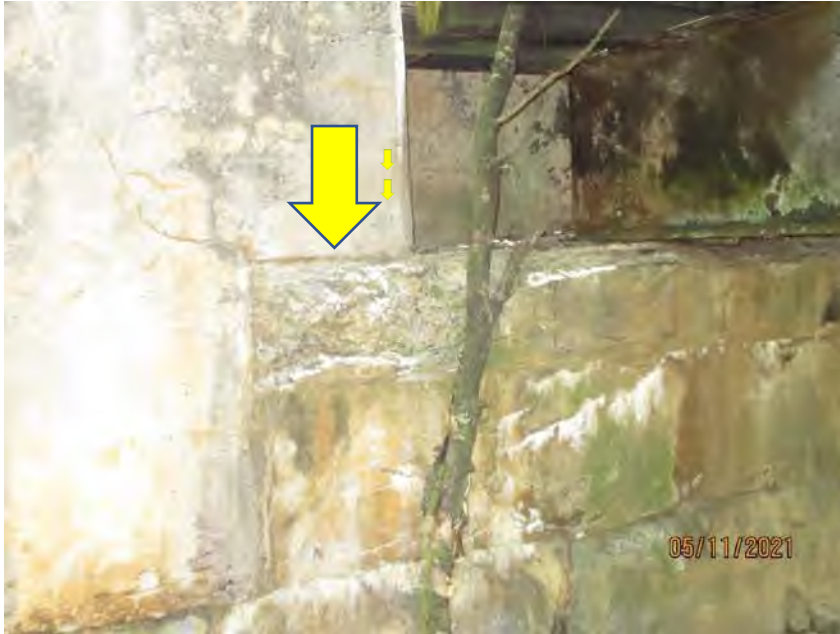
Photo #5

Abutment B upstream side.

Concrete spall:
2' long x 1' high x 2" deep.

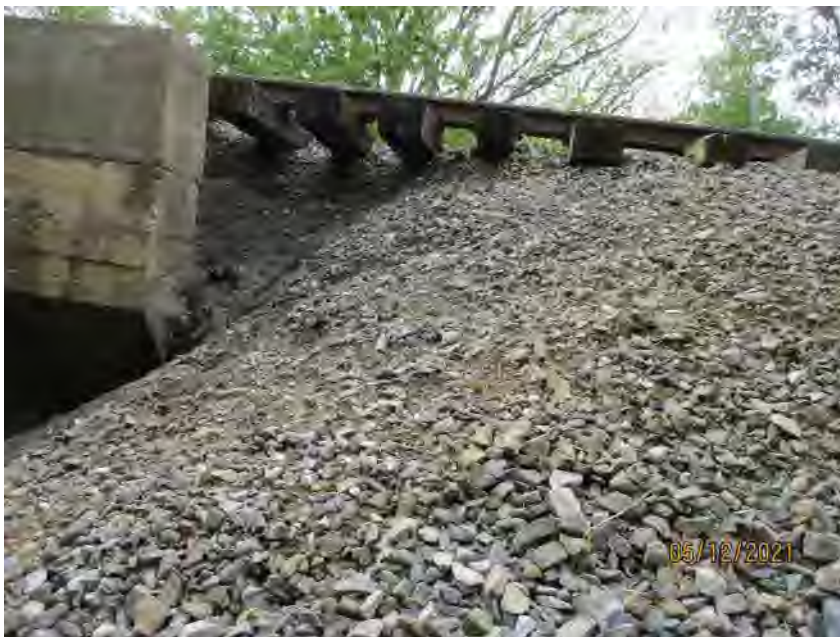
Photo #6

Abutment A upstream side

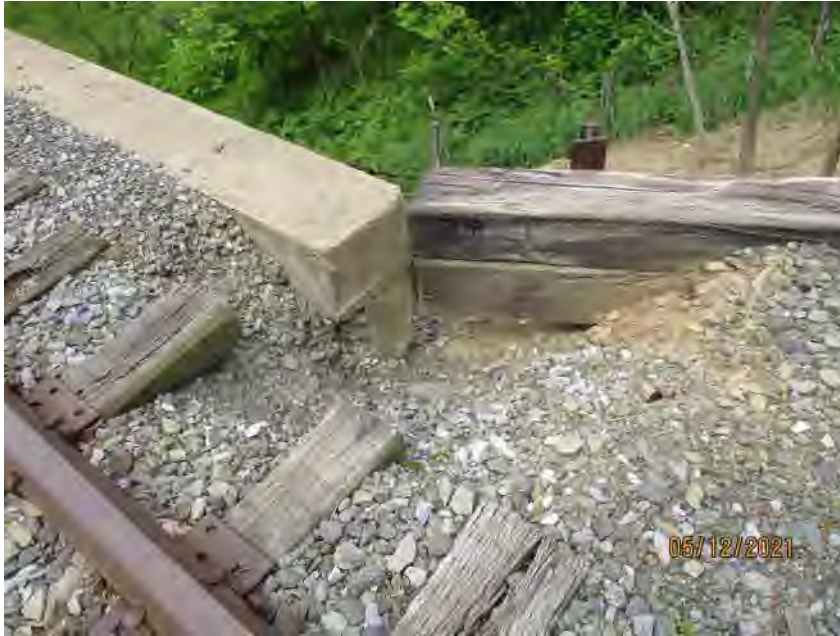
Photo #7

Abutment B erosion behind
wingwall upstream side

Area of erosion:
3'-6" deep x 5'-6" long x 2'-6" wide

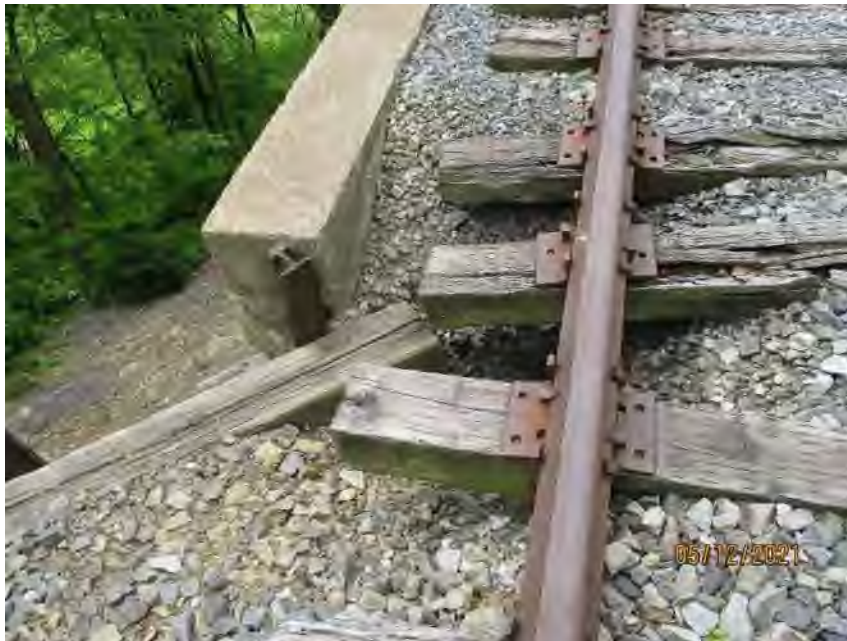
Photo #8

Abutment B erosion behind
wingwall downstream side

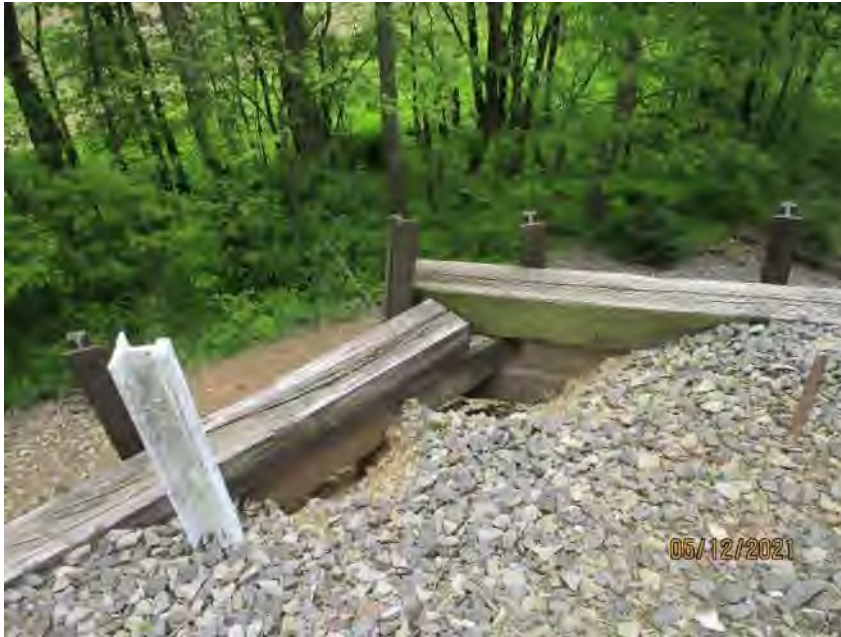
Photo #9

Abutment B erosion behind wingwall downstream side

Area of erosion:
6' deep x 2' long x 2' wide
