NORFOLK SOUTHERN RAILWAY CO. SHENANDOAH VALLEY RAIL CORRIDOR BRIDGE EVALUATION

STRASBURG, VIRGINIA
SHENANDOAH COUNTY

PROJECT NO. 23-1502.101

August 25, 2023

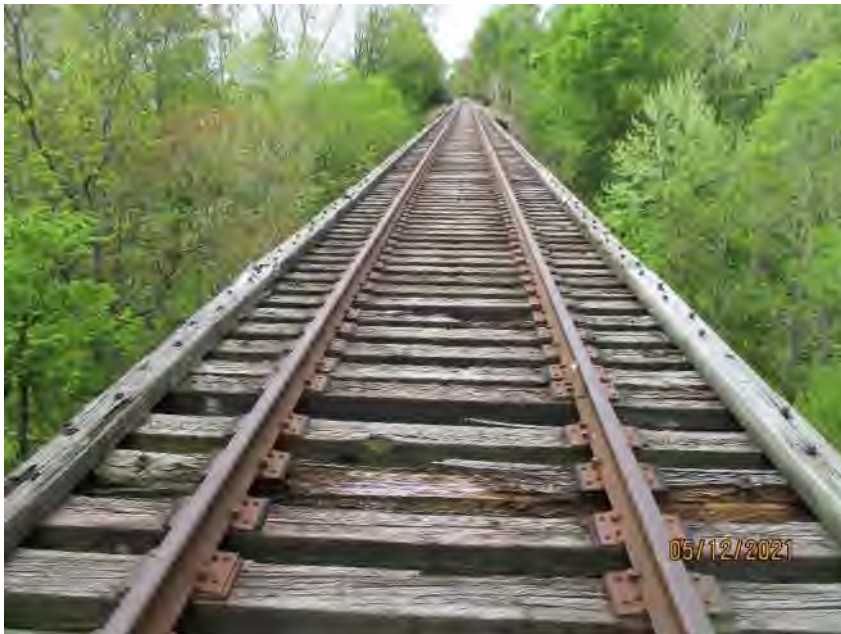
Photo #10

Condition of timber railroad ties
from Abutment B end

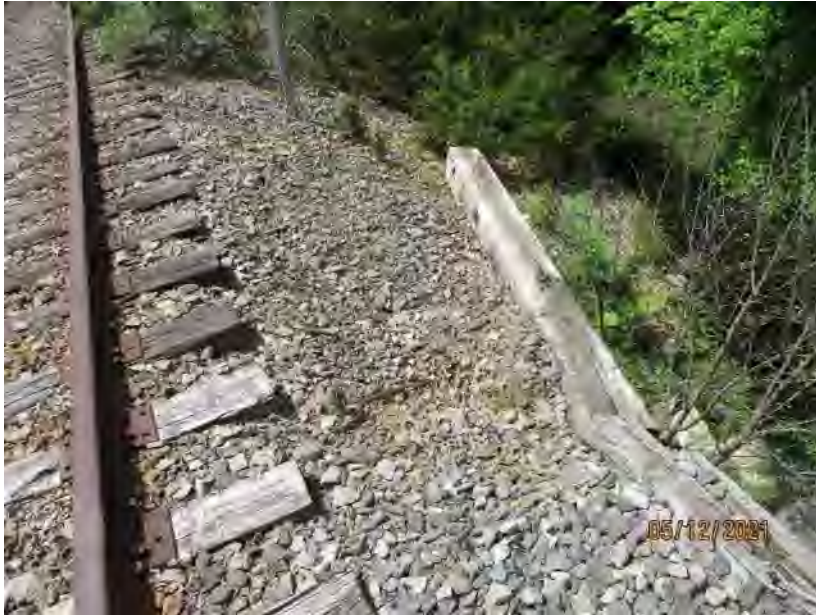
Photo #1

The conditions of the timber railroad ties are mildly deteriorated. See Photo #1.

Wingwalls are in fair condition. Minor area of erosion behind southwest upstream wingwall, 4' long x 2' wide x up to 6" deep. Area of erosion at southeast downstream wingwall, 4' long x 1' wide x up to 3" deep. See Photos #1-#2.

Top of rail looking at southwest upstream wingwall.

Area of erosion:
4' long x 2' wide x up to 6" deep.

- Remove railroad ties.
- Repair erosion behind wingwalls.
- Install a pedestrian railing that meets current safety standards along culvert opening.

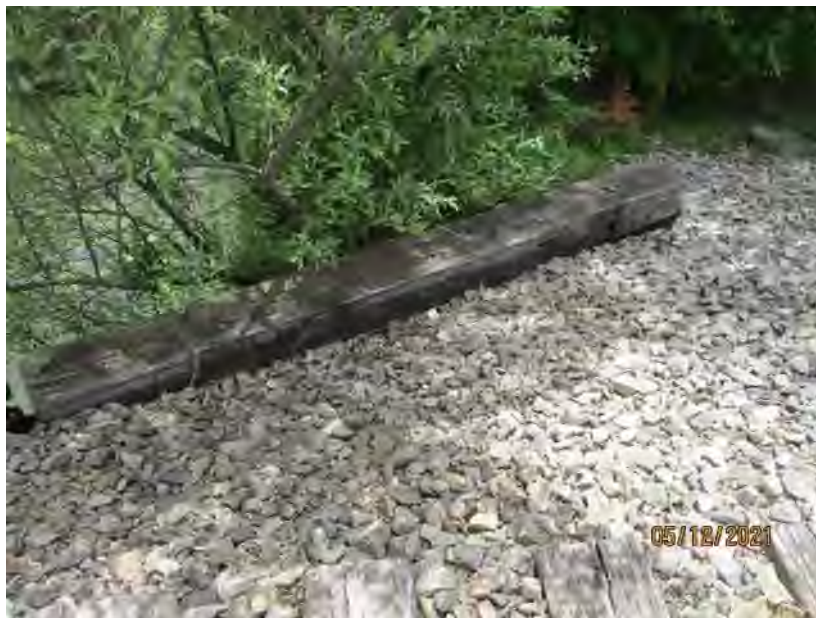
Photo #2

Southeast downstream wingwall

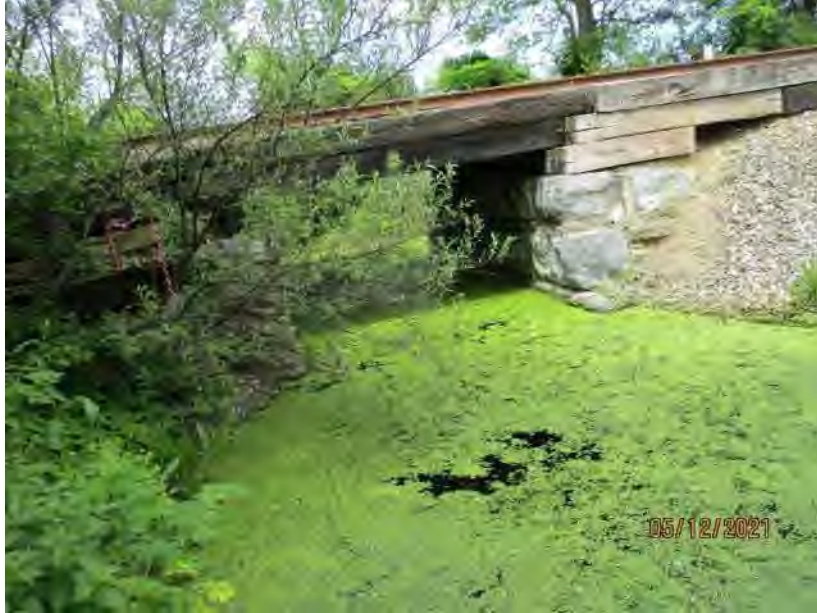
Photo #3

Timber members are in good condition. See Photos #3.

Looking at downstream elevation.

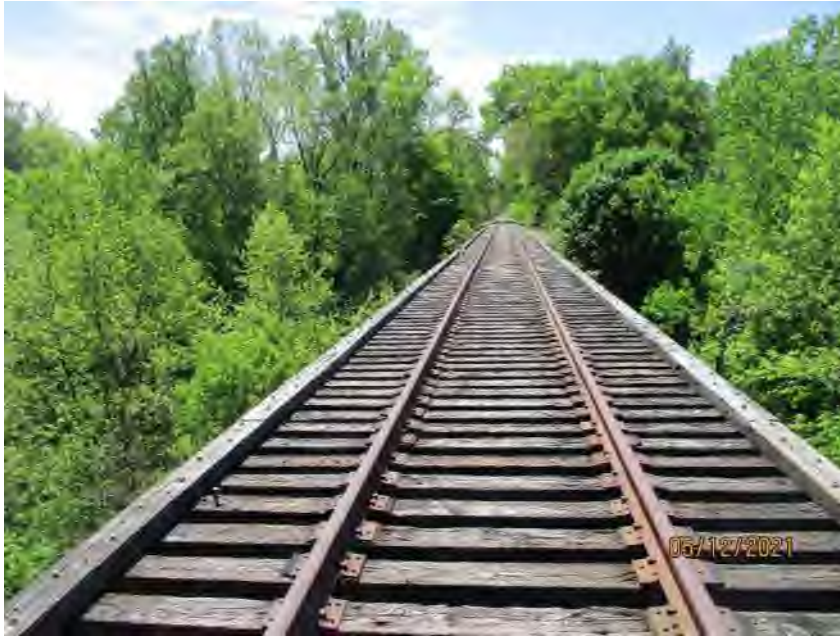
Photo #1

The conditions of the timber railroad ties vary from highly deteriorated (with some missing) to mildly deteriorated. See Photo #1.

Looking south at top of structure toward Abutment A.

Timber railroad ties deteriorated.
Structure unsafe to cross.

- Remove railroad ties and install new timber deck planks.
- Repair/seal cracks in abutments and piers and regrout stone portions of abutment.
- Repair spalls in abutments and piers.
- Install a suitable transition from the gravel railroad bed at both ends of the structure, including grade transitions and installation of a safety guardrail at the transition to the structure.
- Install a pedestrian railing that meets current safety standards.
- Prepare and paint superstructure.

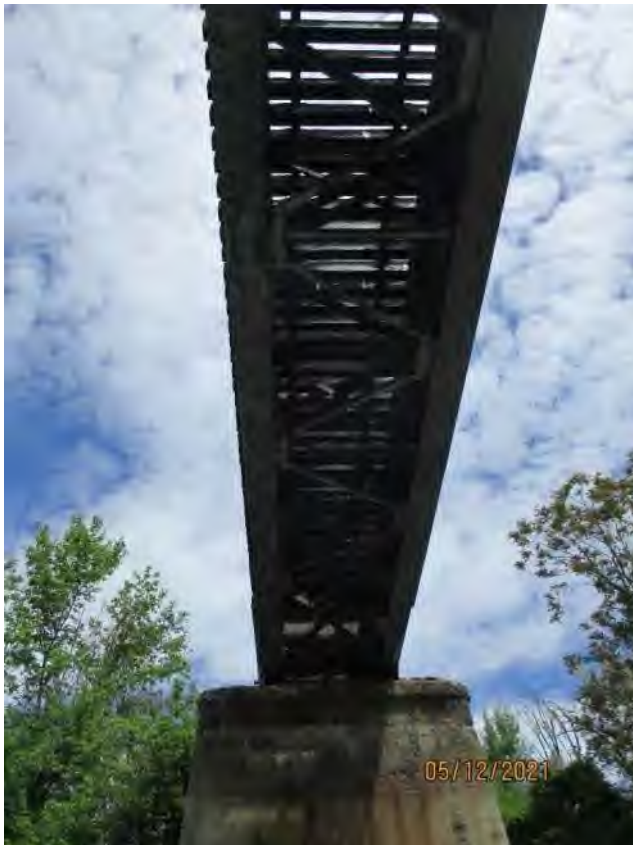
Photo #2

In general, the steel superstructure elements are in good condition. Surface rust exists on all steel members. At time of inspection no measurable section loss was observed to members. See Photos #2, #4-#6.

Span 3, typical underside of the structure.

Surface rust on girders and
superstructure elements with failed
coating.

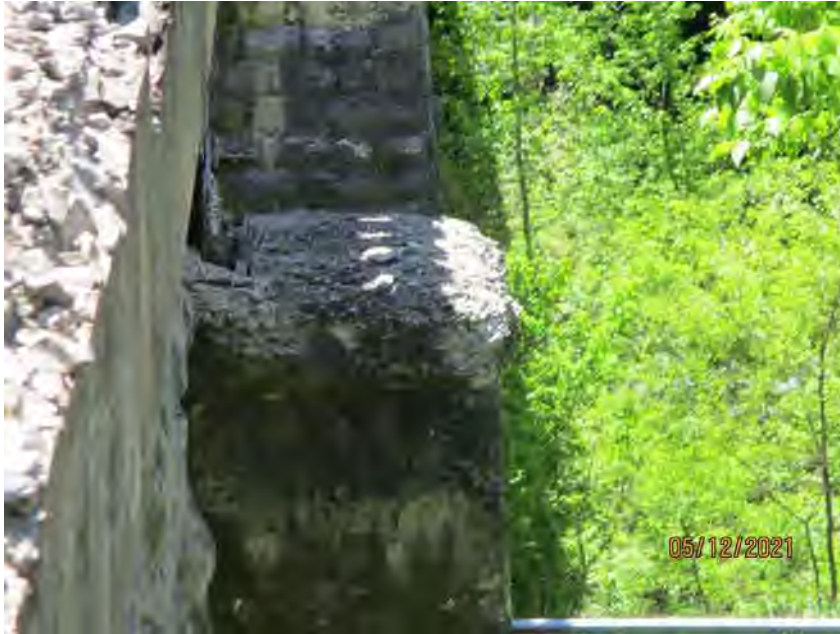
Photo #3

Piers are in fair condition. Both piers have minor to moderate vegetation growth. Pier 1 top of cap has surface spalling all the way around. Pier 2 exhibits corner surface spalling on Span 3 side of cap. See Photos #3-#4.

Pier 1, Span 1 side downstream end of cap.

Top of pier cap exhibit surface spalling all the way around.

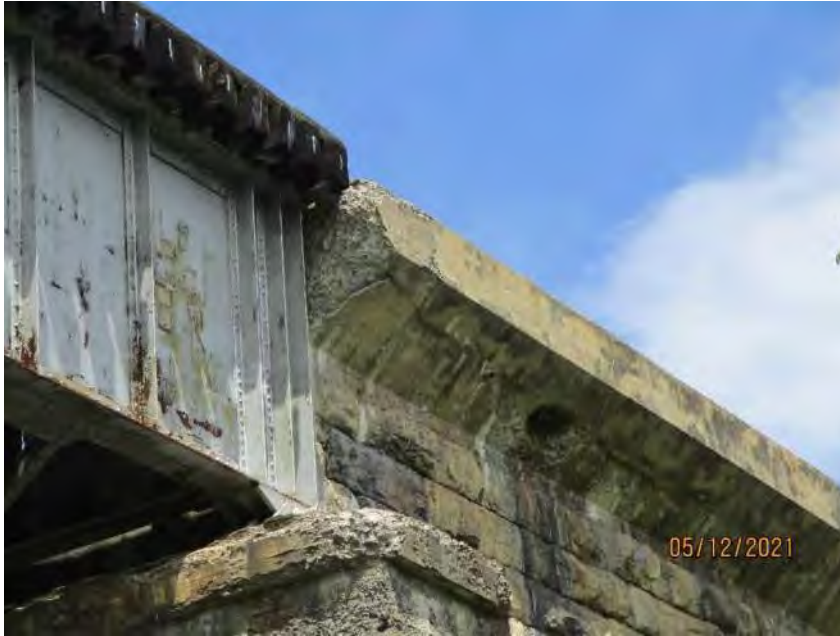
Photo #5

Abutment B is in fair condition. Abutment has several spalls including along edge of bearing seat full width x 3" deep. One spall at top of abutment backwall on the upstream side 2' long x 1' wide x 3" deep. One spall at top of abutment on backwall on downstream side 2' long x 2' wide x 3" deep. On the downstream side on the U-back wingwall, spall 3' long x 2' wide x 3" deep with 1 exposed rebar. See Photos #5-#6.

Abutment B, downstream end wingwall.

Concrete spall:
2' long x 2' wide x 3" deep.

Concrete spall:
3' long x 2' wide x 3" deep
1 exposed rebar.

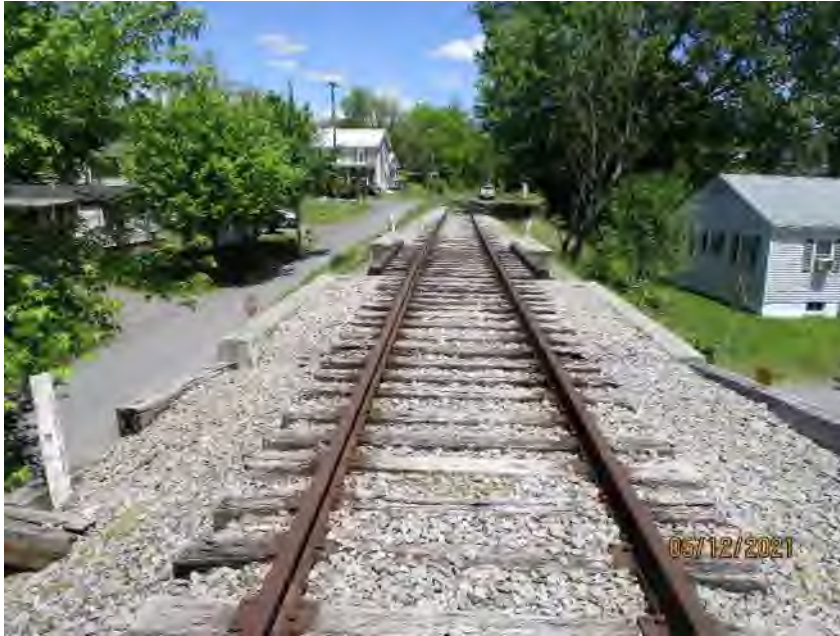
Photo #1

The conditions of the timber railroad ties vary from highly deteriorated (with some missing portions) to mildly deteriorated. See Photos #1-#2.

Looking north at Abutment B.

Timber railroad ties shown are mildly deteriorated.

- Remove deteriorated railroad ties and install new timber deck planks.
- Repair/seal cracks in abutments and regrout stone portions of abutment.
- Install a suitable transition from the gravel railroad bed at both ends of the structure, including grade transitions and installation of a safety guardrail at the transition to the structure.
- Install a pedestrian railing that meets current safety standards.
- Prepare and paint the superstructure.

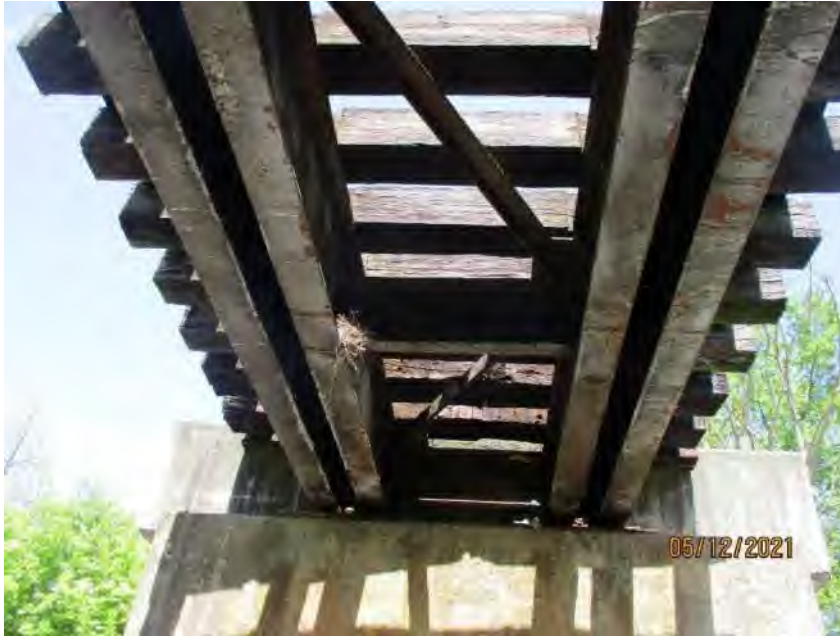
Photo #3

In general, the steel superstructure elements are in good condition. Surface rust exists on all steel members. The superstructure exhibits trace evidence of paint with no protective value remaining. At time of inspection no measurable section loss was observed to members. See Photo #3.

Looking at both double girder units at Abutment B.

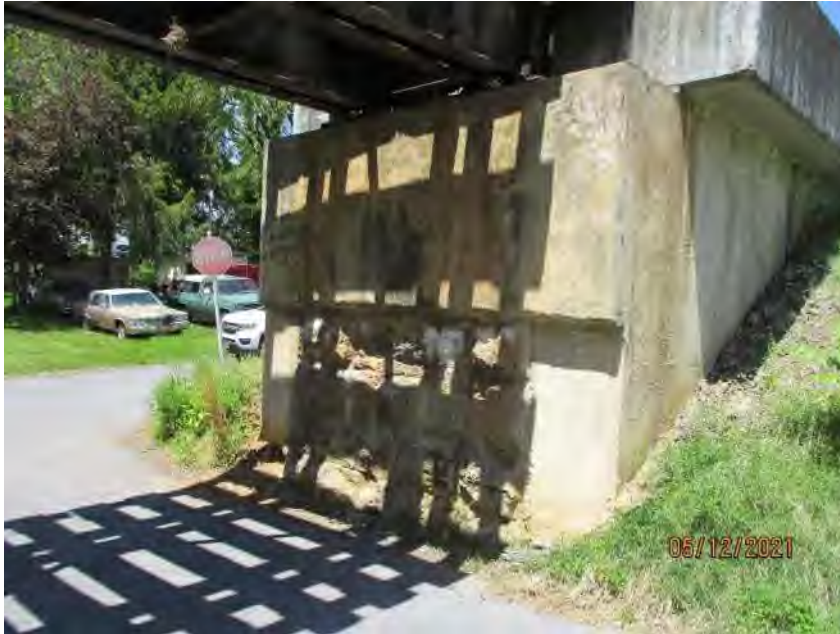
Photo #5

Abutment B has cracking throughout with efflorescence. See Photo #5-#6.

Abutment B.

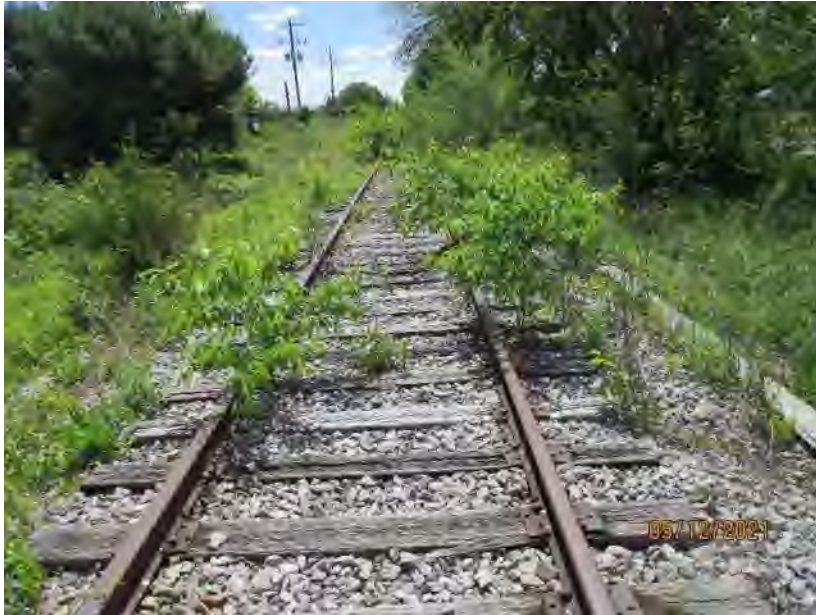
Photo #1

Top of rail above culvert looking south.

Timber railroad ties shown are mildly deteriorated.

Vegetation growth along path.

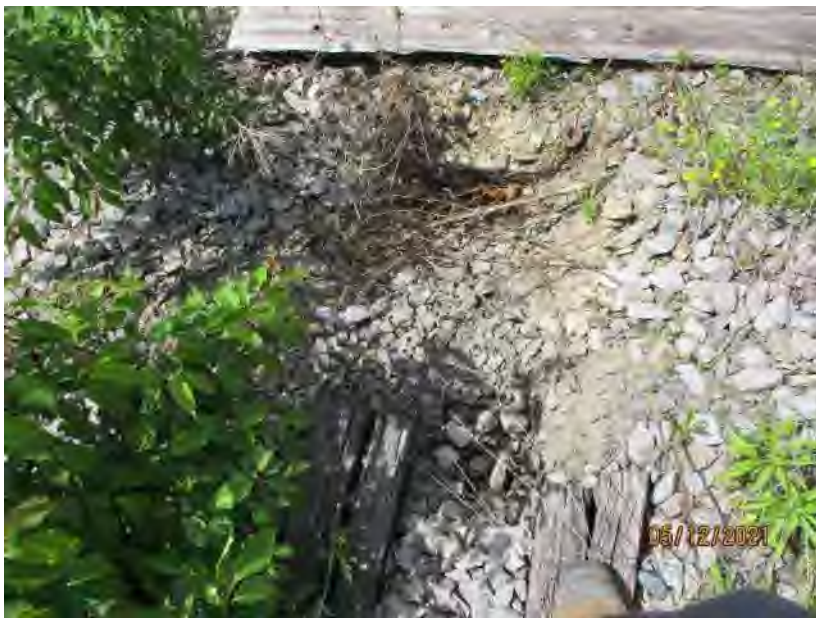
Photo #2

At upstream headwall.

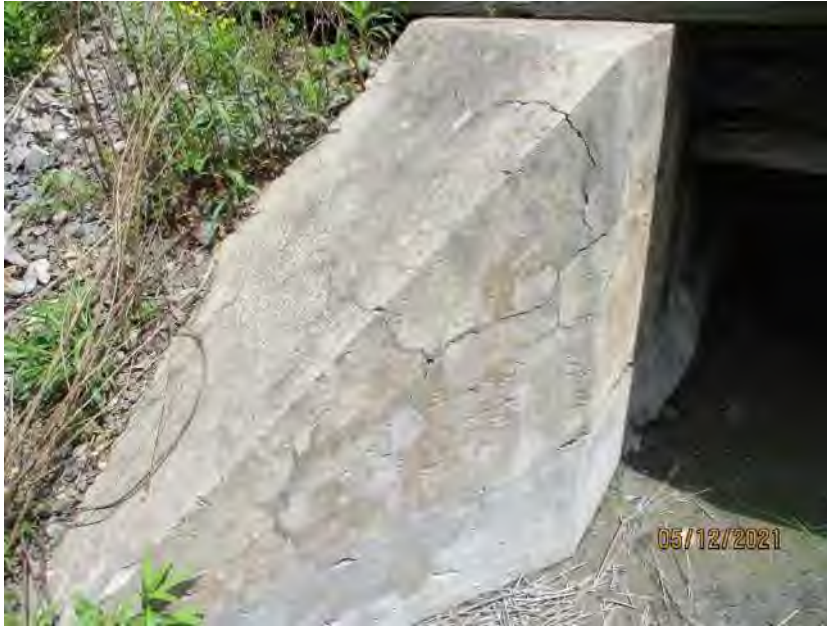
Photo #3

Upstream north wingwall

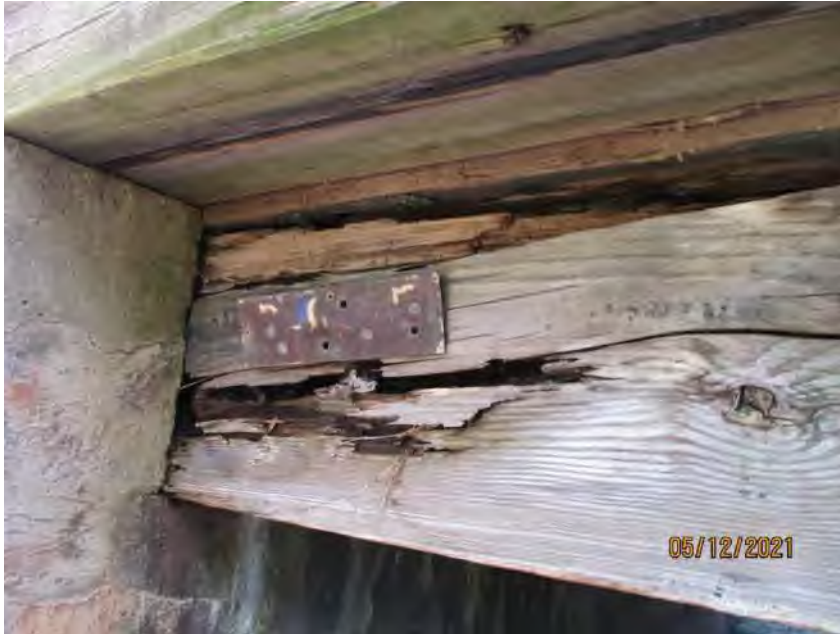
Photo #5

Upstream exterior beam.

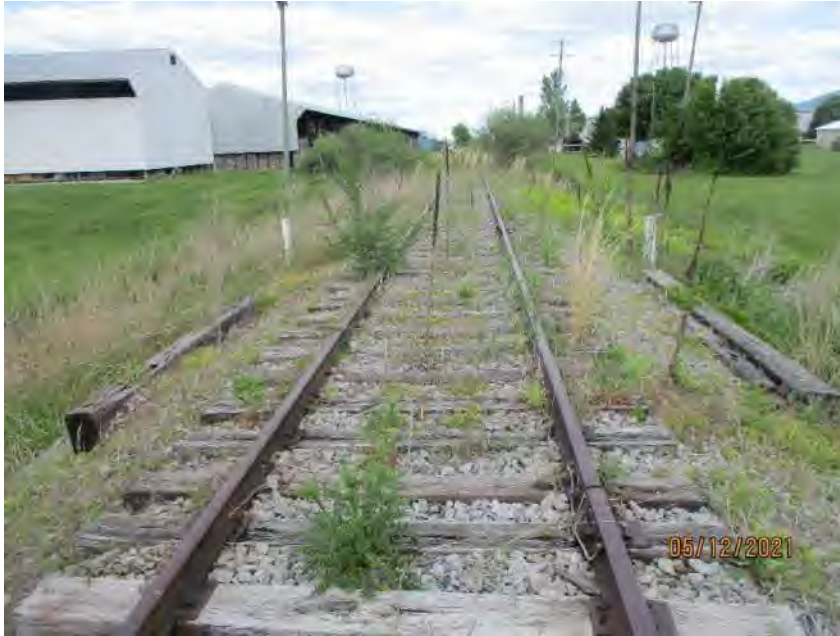
Photo #1

Top of rail above culvert looking north.

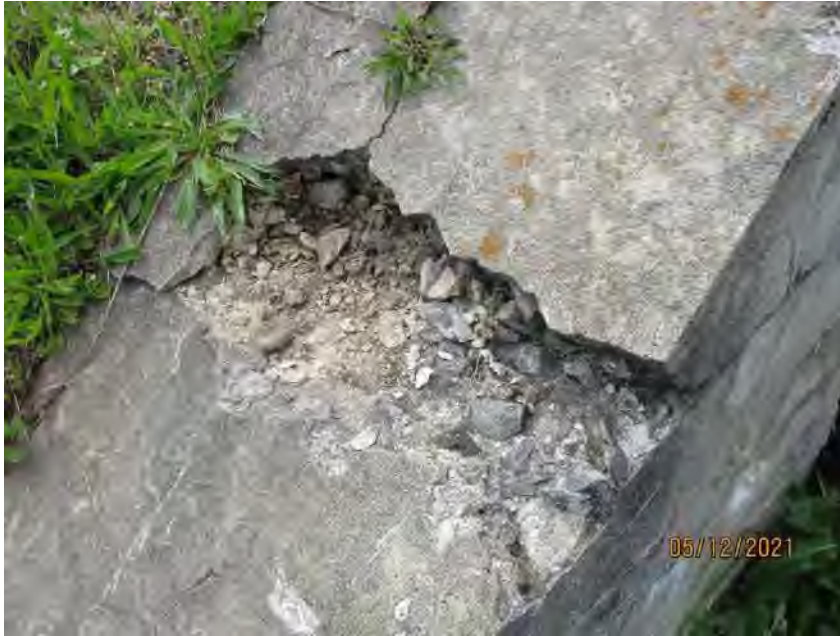
Photo #3

Downstream south wingwall

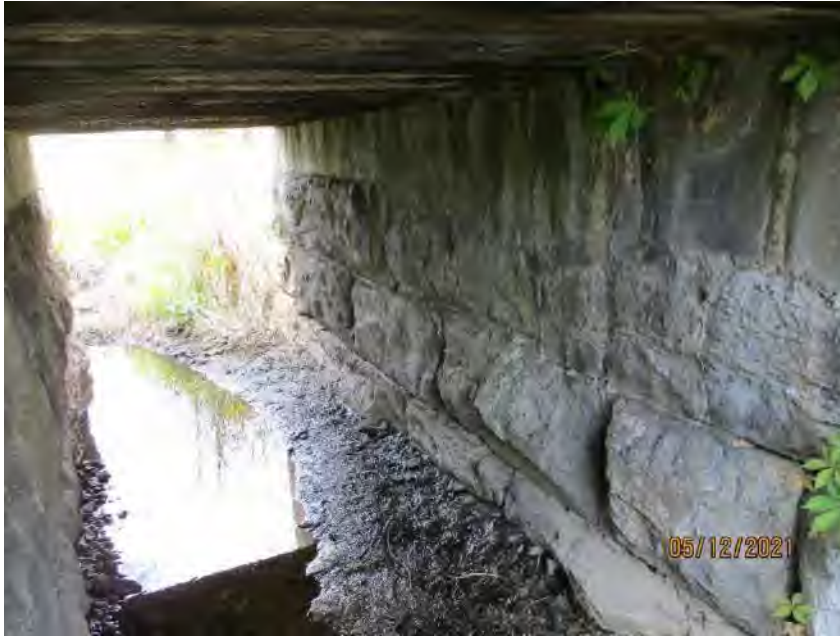
Photo #5

Looking into barrel from the downstream side.

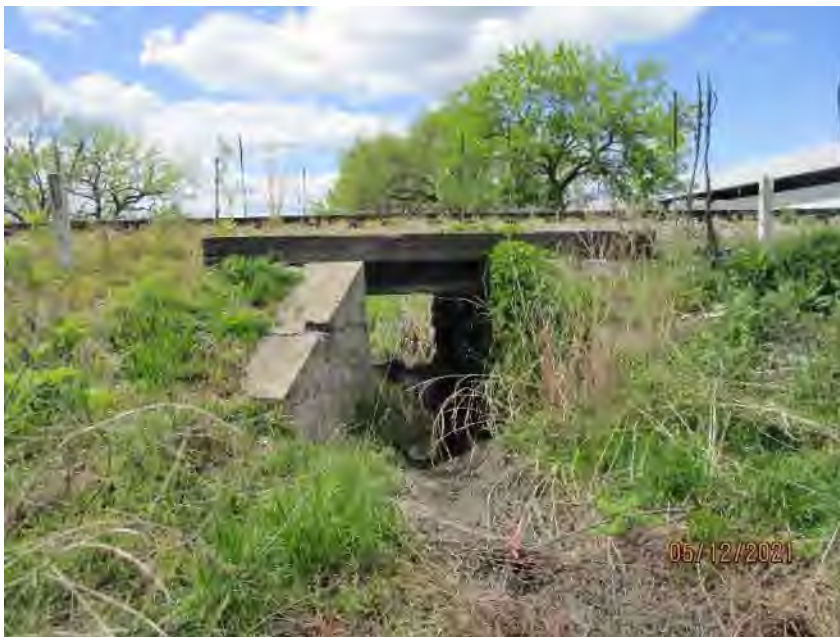
Photo #6

Downstream elevation.

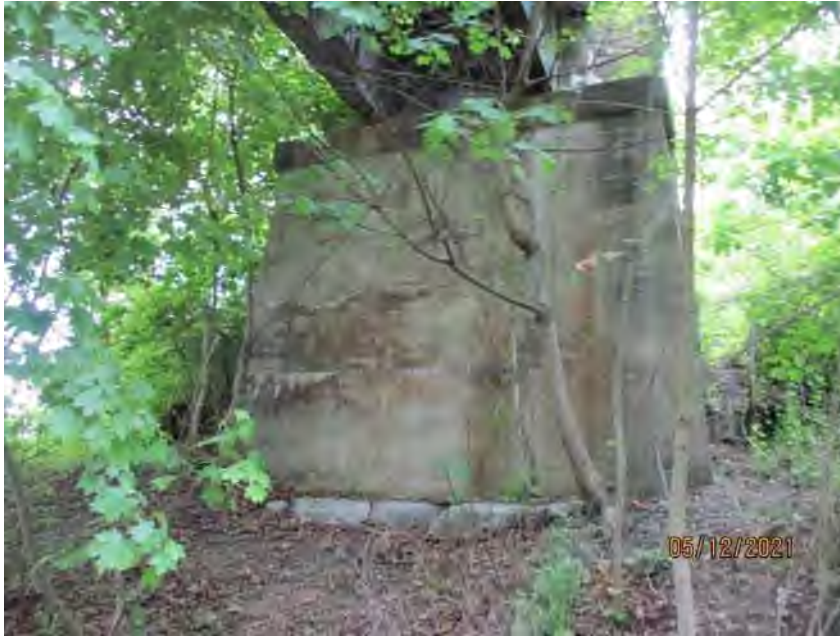
Photo #1

Abutment A is in fair condition with minor cracking with efflorescence. See Photo #1.

Looking at face of Abutment A

Minor cracking with efflorescence throughout.

- Remove railroad ties and install new timber deck planks.
- Repair/seal cracks in abutments and piers and regrout stone portions of abutment.
- Repair spalls in abutments.
- Install a suitable transition from the gravel railroad bed at both ends of the structure, including grade transitions and installation of a safety guardrail at the transition to the structure.
- Install a pedestrian railing that meets current safety standards.
- Prepare and paint superstructure.

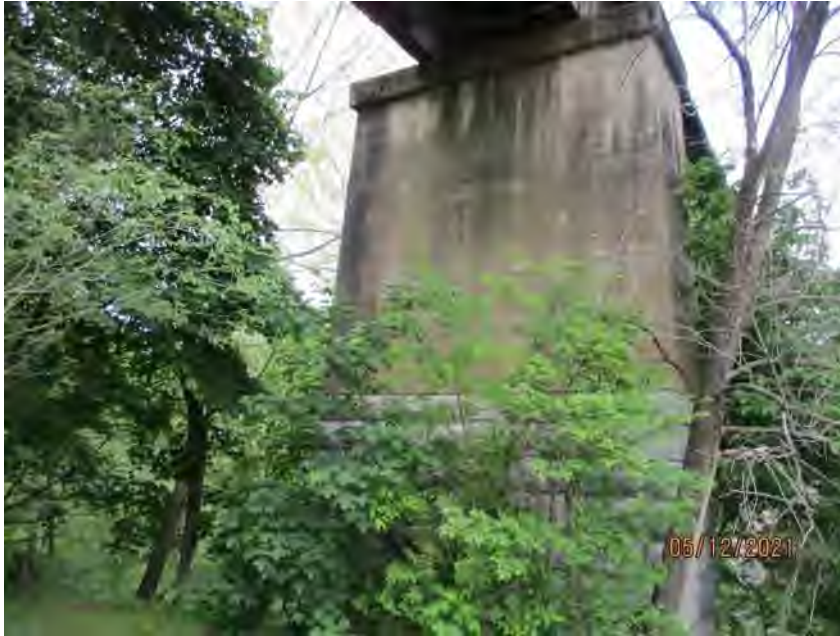
Photo #3

Piers are in fair condition. Both concrete piers have minor to moderate vegetation growth. Concrete piers exhibit minor cracking, some with efflorescence. Metal piers have peeling paint with minor surface rust. Vegetation growth is encroaching on piers. See Photos #3-#5.

Pier 2, Span 2 side.

Moderate vegetation growth.

Concrete piers exhibit minor cracking some with effloresce.

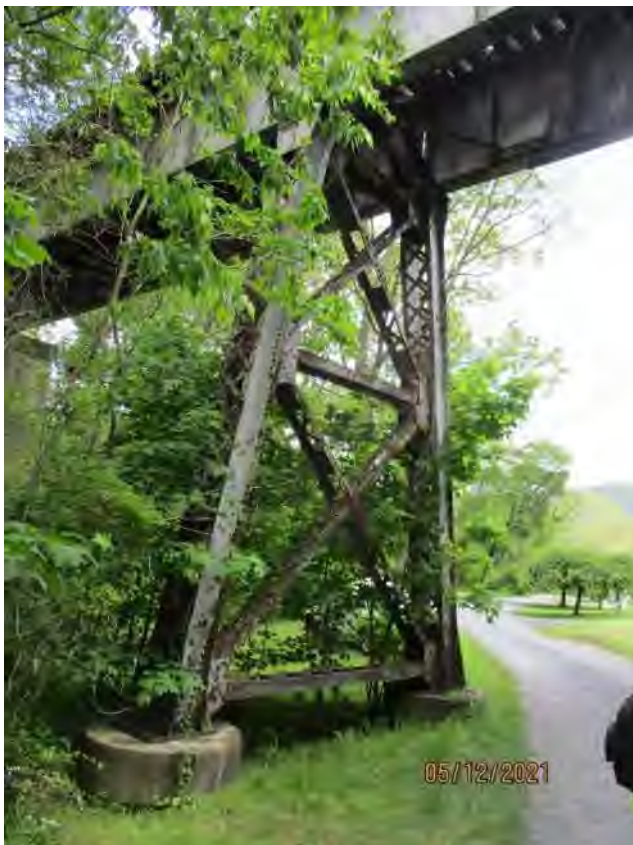
Photo #4

In general, the steel superstructure elements are in fair condition. Surface rust exists on all steel members. The superstructure exhibits flaking and peeling paint. At time of inspection no measurable section loss was observed to members. See Photos #2 & #4.

Pier 1, Span 1 side.

Surface rust on pier with failed coating.

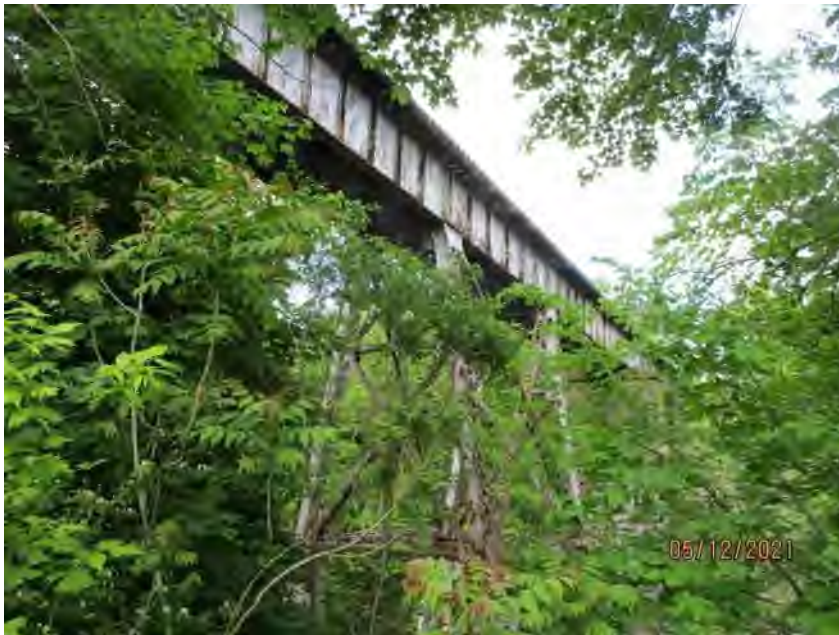
Photo #5

Piers 3 and 4.

Moderate vegetation growth.

Surface rust on pier with failed coating.

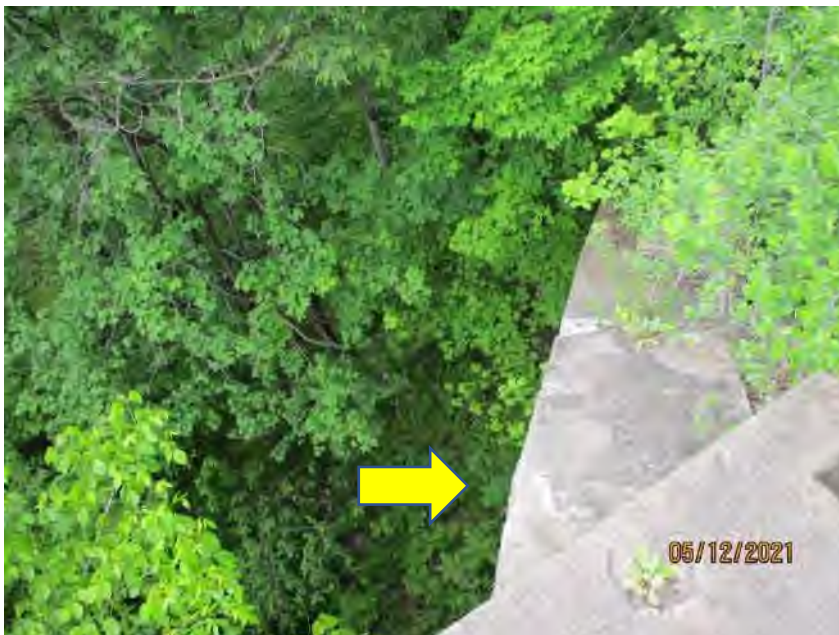
Photo #6

Abutment B is in fair condition with minor cracking with efflorescence. Minor spall on upstream wingwall 1' long x 1' wide x 3" deep. On top of deck heavy vegetations growth. See Photos #6-#7.

Abutment B, upstream wing wall.

Area of concrete spall:
1' long x 1' wide x 3" deep.

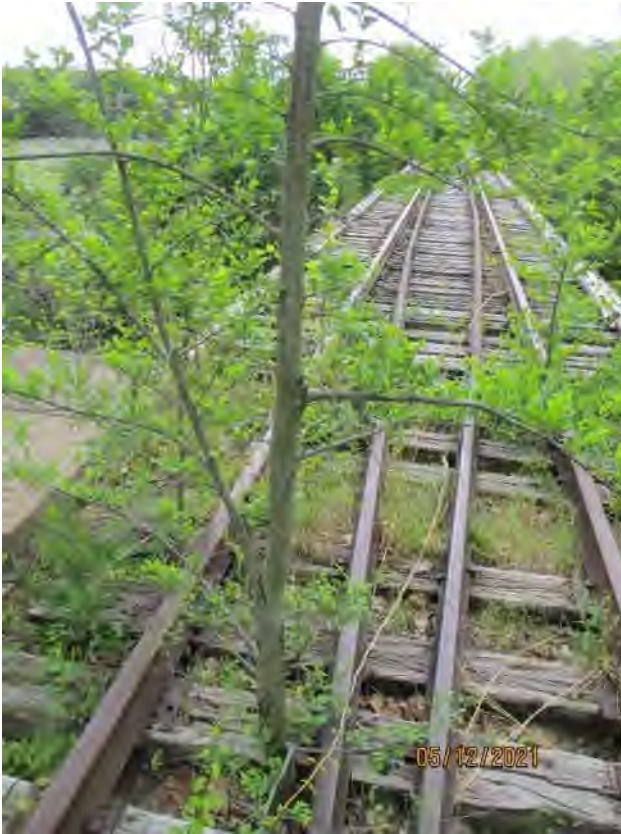
Photo #7

Top of deck looking from Abutment B.

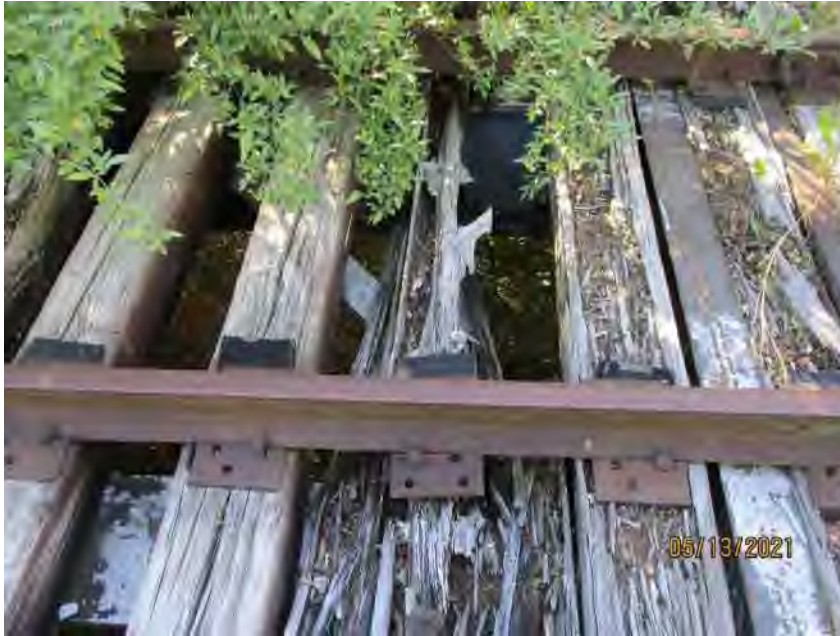
Photo #1

The conditions of the timber railroad ties vary from highly deteriorated to mildly deteriorated. See Photos #1 and the Title Page Photo.

Timber railroad ties shown are heavily deteriorated.

- Remove railroad ties and install new timber deck planks.
- Perform detailed site assessment and repair/seal any cracks found in abutments and piers and re-grout stone portions of abutments and pier as needed.
- Install a suitable transition from the gravel railroad bed at both ends of the structure, including grade transitions and installation of a safety guardrail at the transition to the structure.
- Install a pedestrian railing that meets current safety standards.
- Preparation and painting of the entire superstructure and steel substructure is recommended.
- Repair erosion areas and encroaching vegetation at abutments.

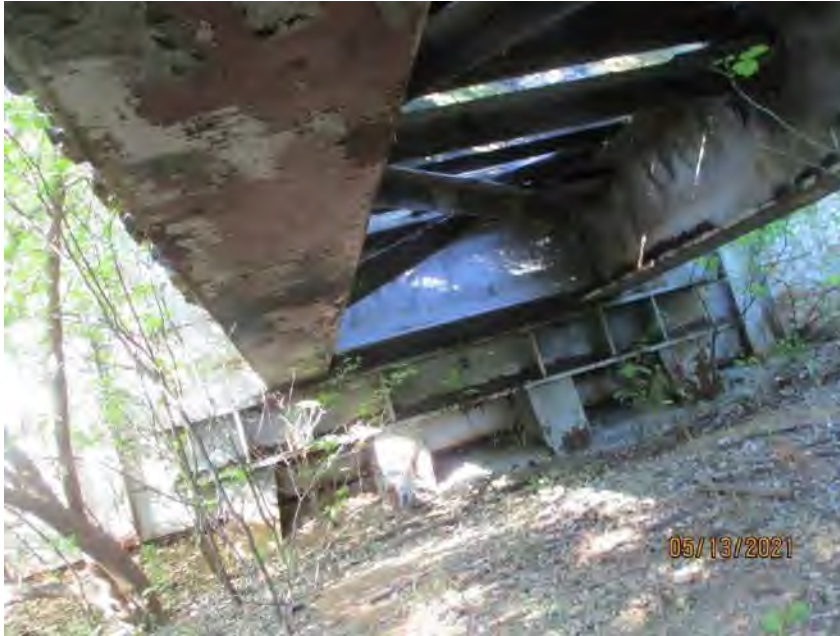
Photo #3

Abutment A is in good condition with light erosion on the downstream side and surface rust throughout. There is heavy vegetation encroaching on the structure. See Photos #3-#4.

Looking south at Abutment A

Typical girder configuration for Spans 1&2 with failed protective coating and minor surface rust throughout.

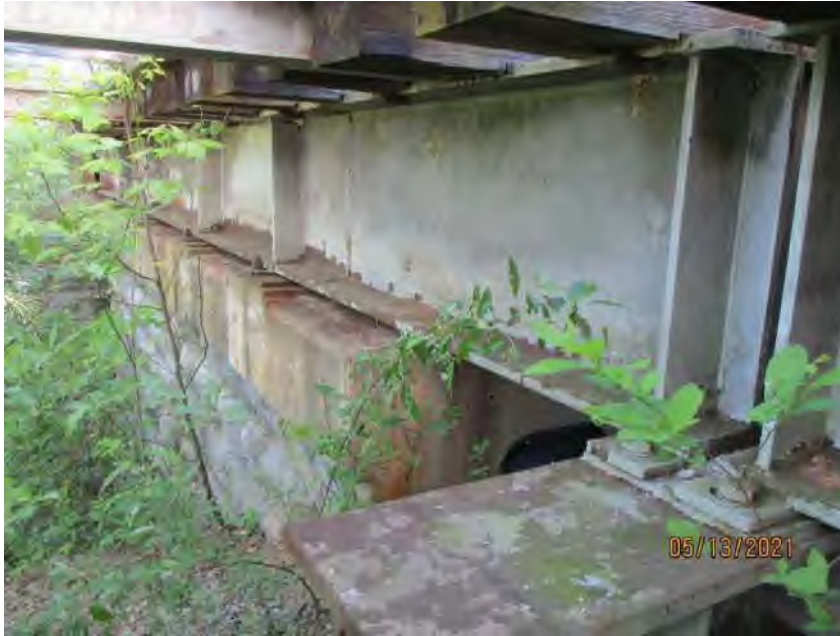
Photo #5

Pier 2 and intermediate support are in good condition with few areas of missing mortar. See Photos #5-#6.

Intermediate support and Pier 1

Upstream side looking east.

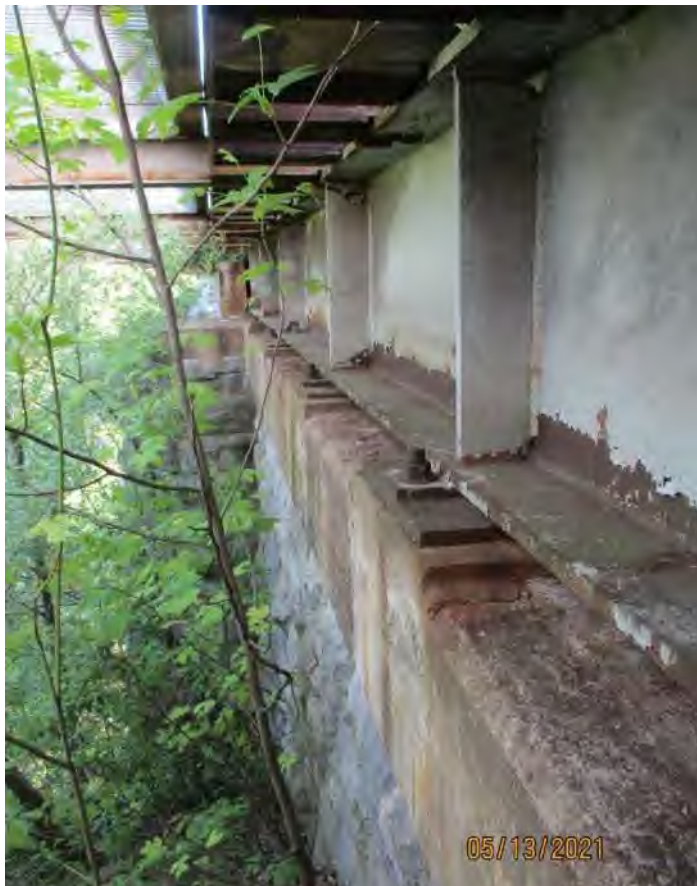
Photo #6

Intermediate support and Pier 2

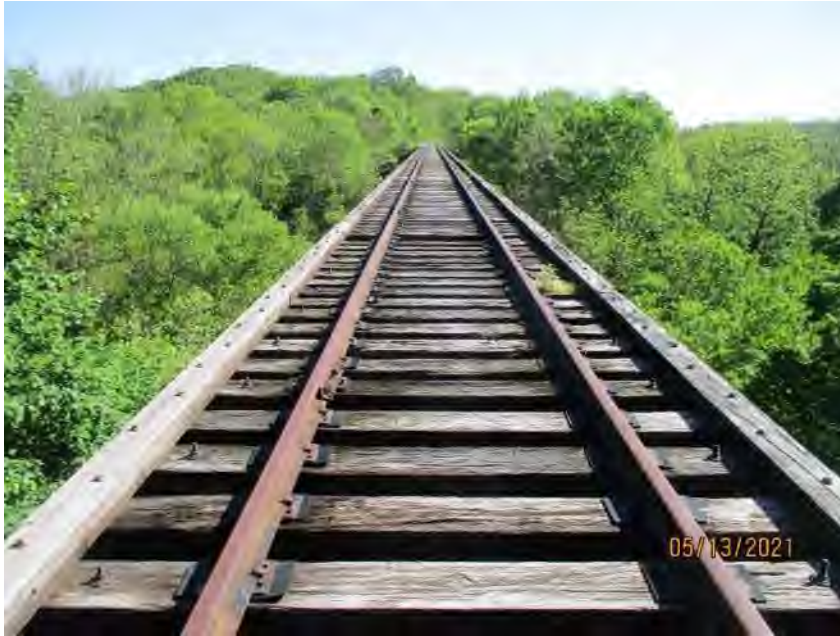
Photo #1

The condition of the timber railroad ties is mildly deteriorated. See Photo #1.

Looking north at top of structure toward Abutment B.

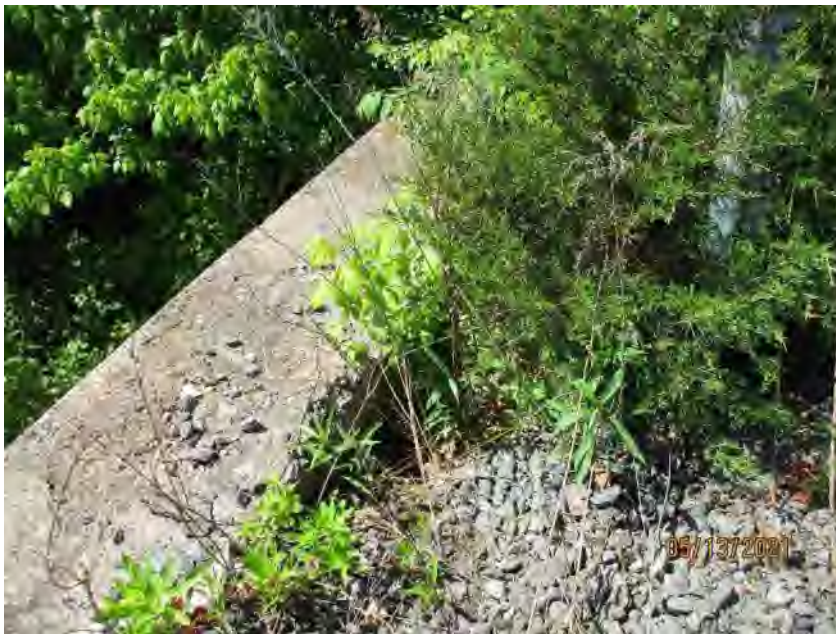
Photo #4

Abutment A has an area of erosion along downstream side of abutment. Erosion measures 6' long x 3' wide x 1.5' deep. See Photos #4-#5. Spalling on the upstream wingwall measured 7' long x 15" wide x 2.5" deep. Spalling on the corner measured 5' long x 6" wide x 2" deep. See Photos #5-#6.

Abutment A downstream side.

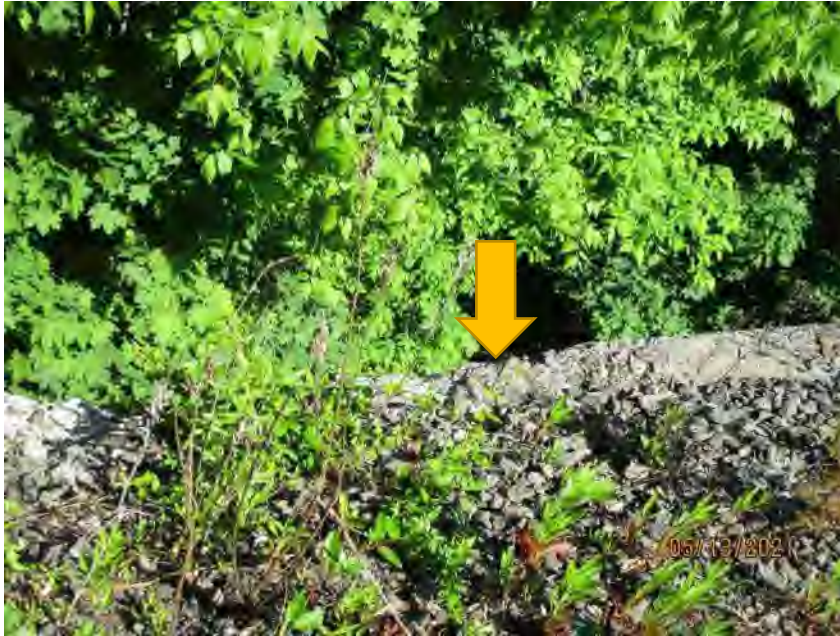
Photo #5

Abutment A wingwall upstream side.

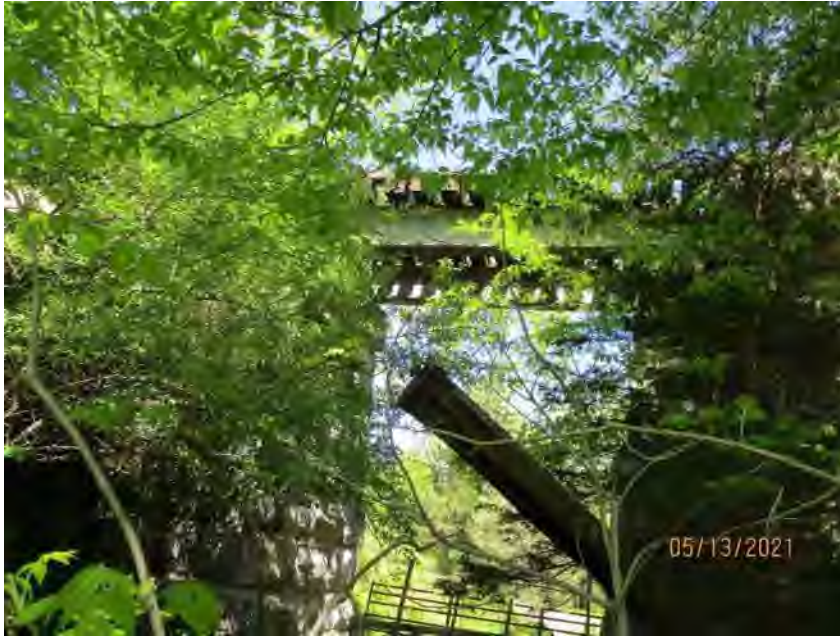
Photo #3

Looking at girders from the downstream side.

Typical girder configuration with failed protective coating and minor surface rust thought out.

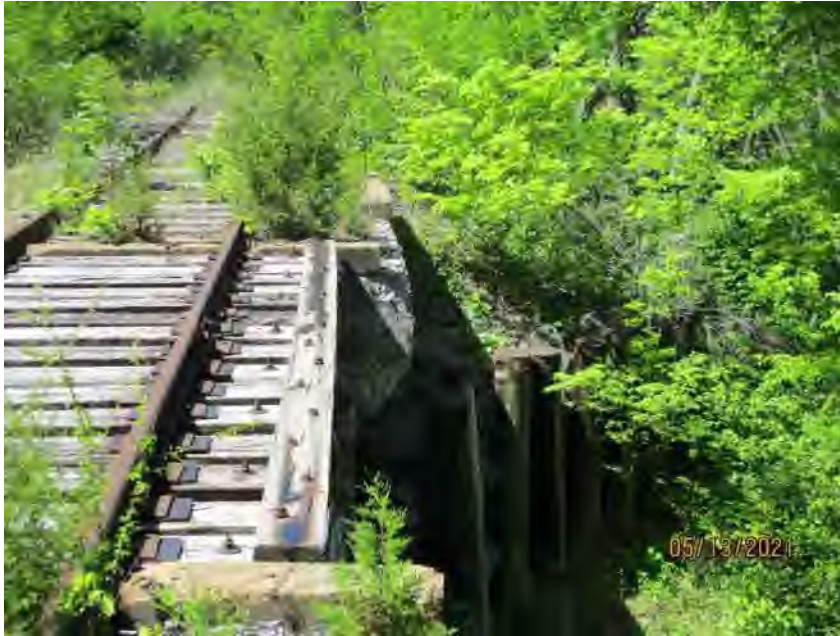
Photo #5

Looking across the structure at Abutment A.

Spall on backwall:
3.5' long x 2' wide x 1'-6" deep.

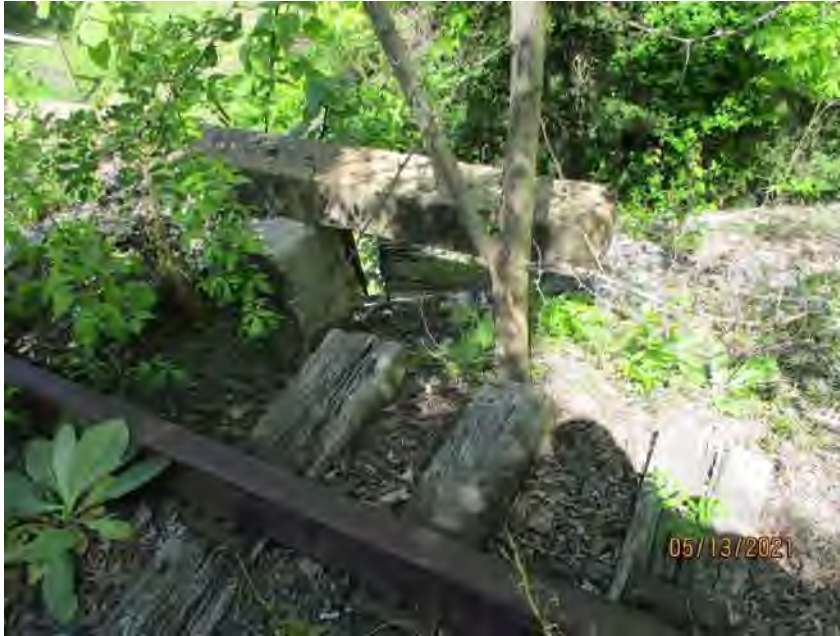
Photo #7

Abutment B upstream side.

A portion of the upstream timber wingwall has fallen away.

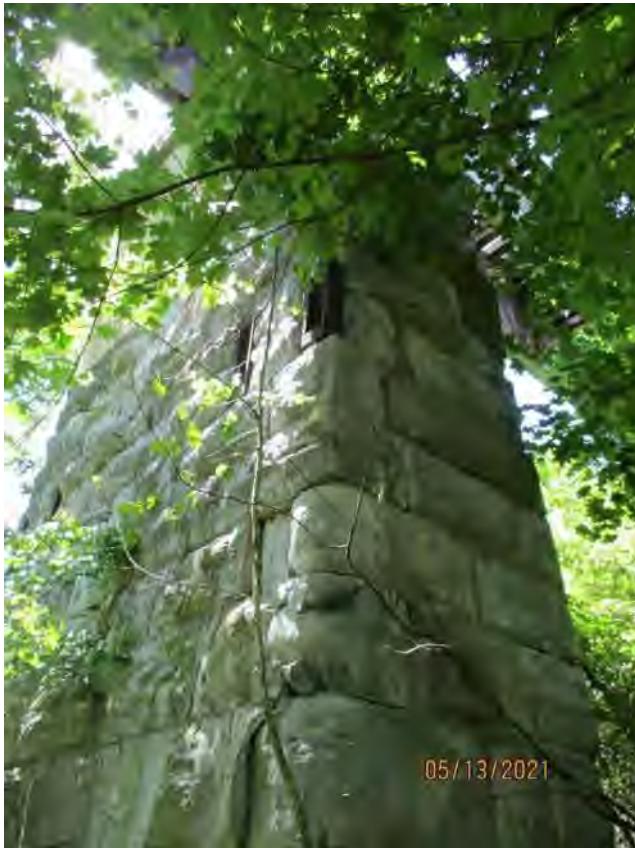
Photo #9

Pier 2 supports Spans 3 and 4. Structure is in good condition with a few areas of missing mortar. See Photo #9.

Pier 2

Stone wall with concrete cap.

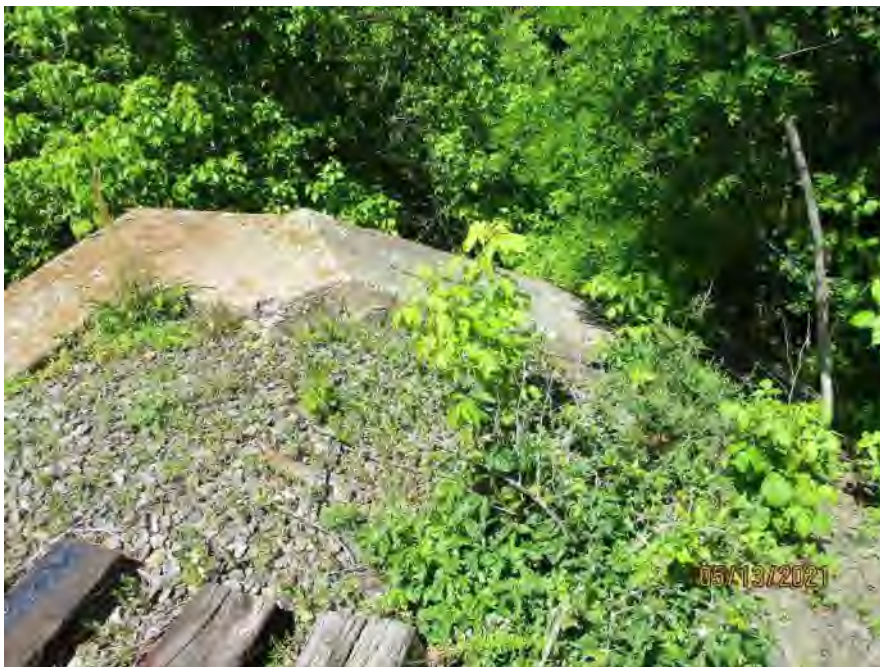
Photo #10

Abutment B has light erosion and missing timber beam on both sides. See Photo #10.

Abutment B

Upstream side erosion with missing timber beam.

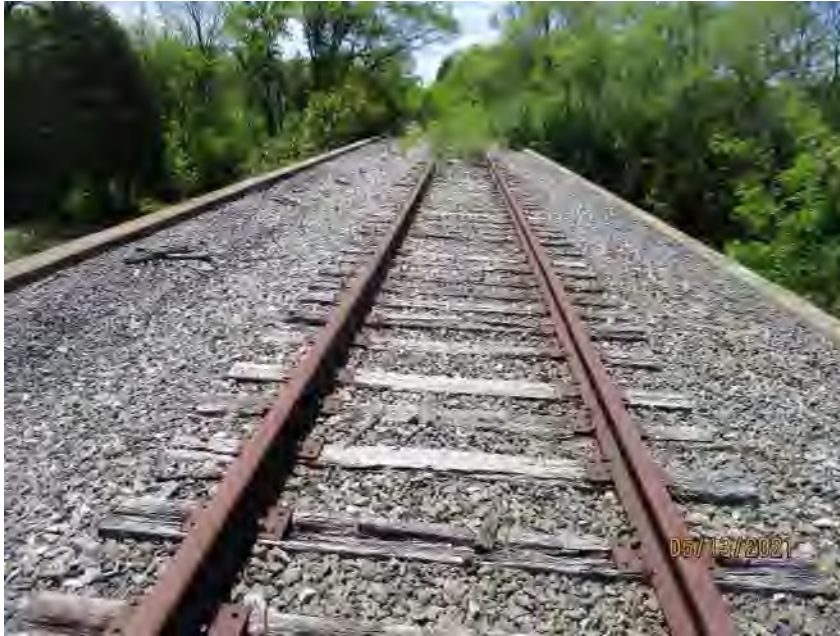
Photo #1

The condition of the timber railroad ties is mildly deteriorated. See Photo #1.

Looking south at Abutment A.

Timber railroad ties shown are mildly deteriorated.
