NORFOLK SOUTHERN RAILWAY CO. SHENANDOAH VALLEY RAIL CORRIDOR BRIDGE EVALUATION

STRASBURG, VIRGINIA
SHENANDOAH COUNTY

PROJECT NO. 23-1502.101

August 25, 2023

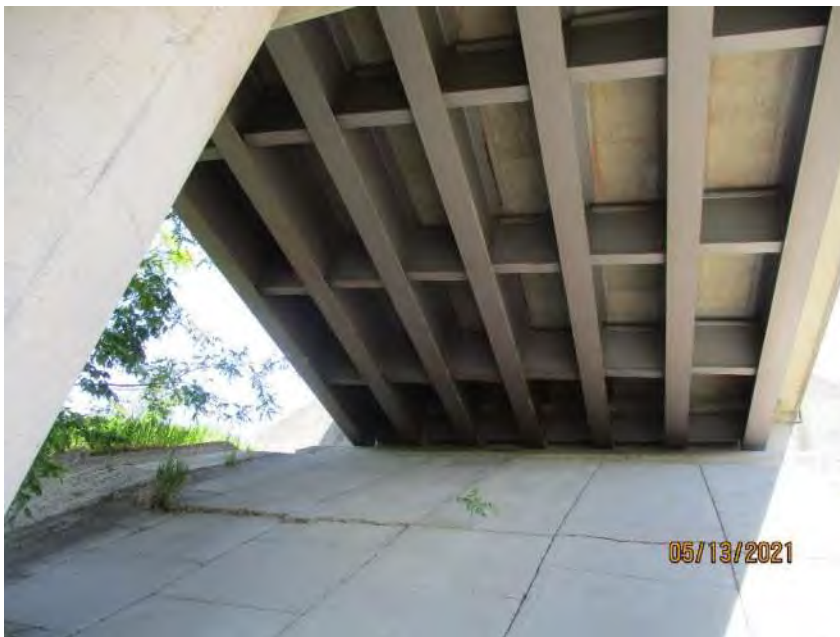
Photo #2

The steel superstructure elements are in good condition with slight paint loss. At time of inspection no measurable section loss was observed to members. See Photos #2-#3.

Span 3

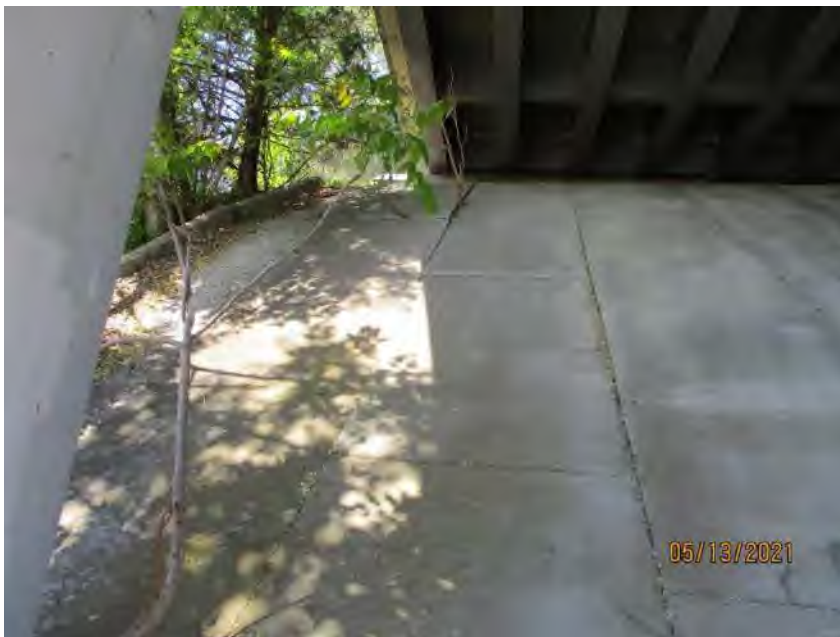
Photo #4

Abutment A is in good condition with vegetation growth on the slope protection. See Photo #4.

Abutment A

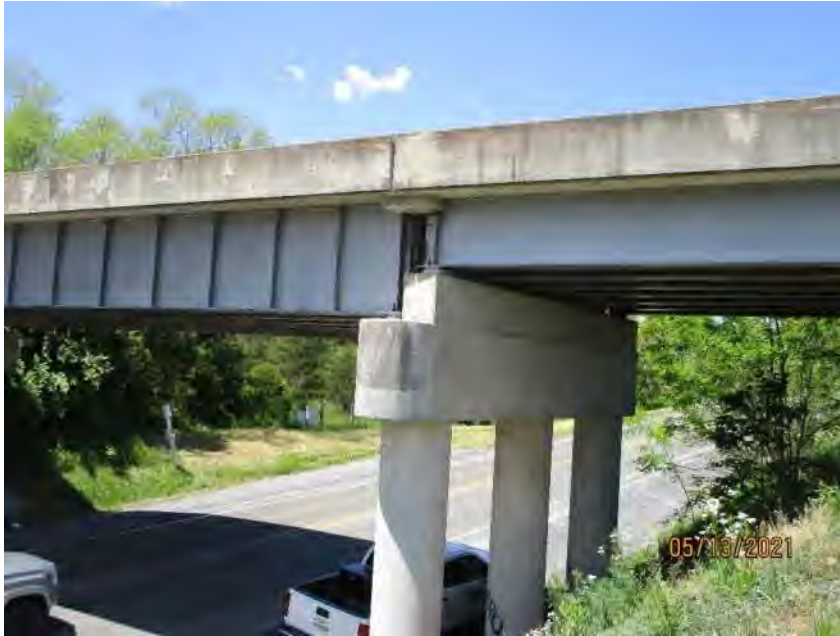
Photo #5

Piers 1 and 2 are in good condition with no noteworthy deficiencies. See Photos #5.

Typical view of Pier 2.

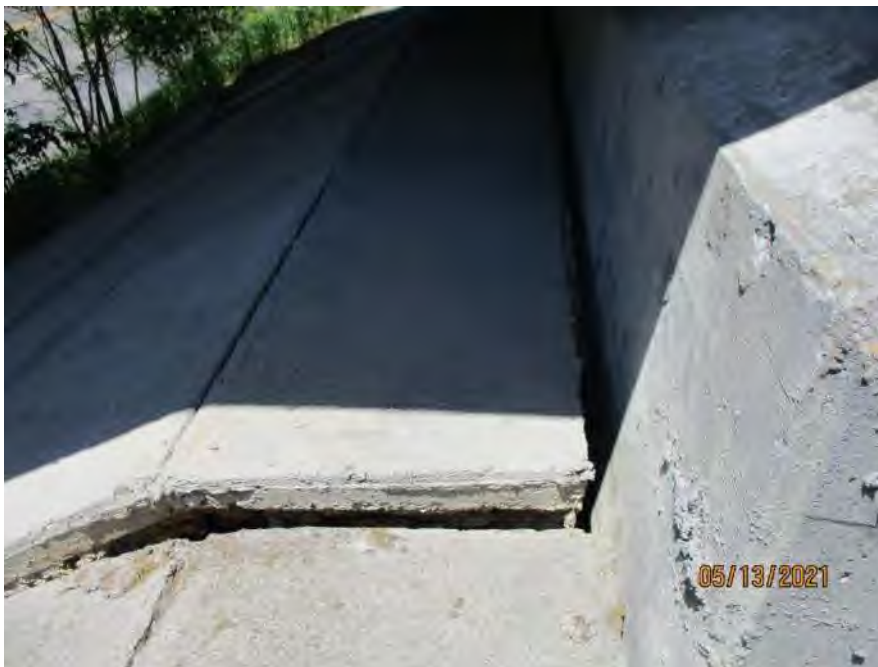
Photo #6

Abutment B is in good condition with the slope protection separated from bearing by 1.5" and settled 2.5". See Photo #6.

Abutment B

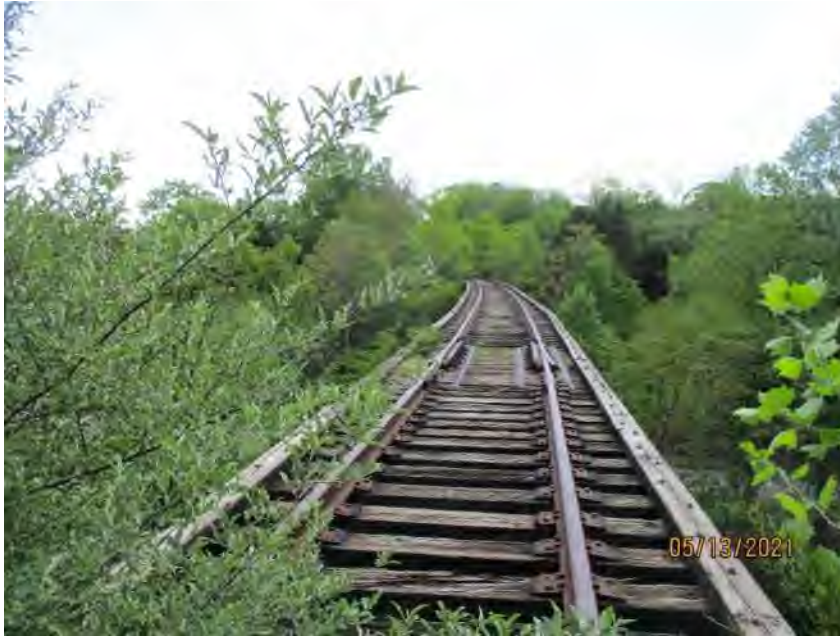
Photo #1

The condition of the timber railroad ties is mildly deteriorated. See Photo #1.

Looking south at Abutment A.

Timber railroad ties shown are mildly deteriorated.

- Remove railroad ties and install new timber deck planks.
- Perform detailed site assessment and repair/seal any cracks found in abutments and piers and re-grout masonry portions of abutments and pier as needed.
- Install a suitable transition from the gravel railroad bed at both ends of the structure, including grade transitions and installation of a safety guardrail at the transition to the structure.
- Install a pedestrian railing that meets current safety standards.
- Prepare and paint superstructure.
- Repair erosion areas at both abutments.

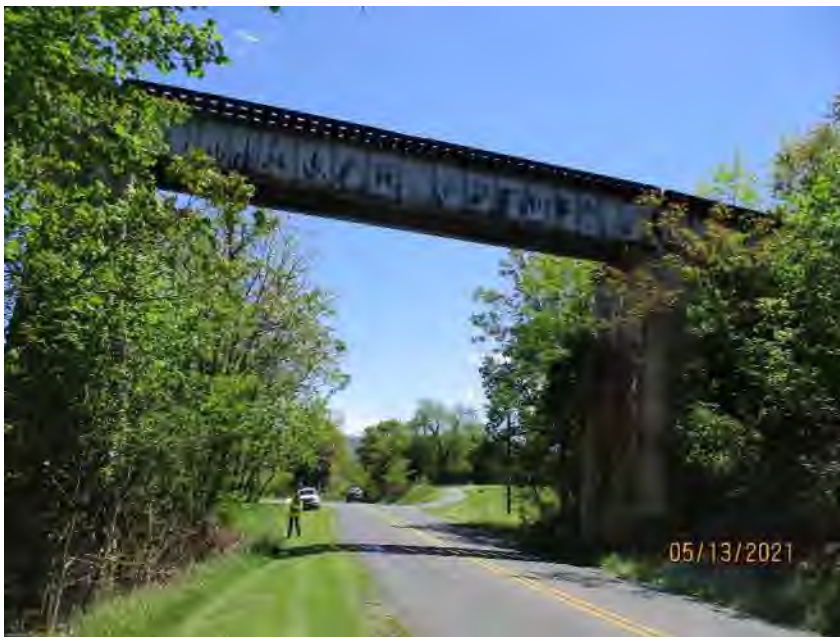
Photo #2

In general, the steel superstructure elements are in good condition. Surface rust exists on all steel members. The superstructure exhibits trace evidence of paint with no protective value remaining. At time of inspection no measurable section loss was observed to members. See Photos #2-#3.

Span 2

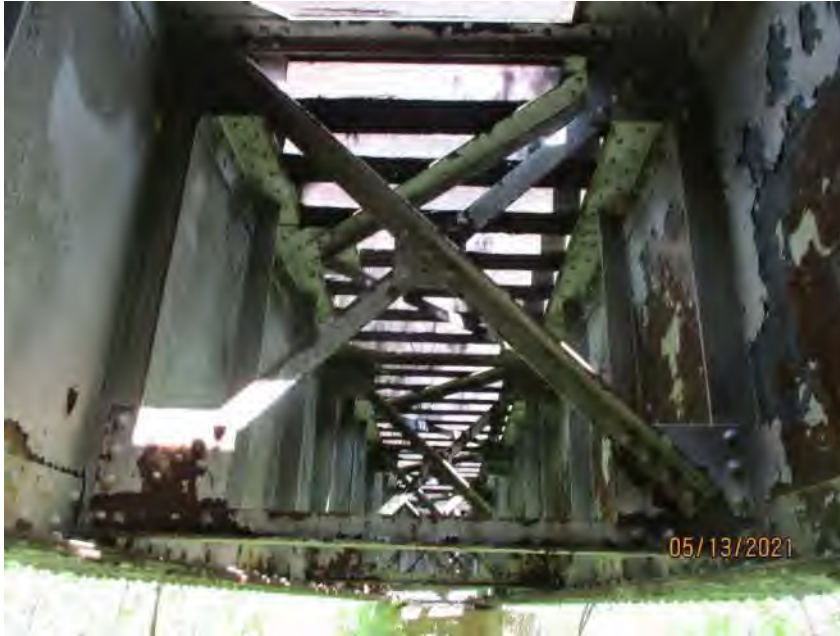
Photo #3

Span 1

Typical girder configuration with failed protective coating and minor surface rust throughout.

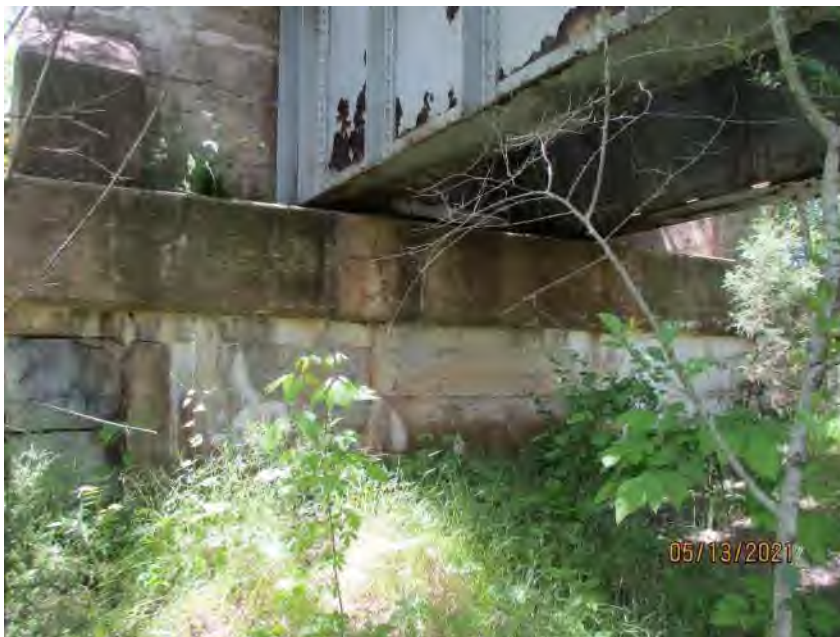
Photo #4

Abutment A is in good condition with vertical cracking throughout and stone masonry missing mortar. See Photo #4.

Abutment A

Abutments are in good condition with few areas of missing mortar and vertical cracking.

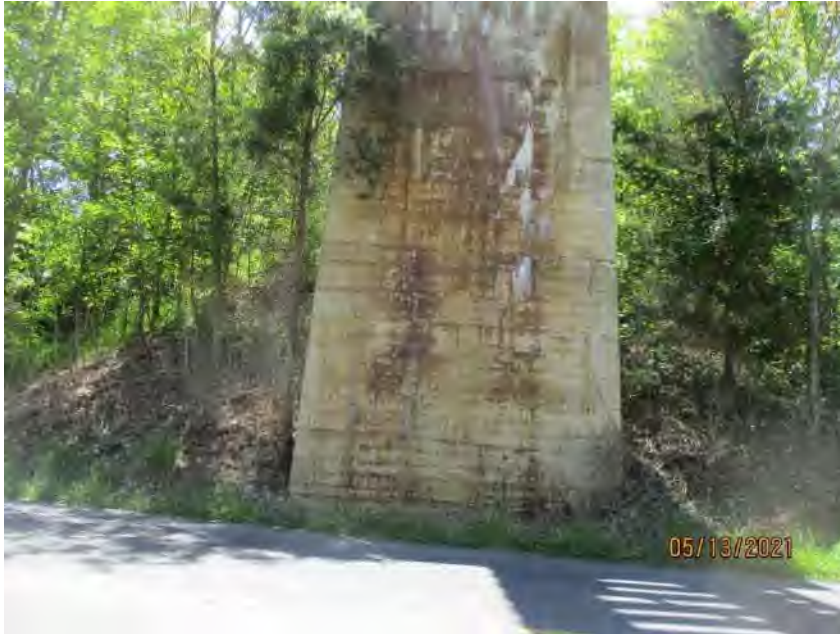
Photo #5

Pier 1 is in fair condition with map cracking and heavy efflorescence. See Photo #5.

Pier 1

Map cracking with heavy efflorescence.

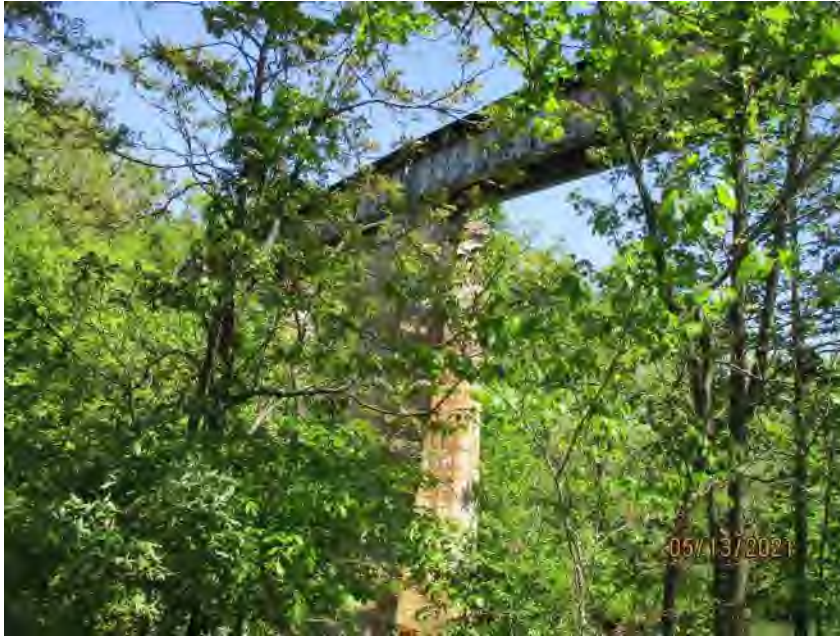
Photo #7

Pier 3 is in fair condition with map cracking and efflorescence. See Photo #7.

Pier 3

Map cracking efflorescence.

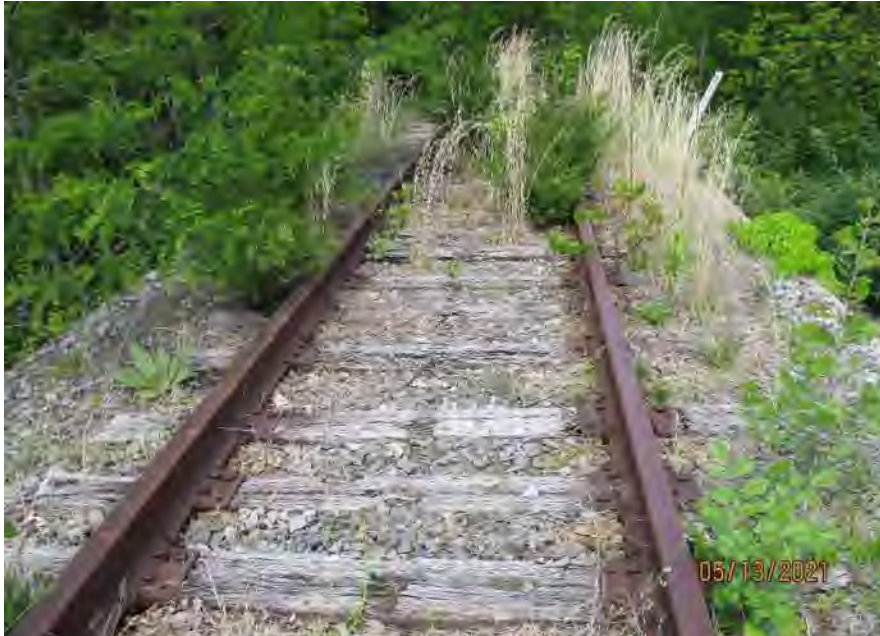
Photo #9

Abutment B is in good condition with minor erosion on both sides. Because of the steep slope and heavy vegetation, the condition of the full abutment could not be assessed. There is vegetation growth along the path. See Photo #8 & #9.

Abutment B
